# Apalachin Creek Background Report

Tioga County Soil and Water Conservation District

**DECEMBER 2019**

Inter-Fluve Engineering  
501 Portway Avenue, Suite 101  
Hood River, OR 97031

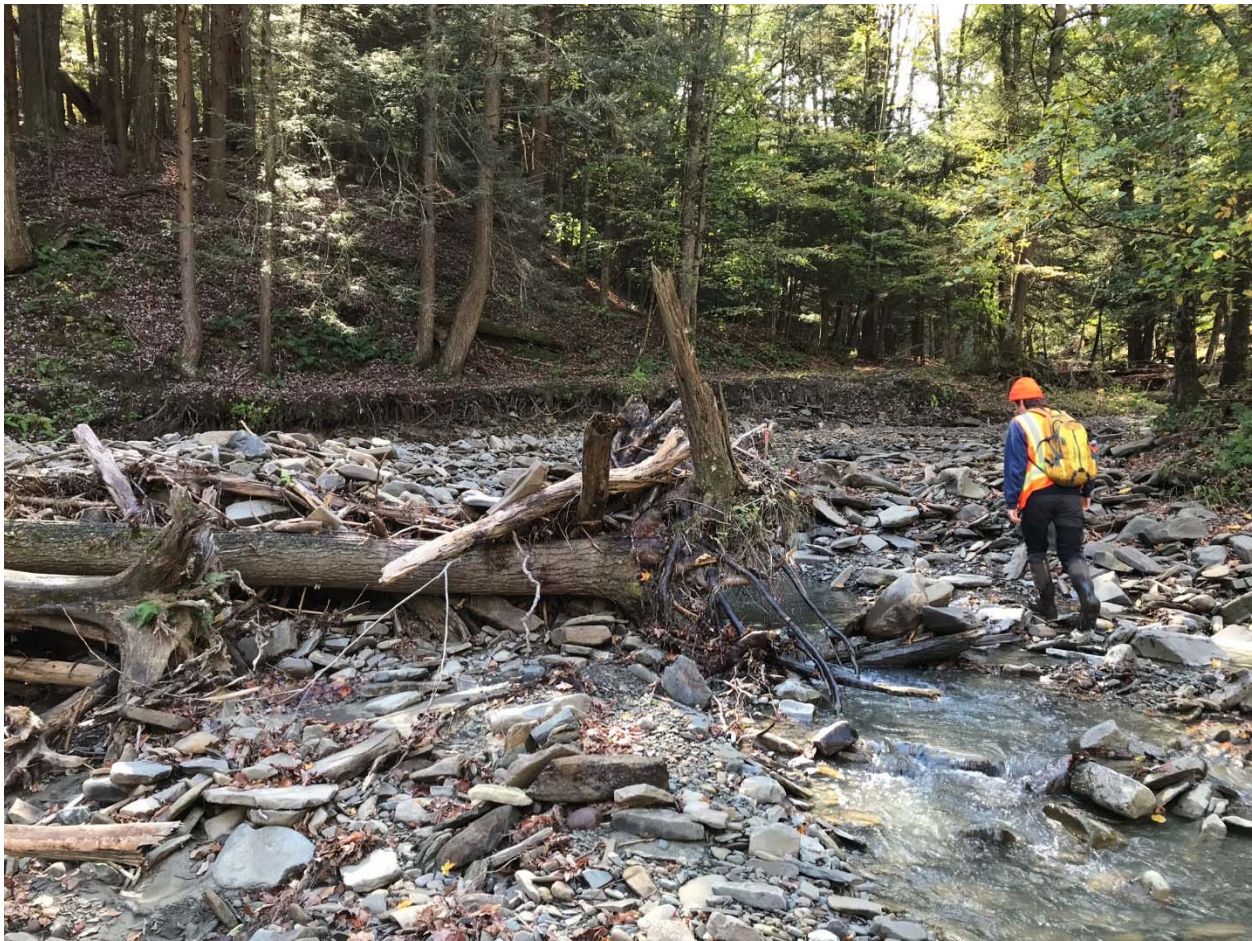
***Figure 8. Example of large wood in the unnamed tributary along Fox Road. Note how flow has bypassed the large woody debris jam by cutting a new channel on the right side of the picture. The flat bench along the forest floor visible in the background is the former top of bank corresponding to when the debris jam functioned as local grade control and defined the channel thalweg elevation. Note that although bypassed, the wood has remained in place, continuing to retain a substantial volume of coarse sediment. Photo taken October 19, 2018.***

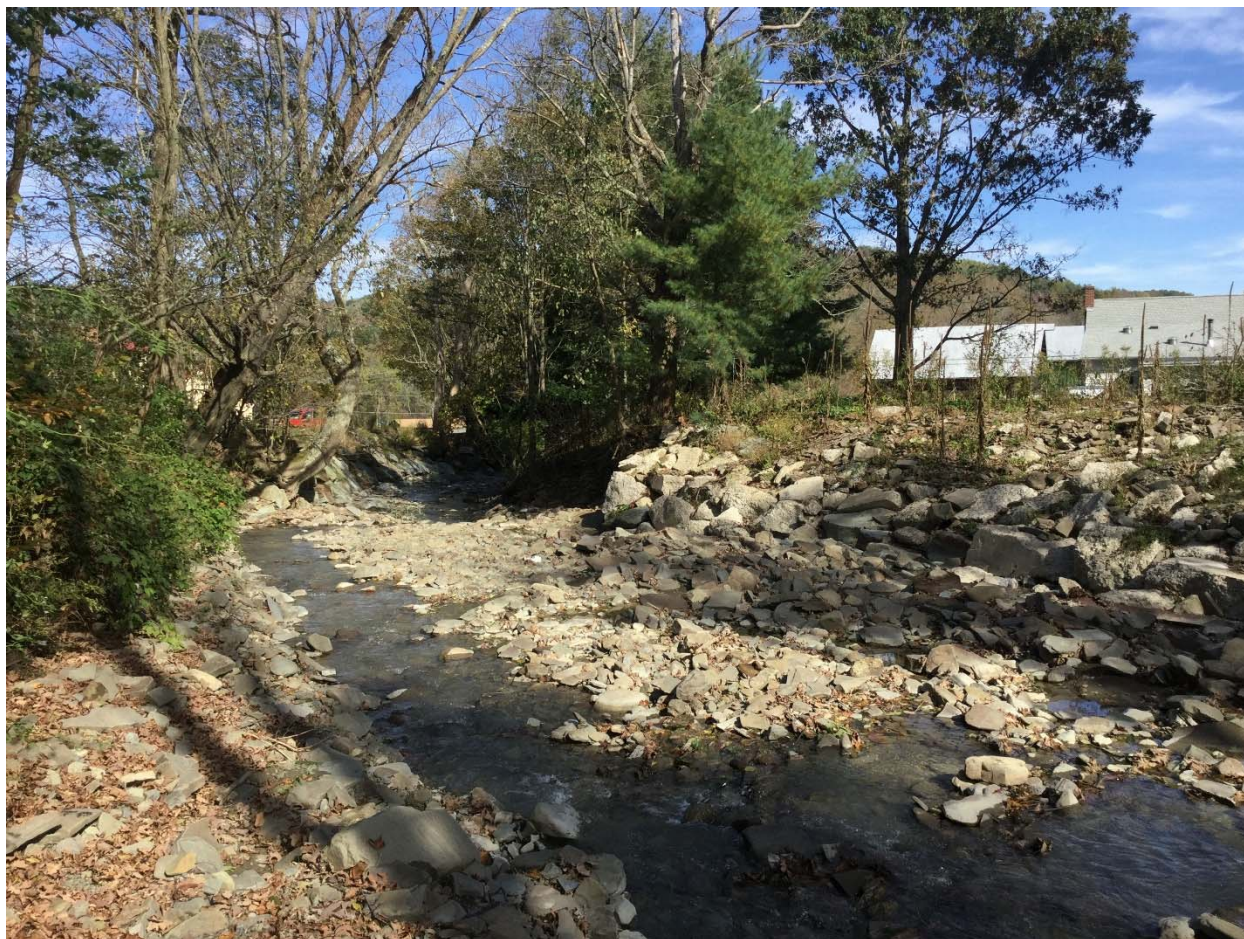
The lower reach of the Fox Road tributary has been straightened and channelized with agriculture, residences, and infrastructure encroaching on both banks (Figure 9). Rip rap has been locally placed to prevent lateral movement of the stream and protect infrastructure. In addition, field observations during the culvert inspection (see Appendix C) suggest culvert placement and elevation affects the overall longitudinal slope of the creek.

***Figure 9. Lower reach of the unnamed tributary along Fox Road showing rip rap placed on the channel banks to protect infrastructure and private property. Photo taken October 19, 2018.***

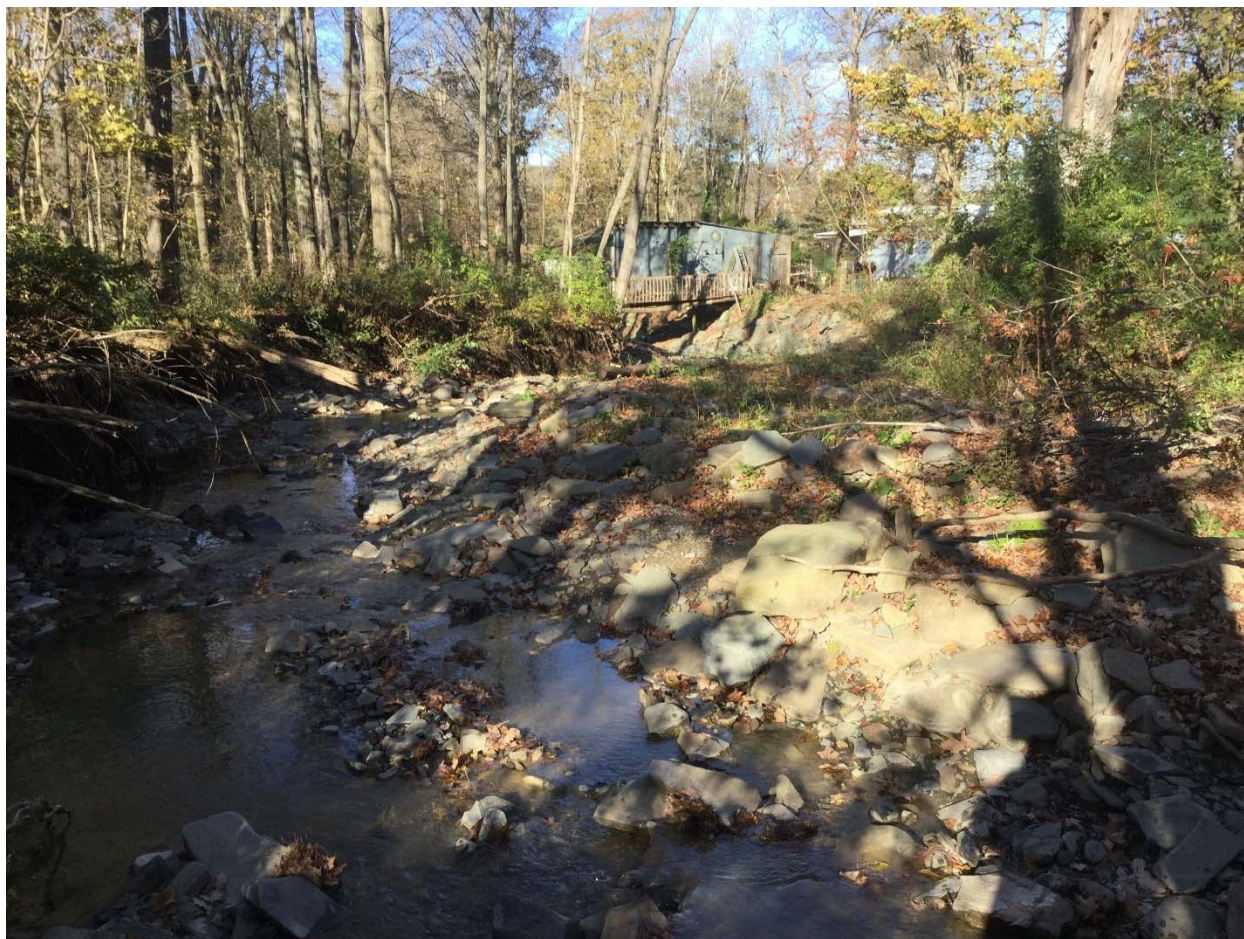
The unnamed tributary along Harnick Road is 1.4 miles long with an average slope of 0.05 ft/ft (Figure 10). The profile shows no steep, upper reach in this particular watershed, and that is corroborated by field observations. The headwaters upstream of Harnick Road instead consist of various field and road drainage channels that converge near the beginning of a recognizable channel at Harnick Road. The mid-upper reach extends to station 6,000 feet and flows through a narrow, forested corridor adjacent to pastured or mowed fields. The middle reach of the tributary runs through a steep forested valley with minimal floodplain. The lower reach downstream of station 1,200 feet is entrenched below the former floodplain with poor connectivity. Houses built near the channel are being threatened by bank erosion (Figure 11).

***Figure 11. House built near the bank of the unnamed tributary along Harnick Road. Photo taken October 19, 2018.***

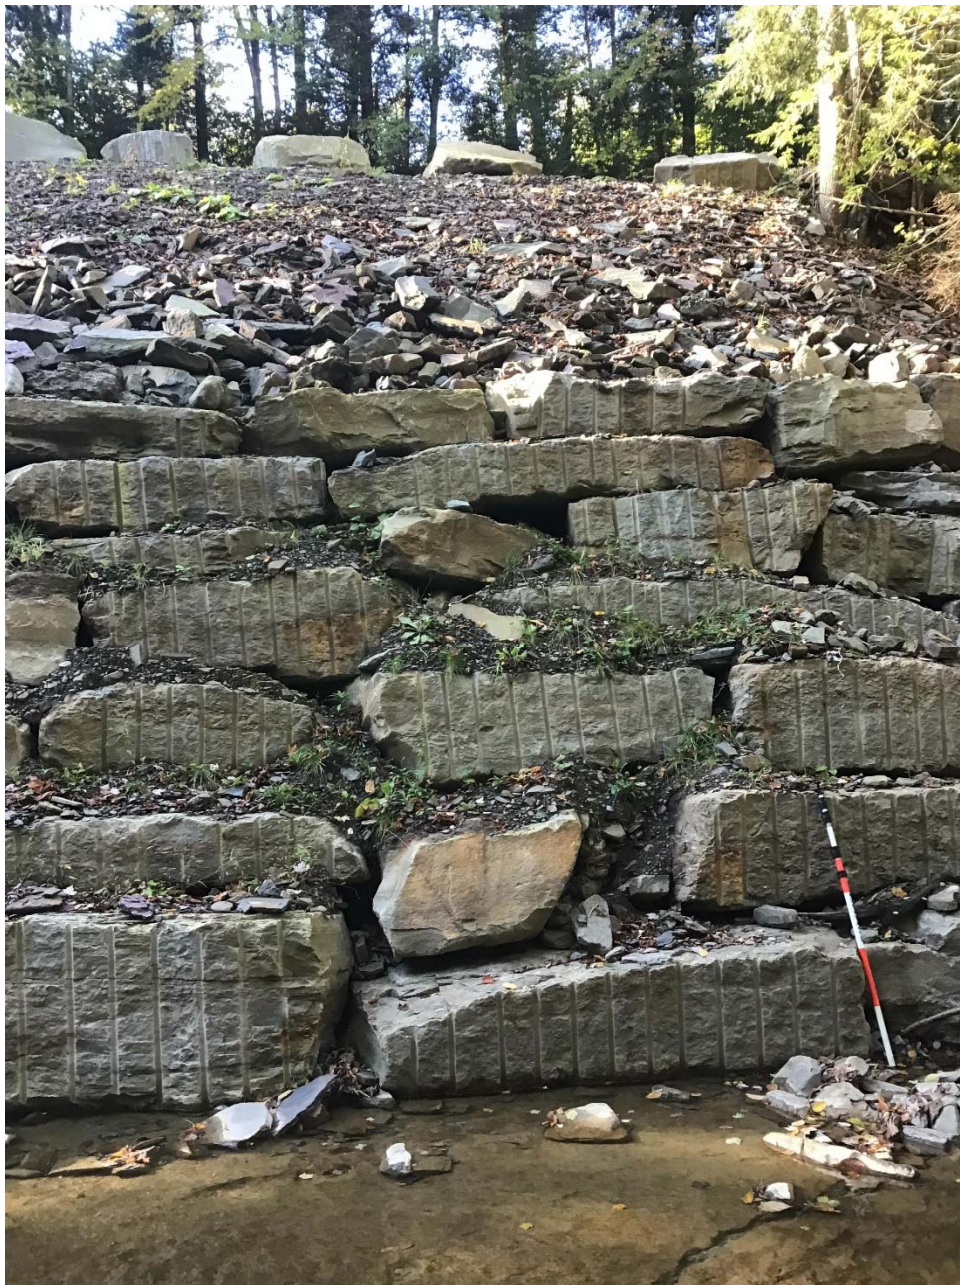
The middle reach of the Gaylord Road tributary is characterized by a confined channel with limited overbank areas; Gaylord Road runs along the top of the bank. Bank erosion threatens the road in numerous places, many of which have been stabilized using large rock revetment (Figure 16). The lower reach of the tributary extends from station 1,000 feet to the creek mouth. The channel has been straightened and dredged, and the culvert beneath Gaylord Road at station 600 feet is perched with bank erosion occurring along the downstream banks. The structural condition of the crossing is considered critical (see Appendix C).

***Figure 16. Stacked stone revetment used to protect Gaylord Road from being eroded by the creek. Photo taken October 19, 2018.***

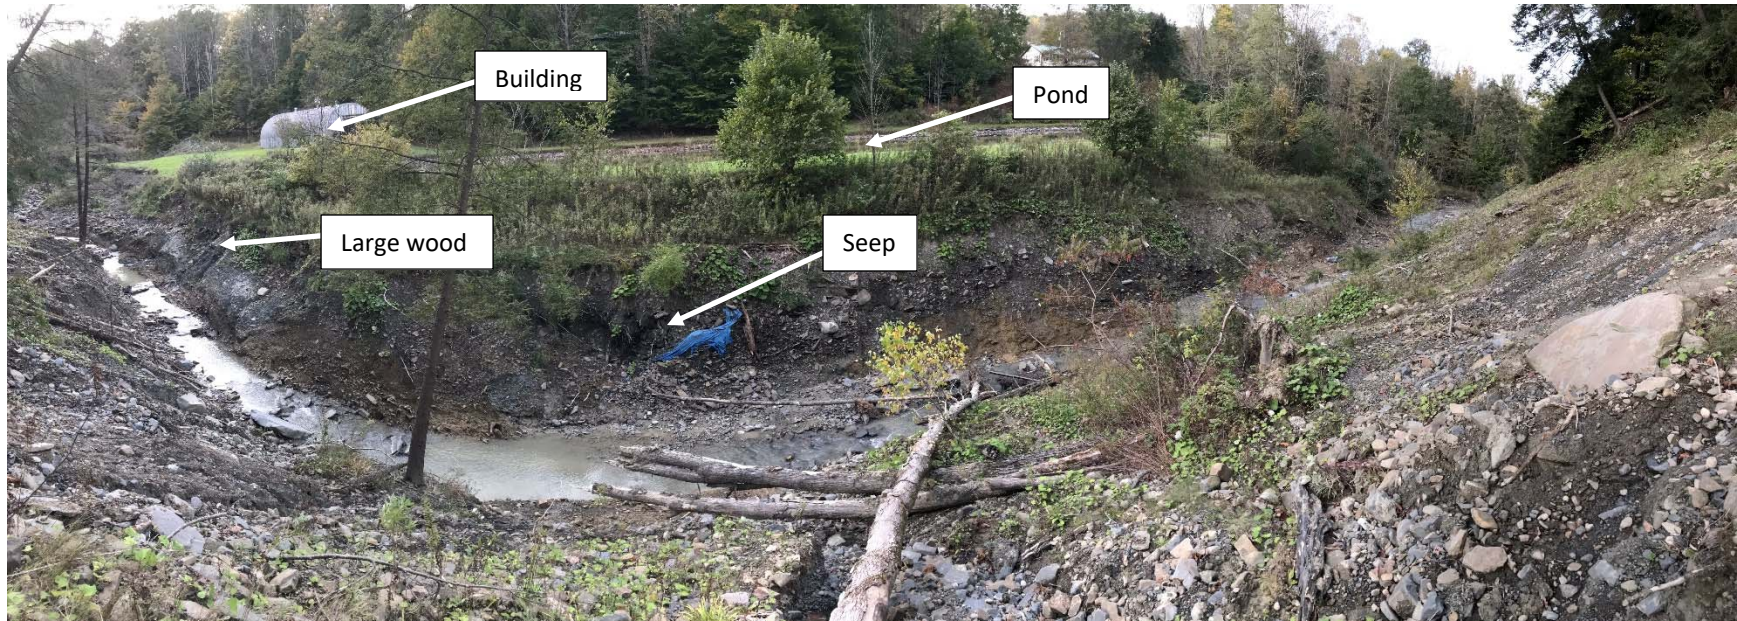
***Figure 19. Panoramic view of incised channel and left bank with pond. Location of seep is noted. Blue article in photograph is a geotextile trapped within slumped bank material below the seep. Photo taken October 19, 2018.***

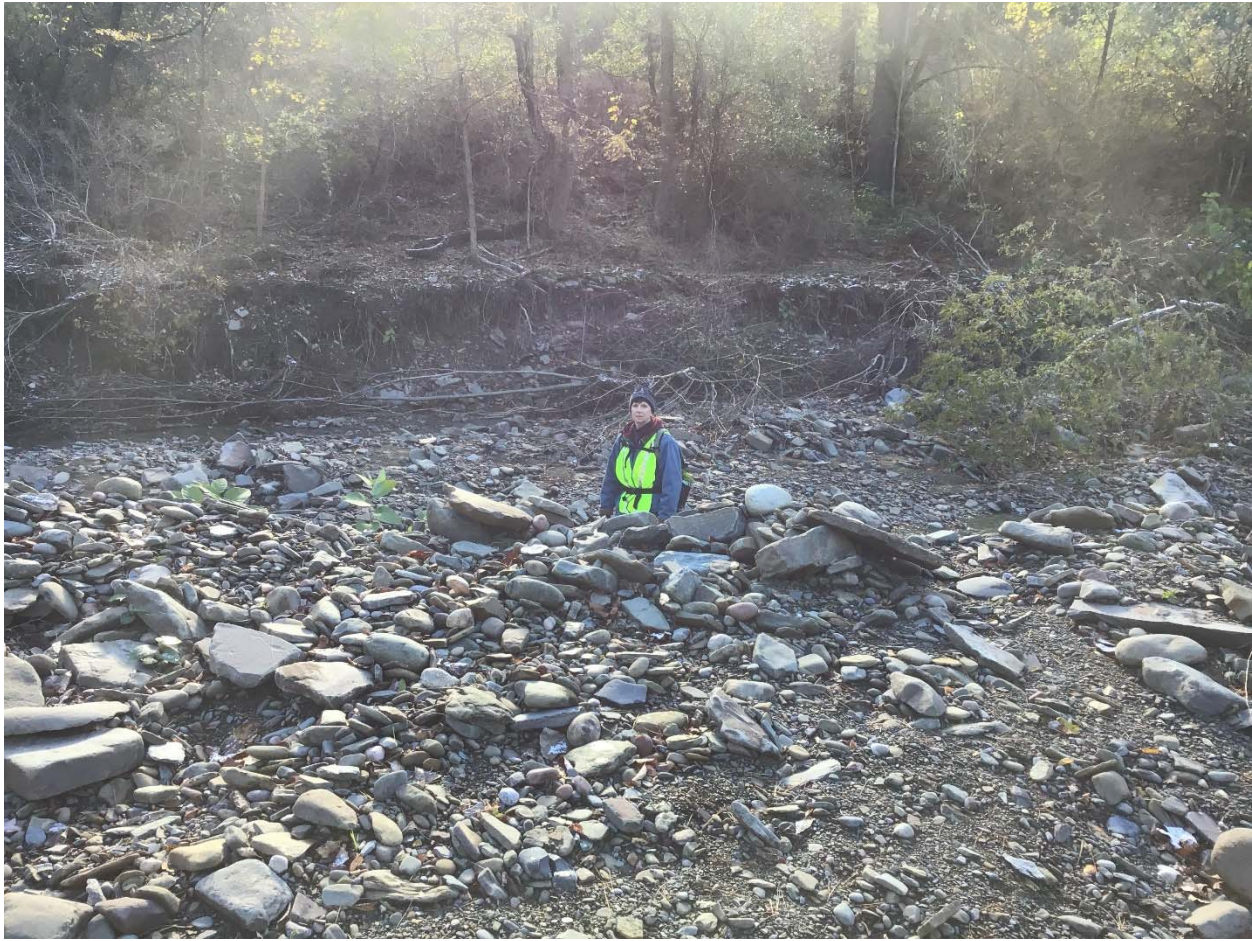
***Figure 20. Bar deposited a short distance downstream of incised channel at pond. Exposed roots and undercut tops of the opposite bank suggest that bank erosion occurred during recent high flows. Photo taken October 18, 2018.***

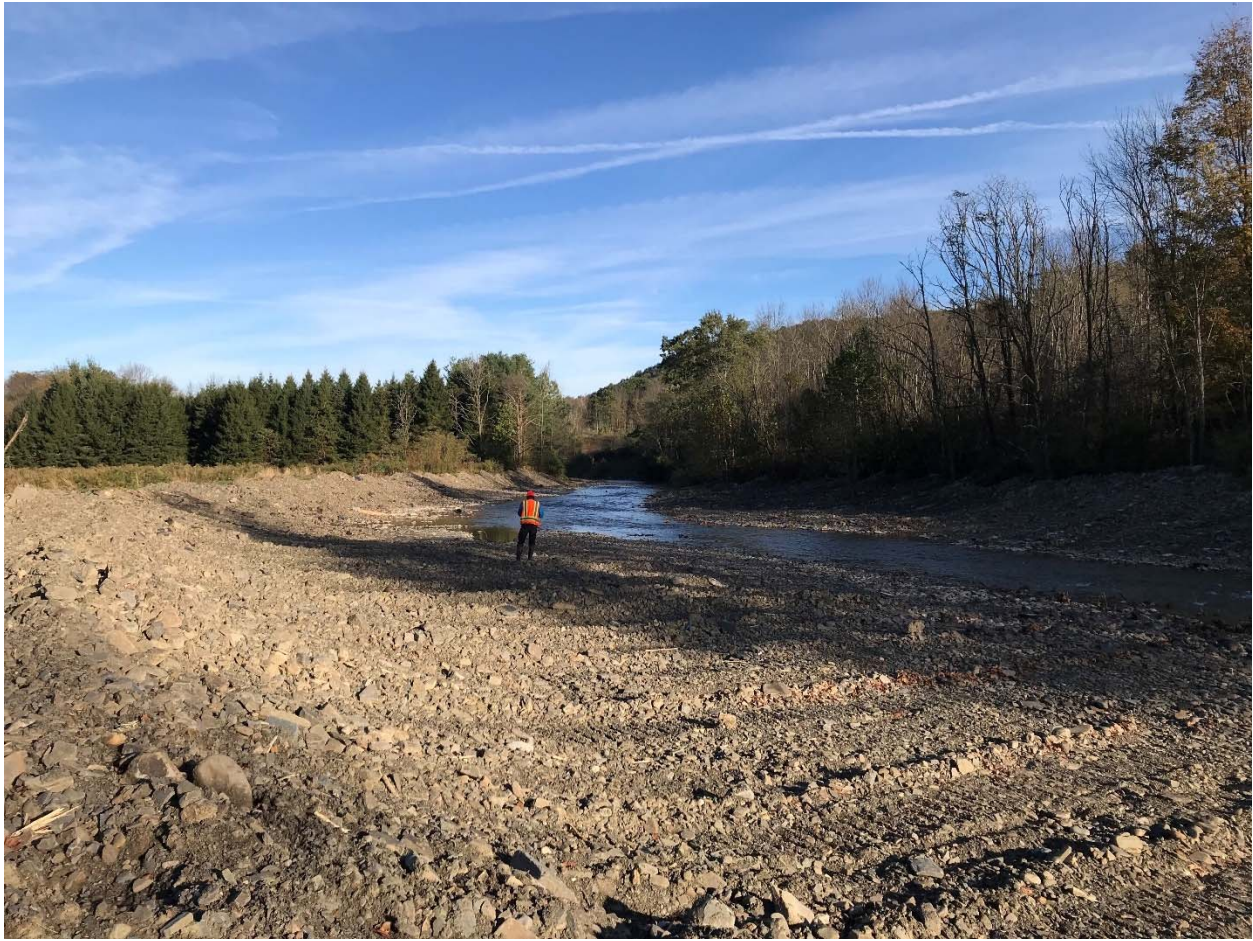
***Figure 28. Looking downstream along Apalachin Creek near Ap-30000. Dredging and berming of the channel has resulted in an over-wide cross section, which reduces the channel's ability to transport sediment, resulting in deposition and more dredging. Furthermore, dredging is an activity that can have detrimental effects on upstream bed levels (i.e., causing headcutting), downstream hydraulics and sediment transport, aquatic habitat, and riparian species and therefore requires a permit. Berming can reduce instances of overbank flow and floodplain storage, thereby increasing downstream flood peaks. Photo taken October 19, 2019.***

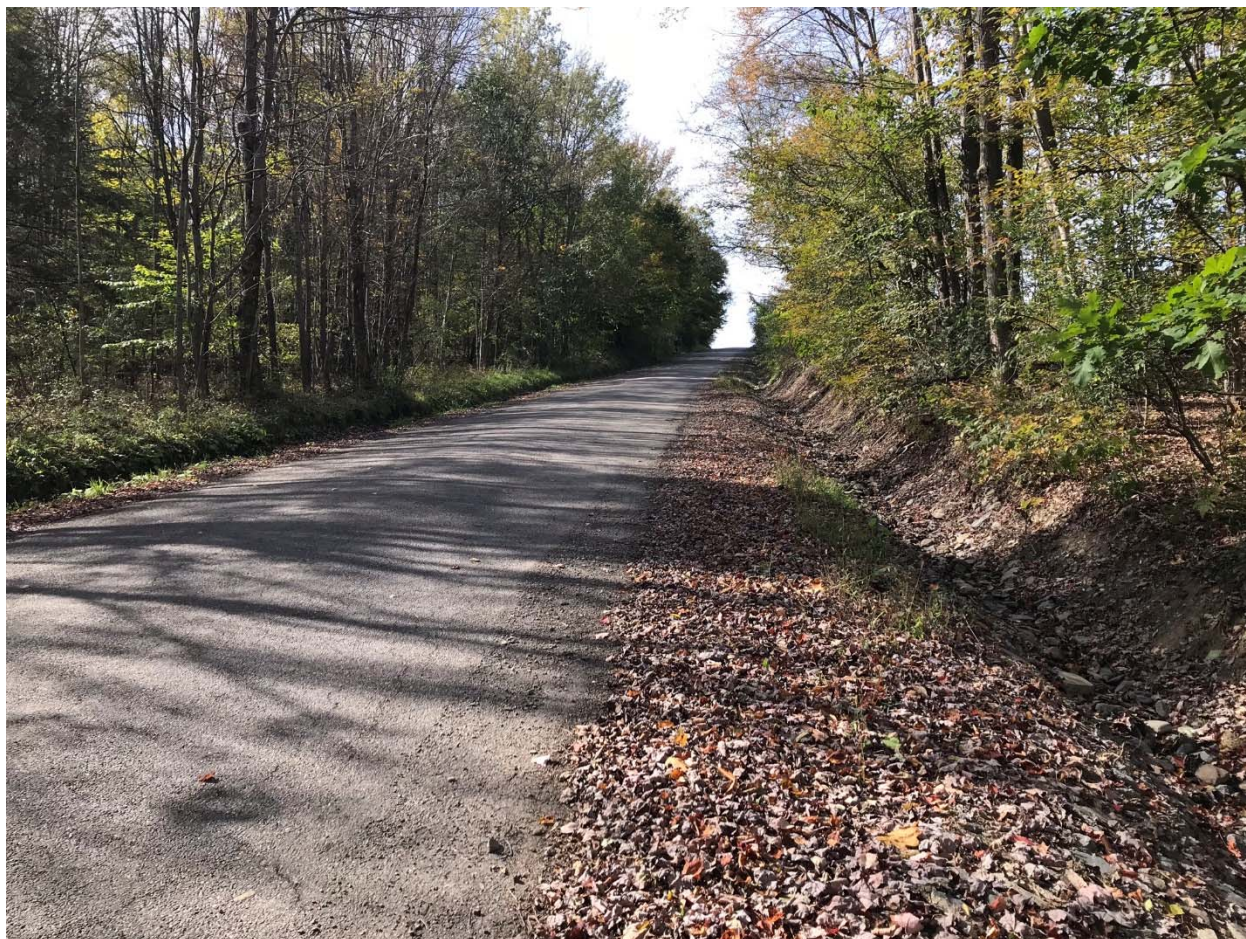
***Figure 35. Incised road ditch along Fox Road (ApFo-4000). Photo taken October 19, 2018.***

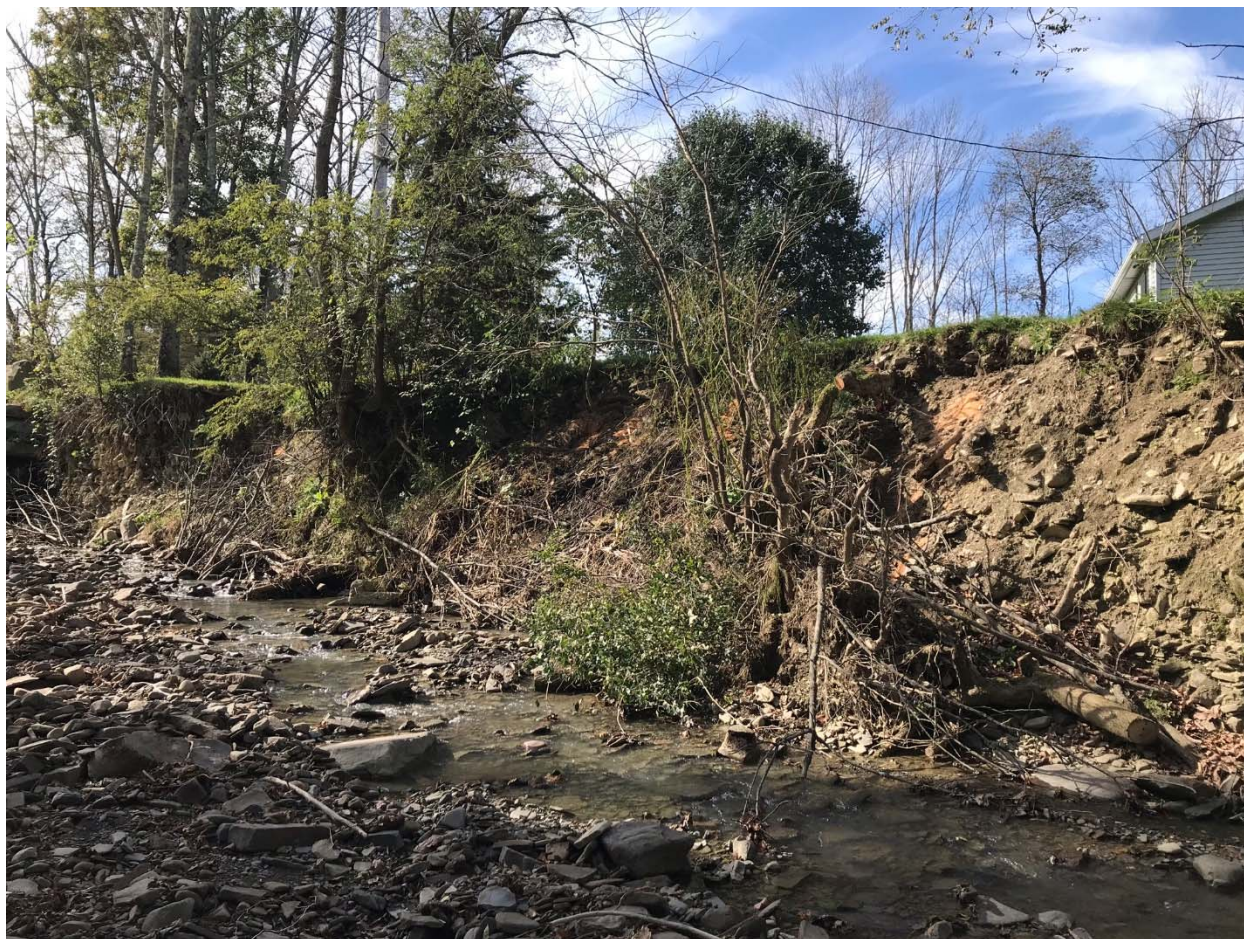
***Figure 37. Eroding bank immediately downstream of culvert at ApFo-1300. Note proximity of residence. Photo taken October 19, 2018.***

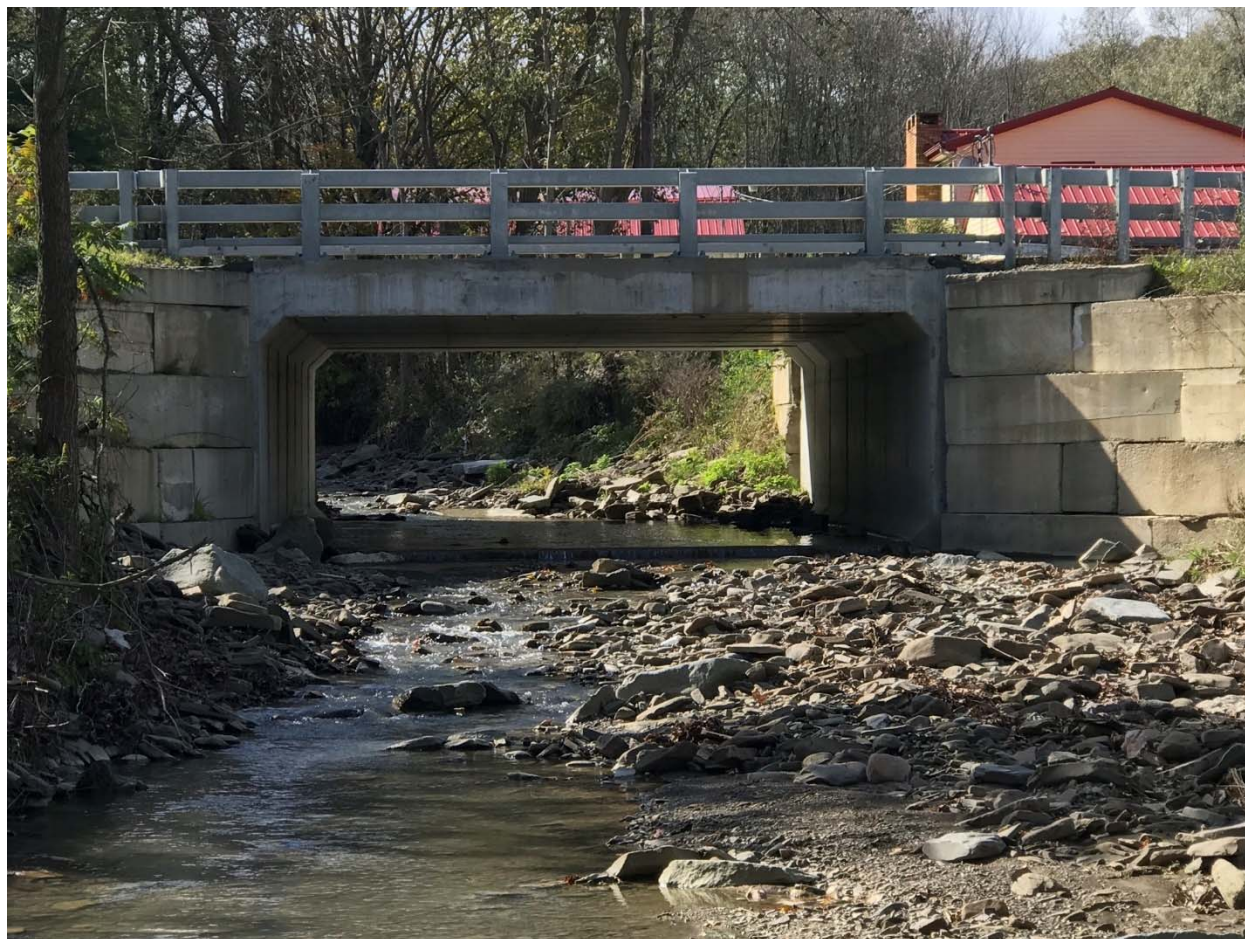
***Figure 38. Looking upstream at Pennsylvania Avenue crossing ApFo-600. Concrete bed is slightly perched. Photo taken October 19, 2018.***

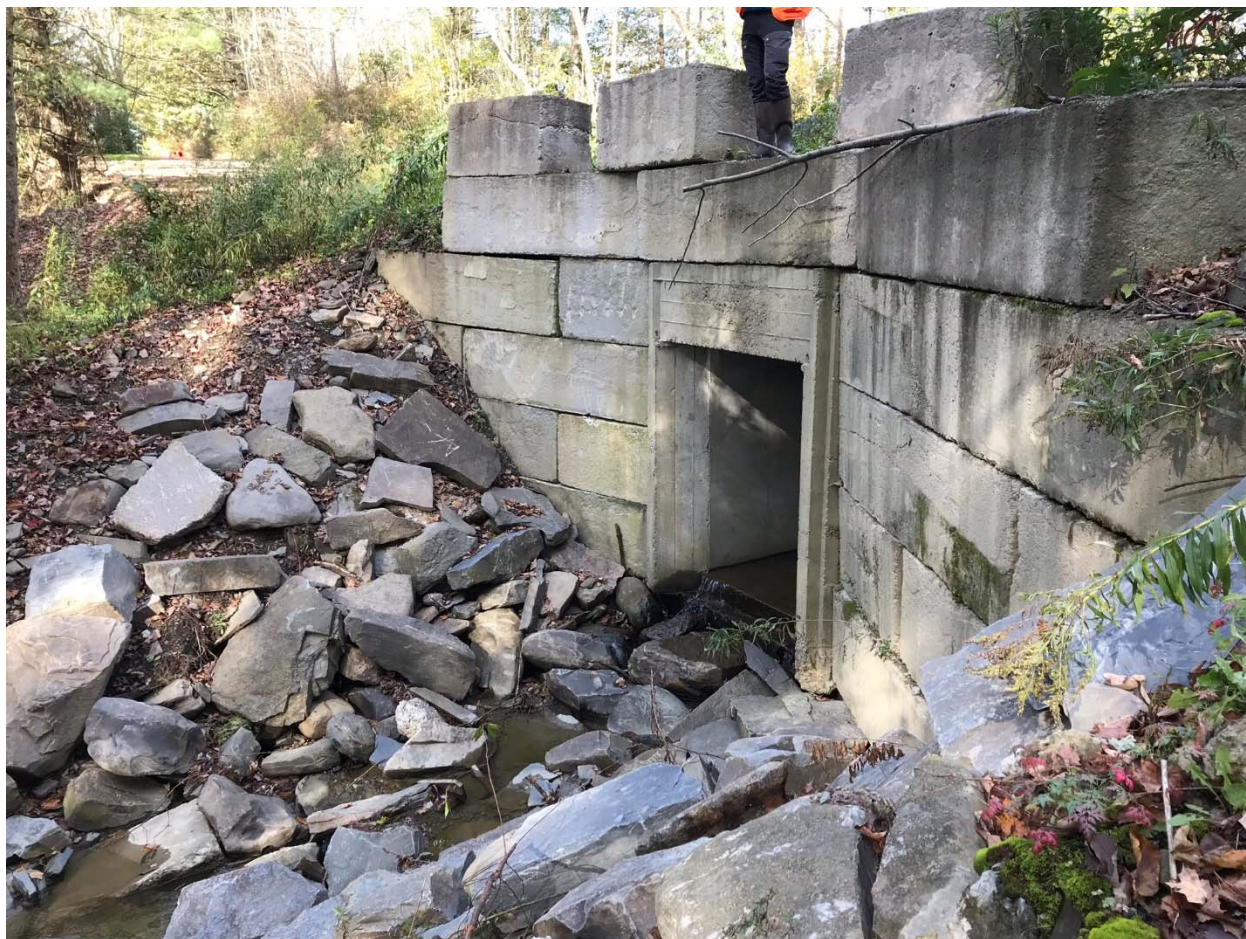
**Figure 40. Undersized box culvert at Apha-5800. Photo taken October 19, 2018.**

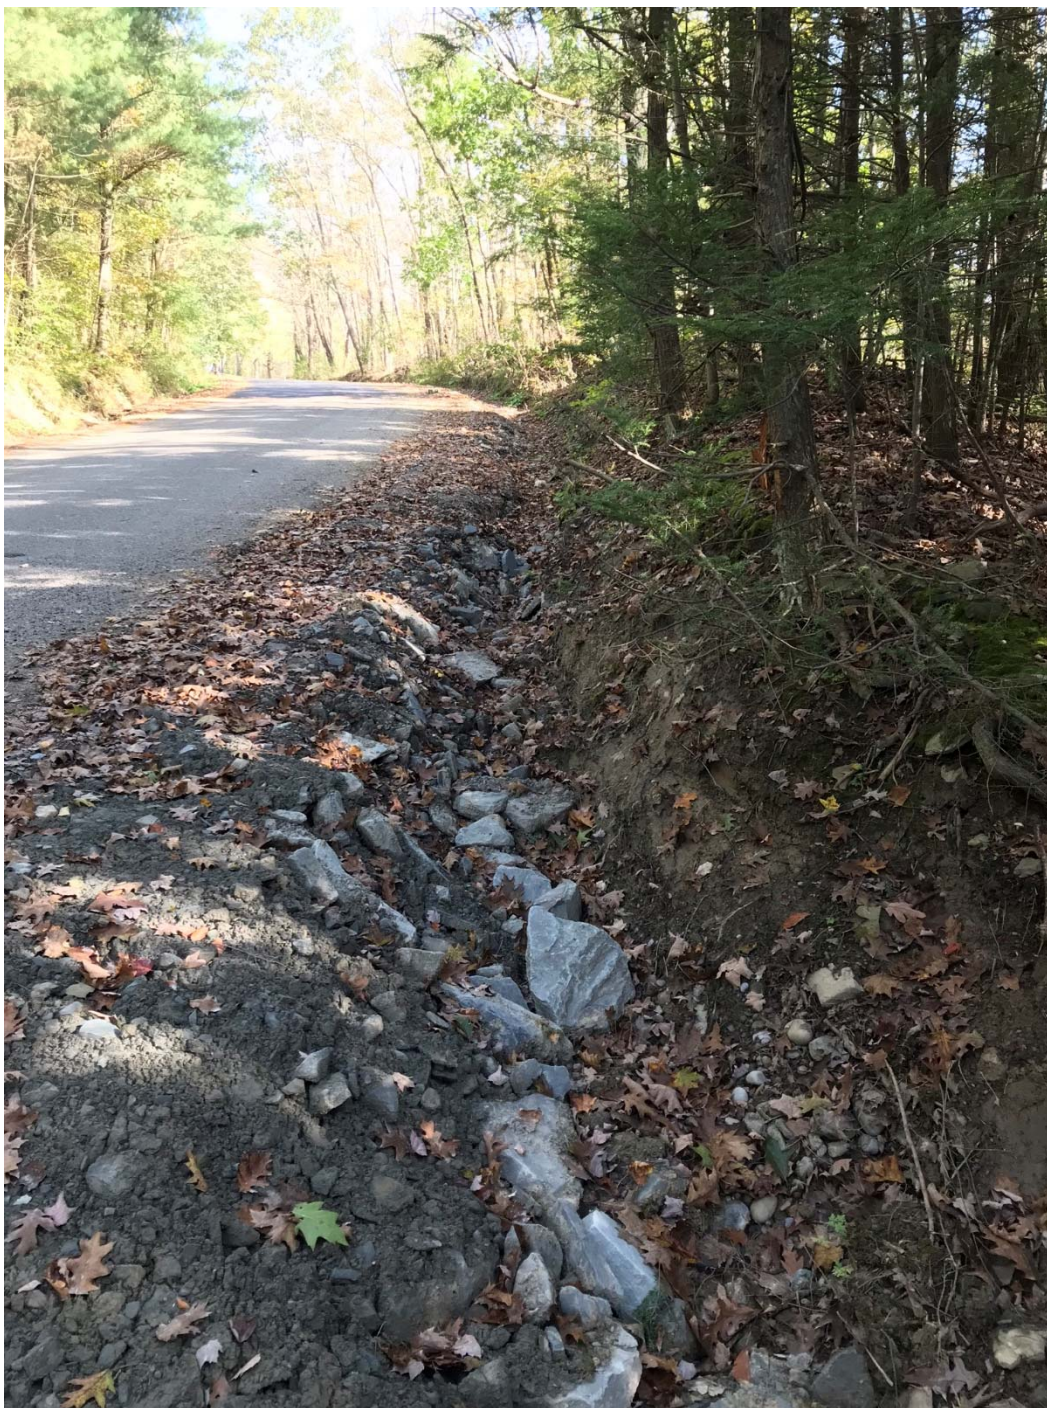
***Figure 42. Eroding road ditch along Harnick Road delivering sediment to the Harnick Road tributary (project ApHa-2600). Photo taken October 19, 2018.***

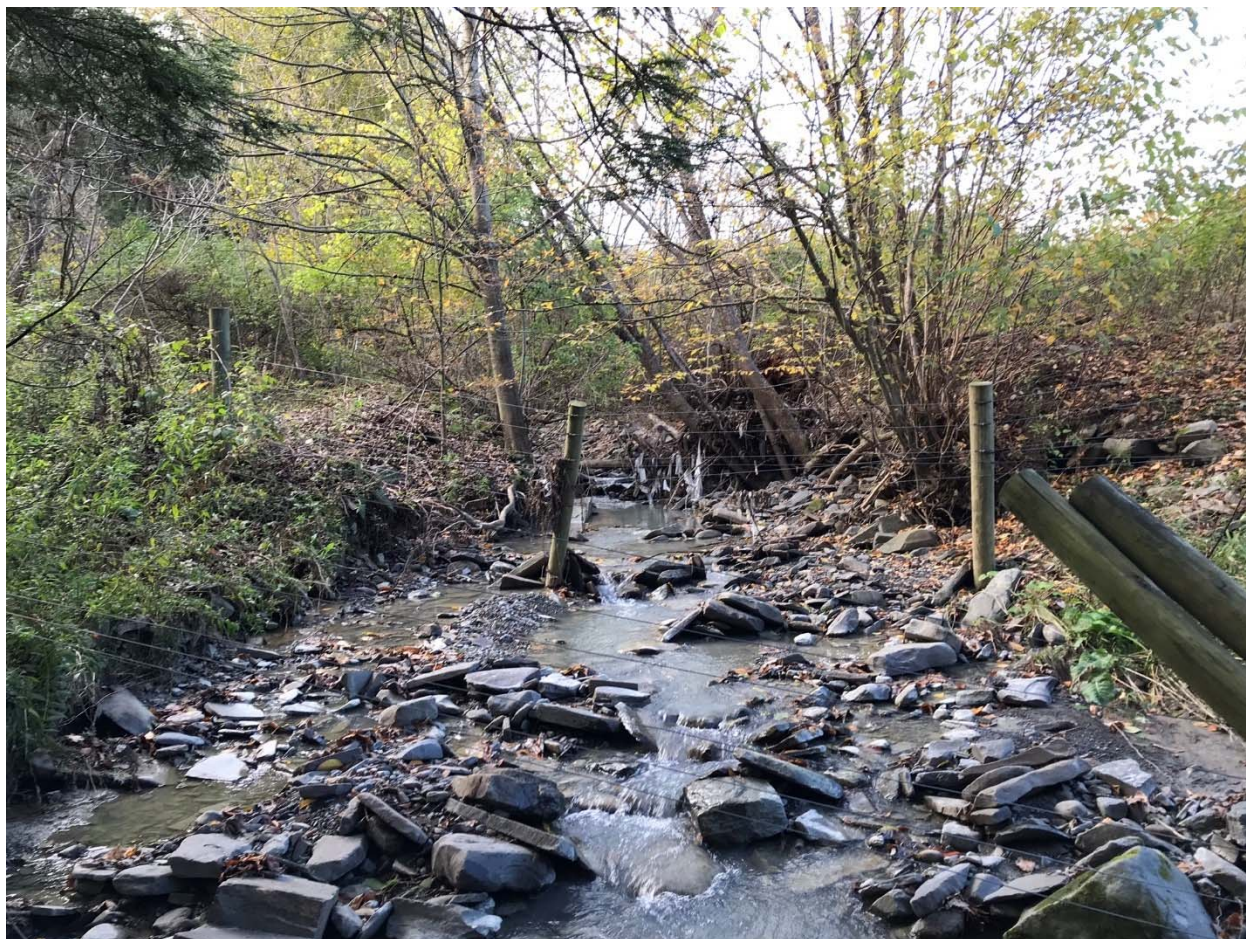
***Figure 46. Fence across channel at ApCa-3500. Photo taken October 19, 2018.***

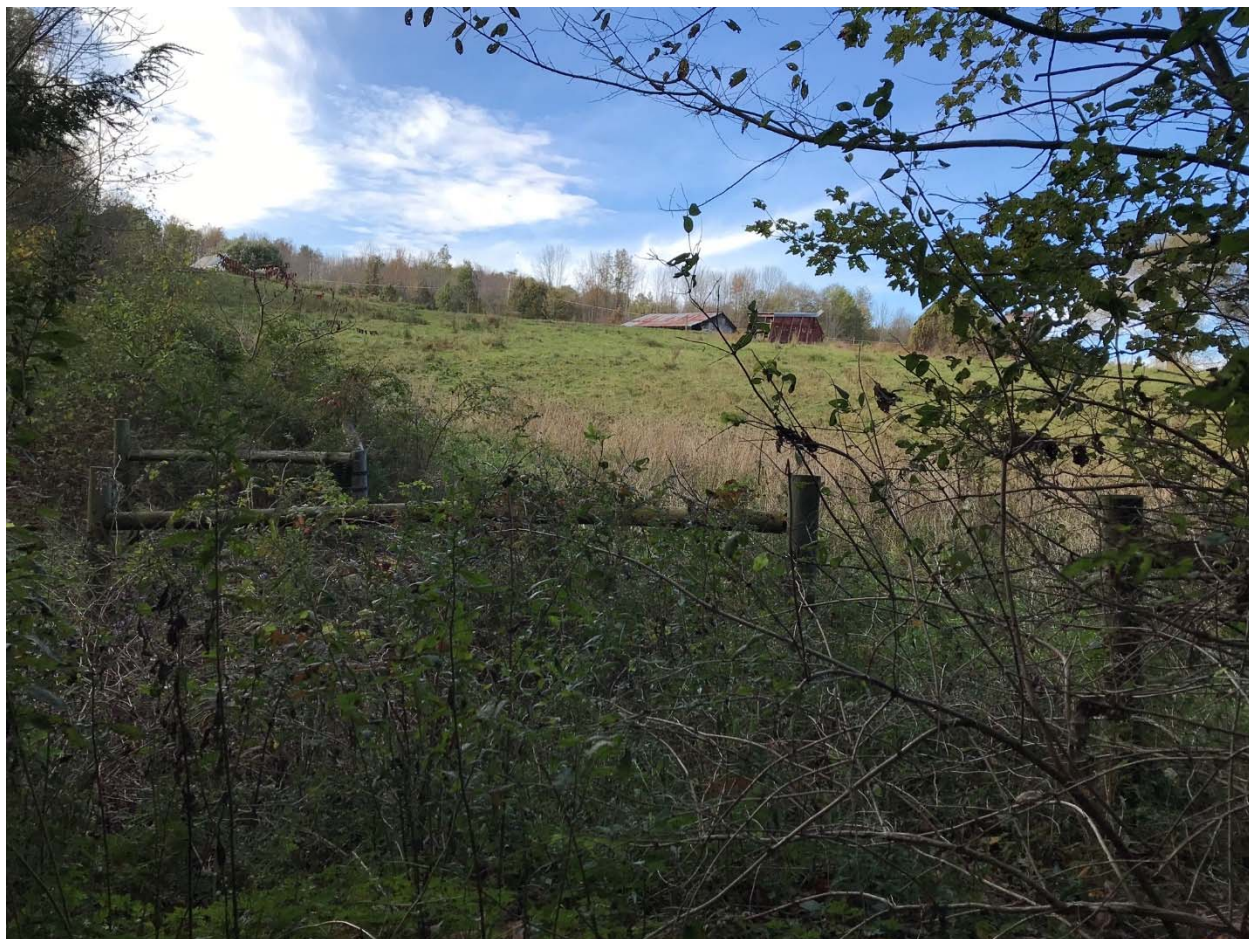
***Figure 47. Gap in riparian buffer at ApCa-3500. Photo taken October 19, 2018.***

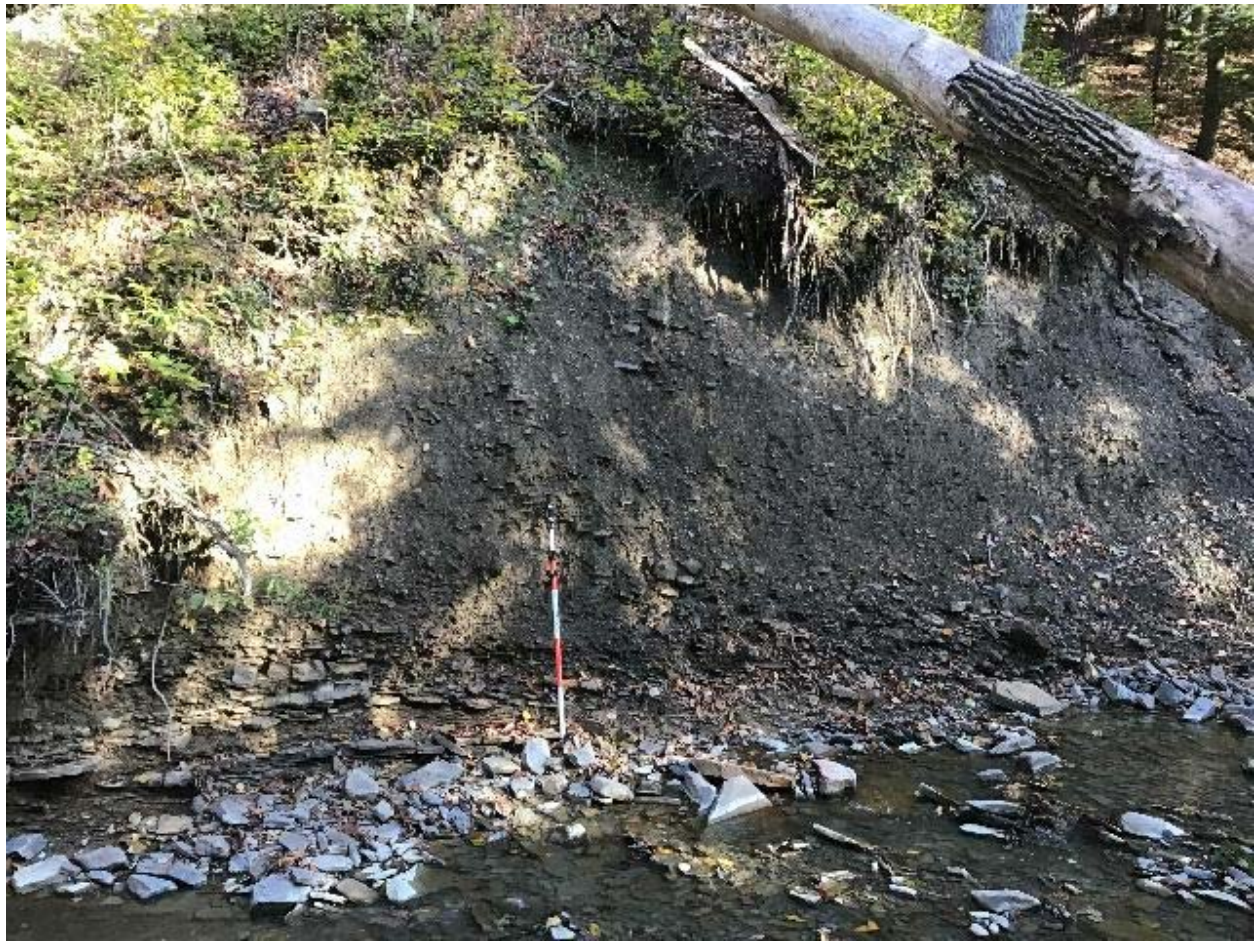
***Figure 58. Bank erosion at ApGa-3700. Photo taken October 19, 2018.***

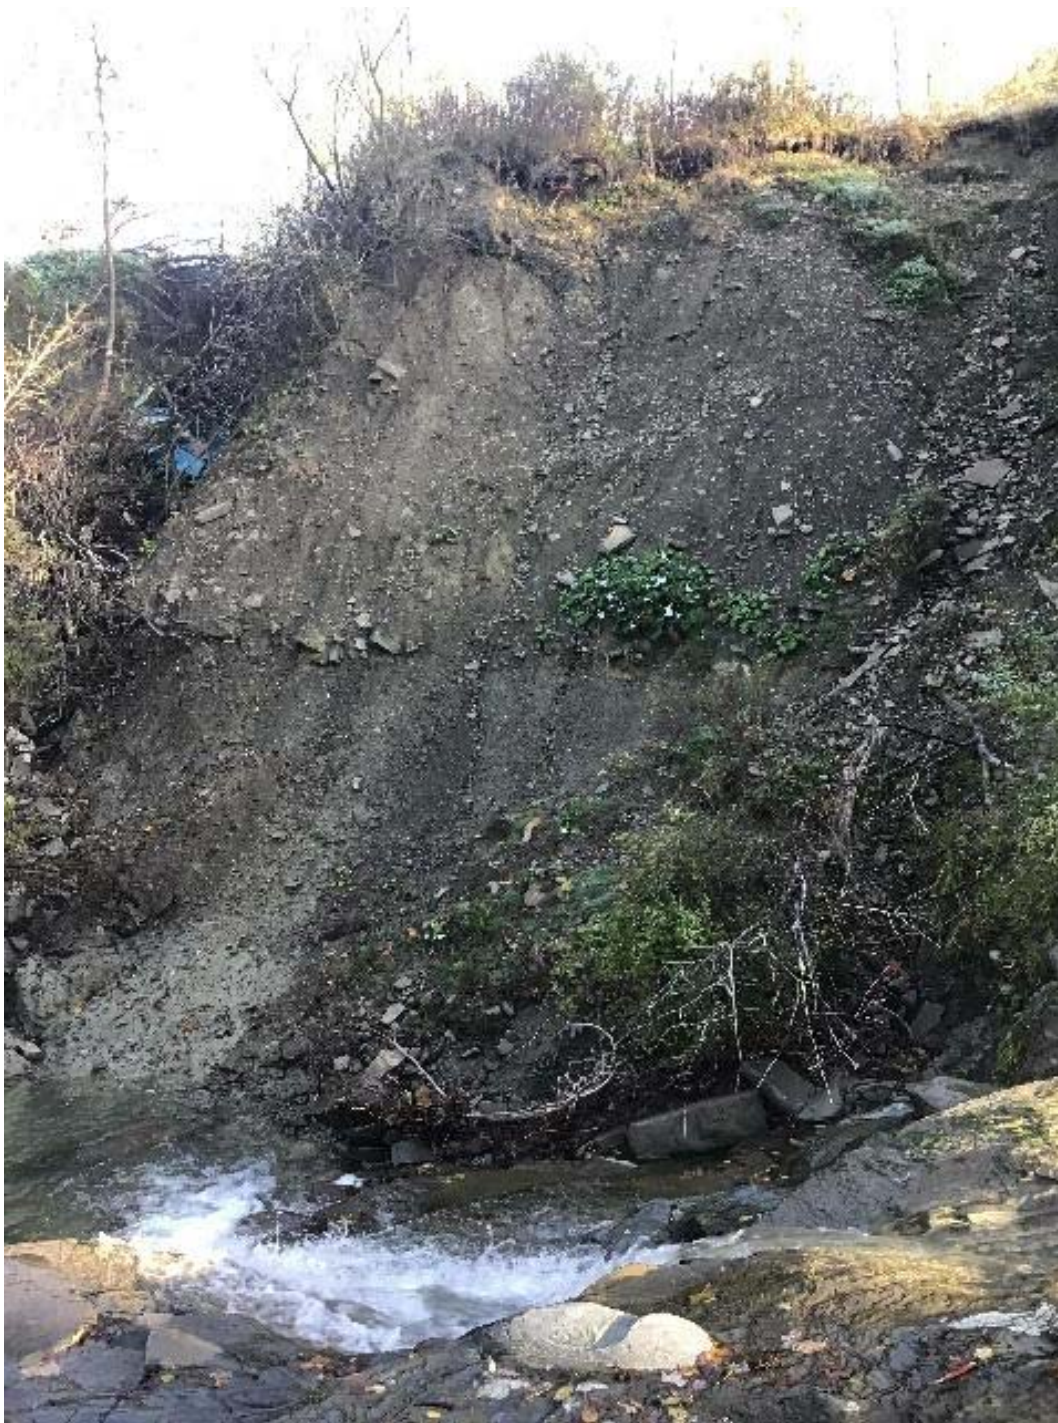
***Figure 59. Eroding bank at ApGa-1700. Photo taken October 19, 2018.***

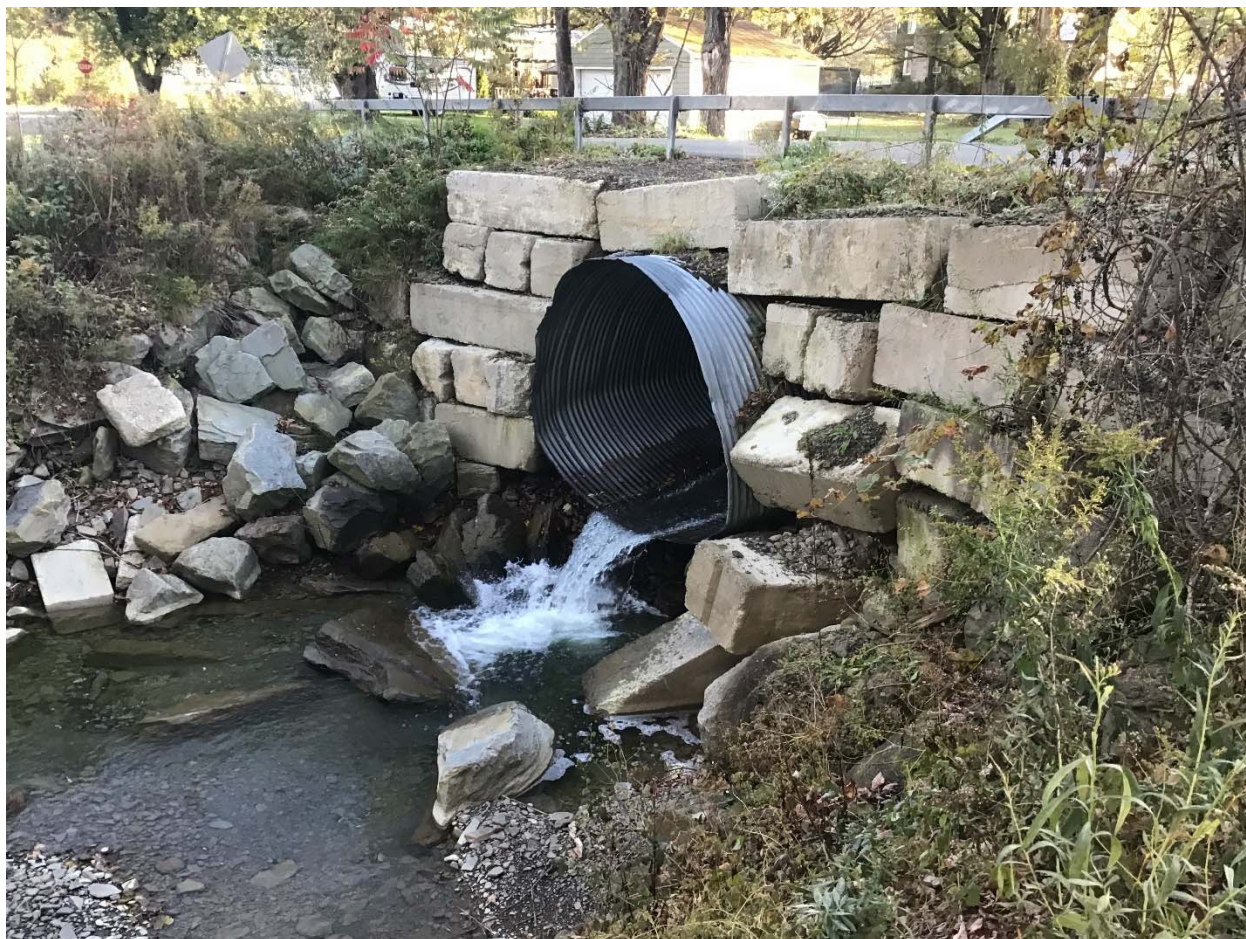
***Figure 60. Outlet of perched and undersized culvert at ApGa-600. Photo taken October 19, 2018.***
