# Apalachin Creek Background Report

Tioga County Soil and Water Conservation District

**DECEMBER 2019**

Inter-Fluve Engineering  
501 Portway Avenue, Suite 101  
Hood River, OR 97031

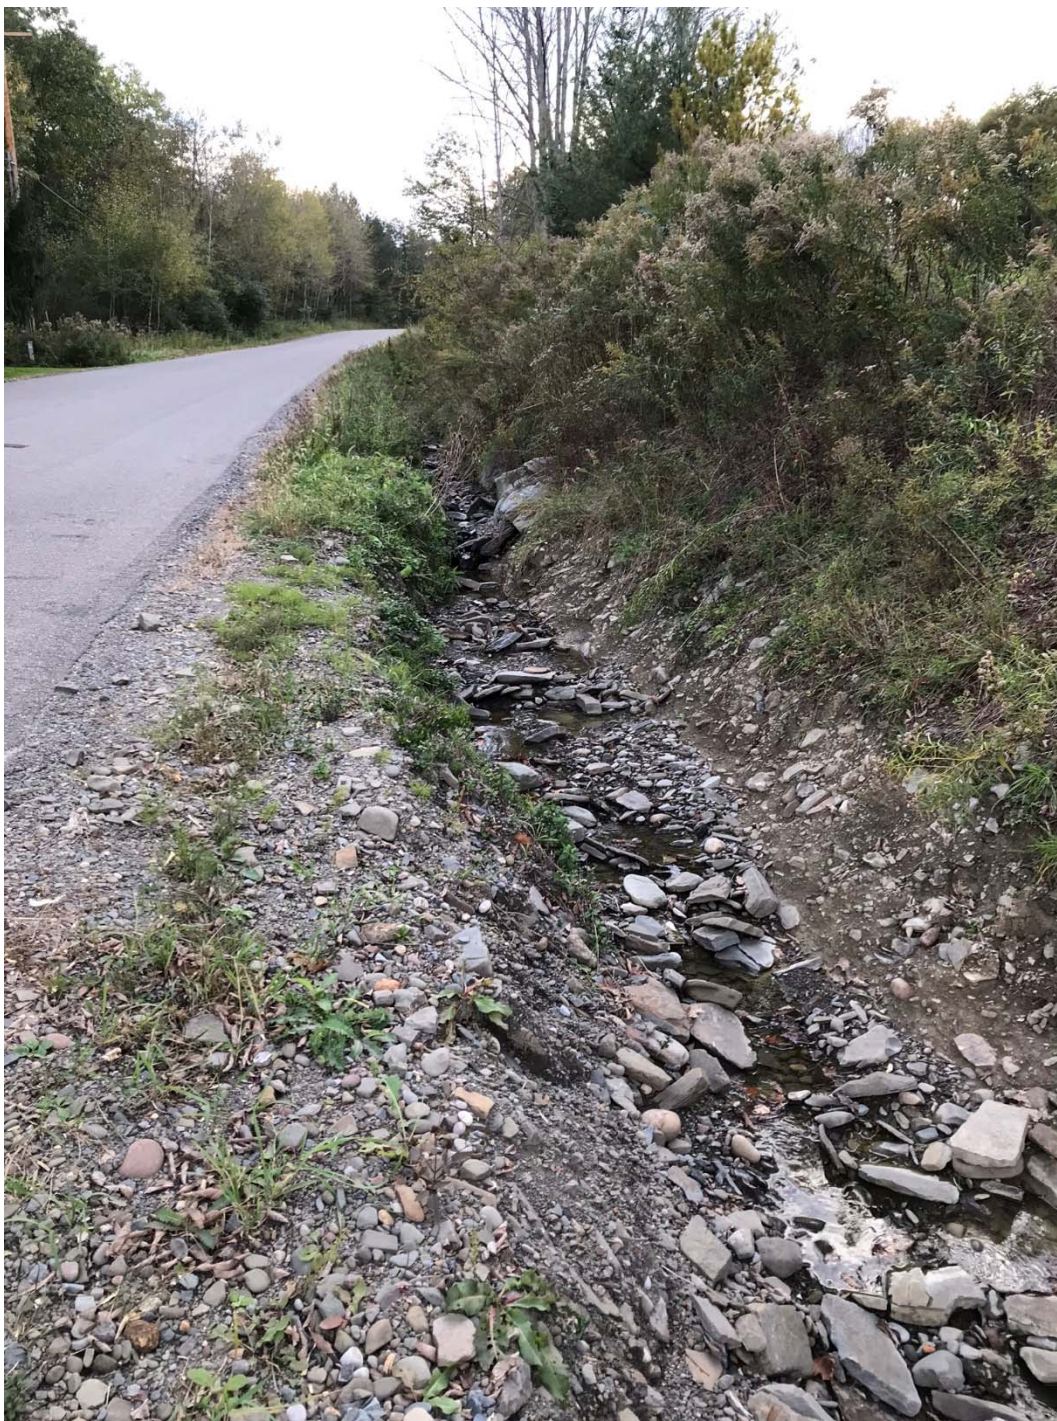
**Figure 62. Incised road drainage ditch along Long Creek Road (ApLo-10800). Photo taken October 19, 2018.**

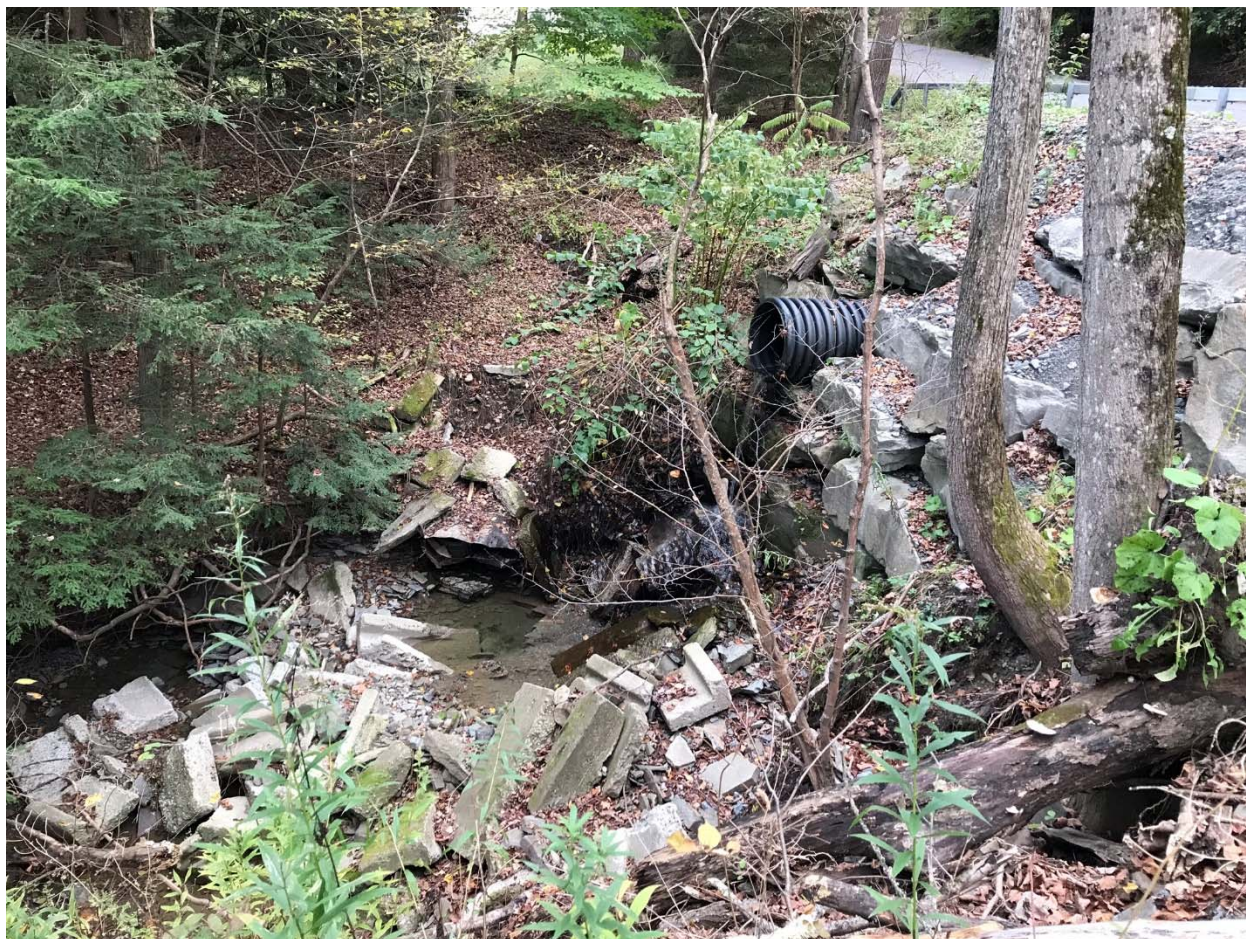
***Figure 66. Perched culvert outfall at ApLo-9200. Photo taken October 19, 2018.***

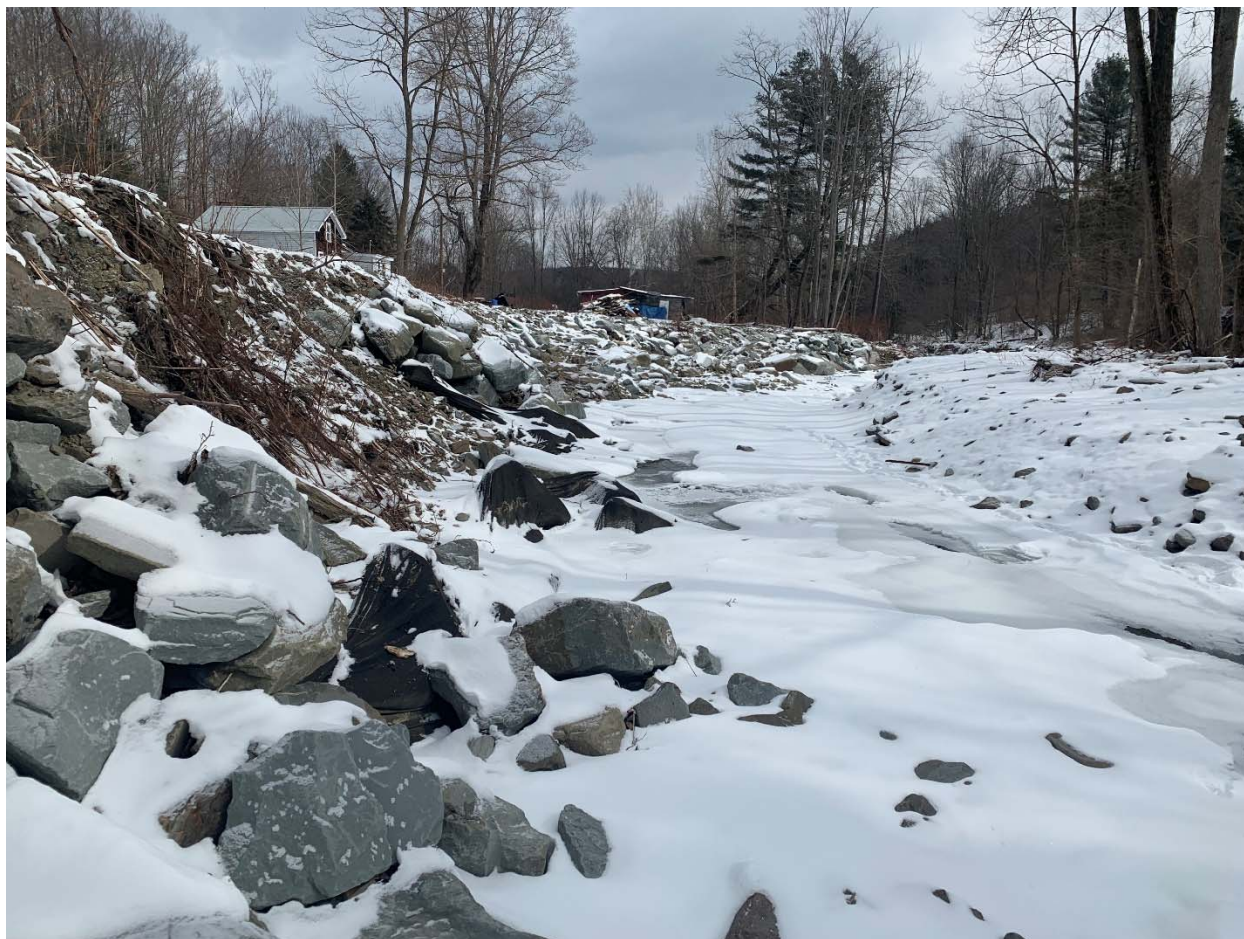
***Figure 68. Failing rock bank protection at ApLo-3800. Photo taken March 7, 2019.***

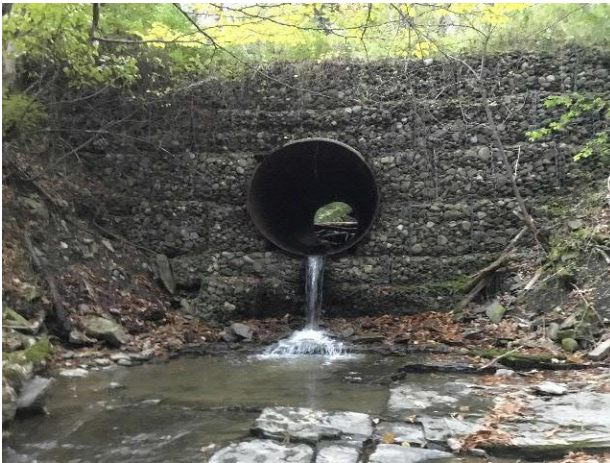
Beach Road over Unnamed Tributary to Deerlick Creek - structure outlet. Note that culvert is perched 4.6 feet above streambed. Downstream channel has been scoured to bedrock due to high-velocity flows exiting culvert and limited sediment supply (likely due to constriction).

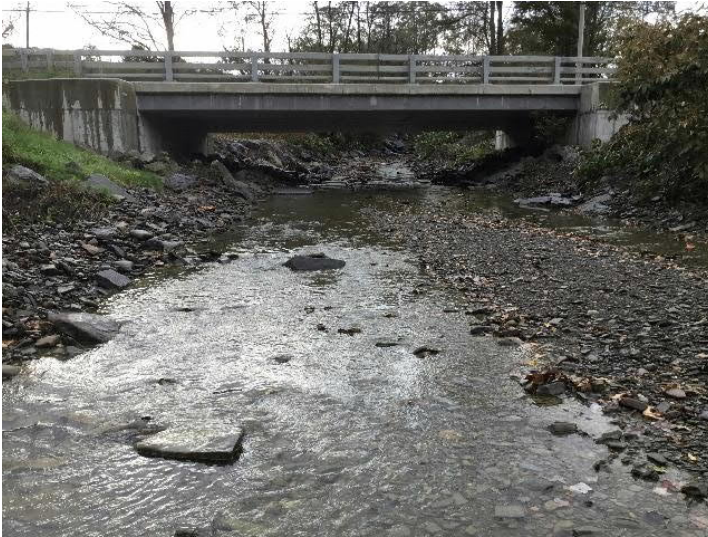
Pennsylvania Avenue over Long Creek - structure outlet. Note the erosion of the embankment and armoring below and immediately downstream of the crossing structure.

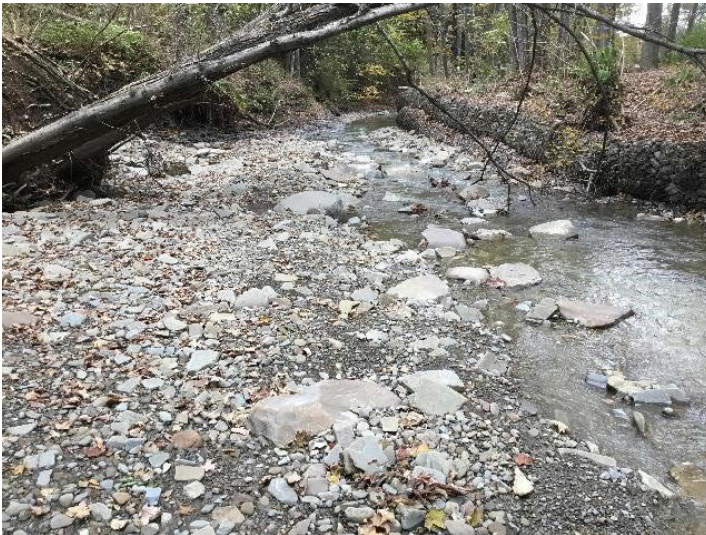
Long Creek Road over Long Creek (downstream of Section 4.4 crossing). Photograph of downstream channel. Note gabions retaining bank on right, eroded bank on left, and sediment deposition on left side of channel. Gabions farther downstream are undermined and leaning into stream.

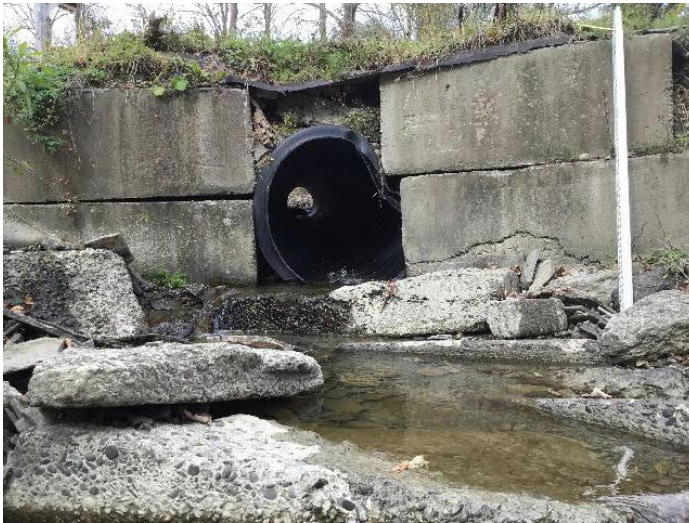
Long Creek Road over Unnamed Tributary to Long Creek - structure outlet. Note deformed outlet of pipe; misaligned wingwalls; vertical hydraulic drop downstream of outlet, and eroding soil and exposed geotechnical fabric supporting the road above the culvert.

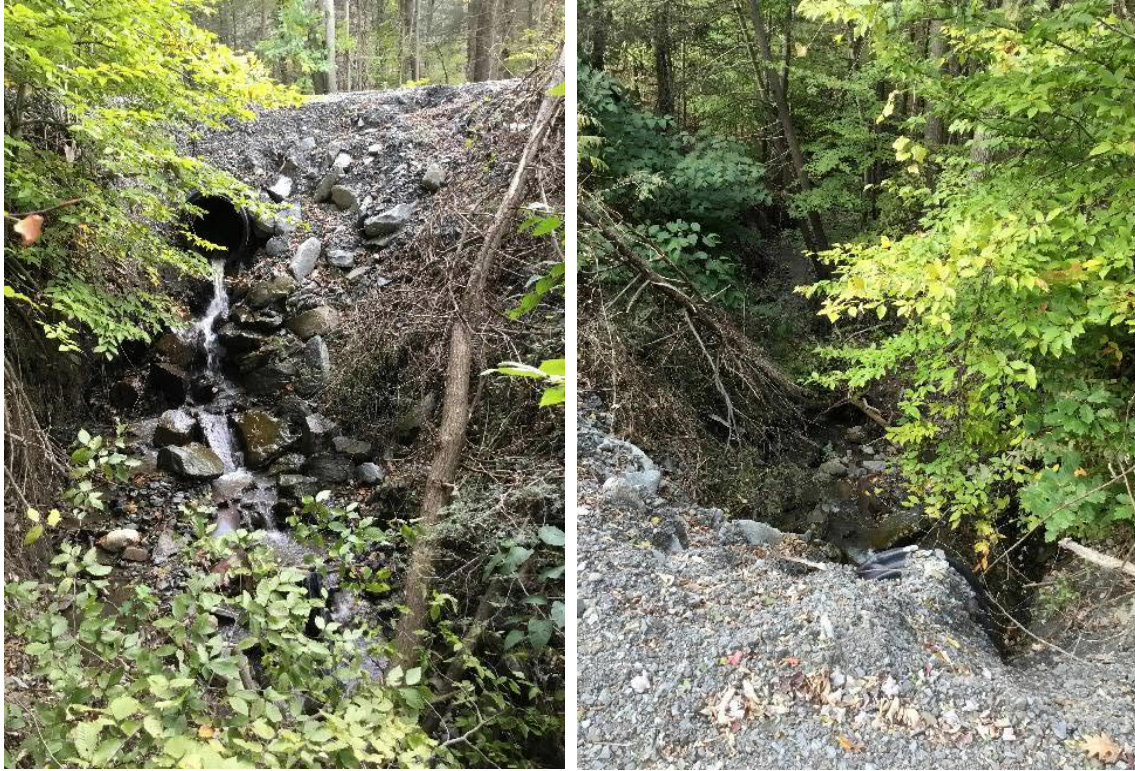
Chestnut Ridge Road over Deerlick Creek. Photograph of crossing outlet (left) and looking down at outlet from above (right). Note the large grade change, the perched outlet, and the erosion of the road evident in both photos.

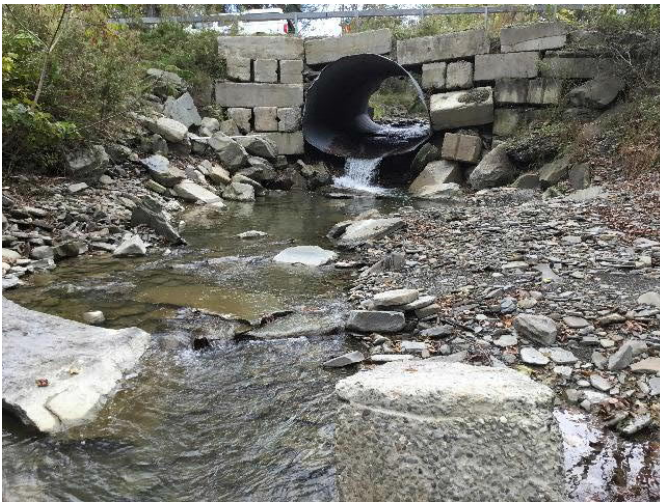
Gaylord Road over Unnamed Tributary to Apalachin Creek (at Little Hill Road) - crossing outlet. Note unstable headwalls and perched, undermined outlet of culvert.

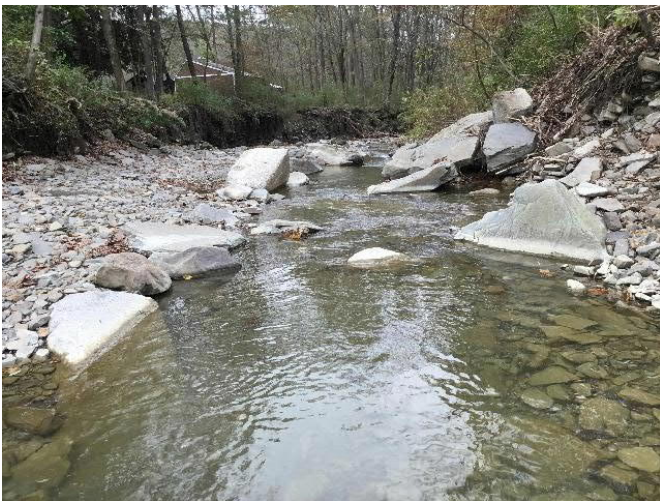
Gaylord Road over Unnamed Tributary to Apalachin Creek (at Little Hill Road). Eroded channel banks downstream of structure threaten residential property on river left.

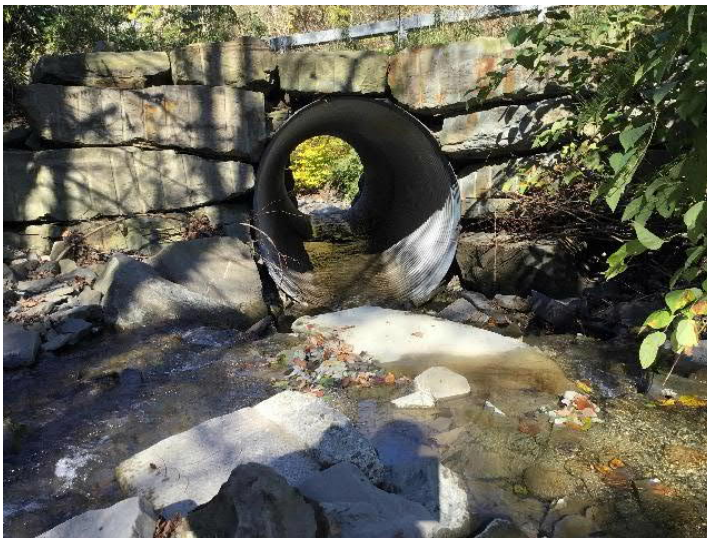
Gaylord Road over Unnamed Tributary to Apalachin Creek (upstream of Section 4.6 crossing) - structure inlet. Note misaligned headwall and constriction of stream.

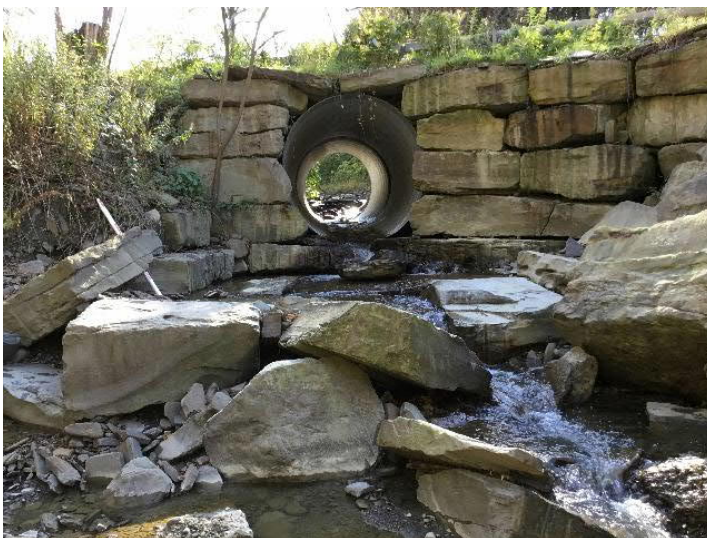
Gaylord Road over Unnamed Tributary to Apalachin Creek (upstream of Section 4.6 crossing) - structure outlet. Note that outlet is perched. Also note headwall in poor condition and displacement of joint inside of culvert pipe.

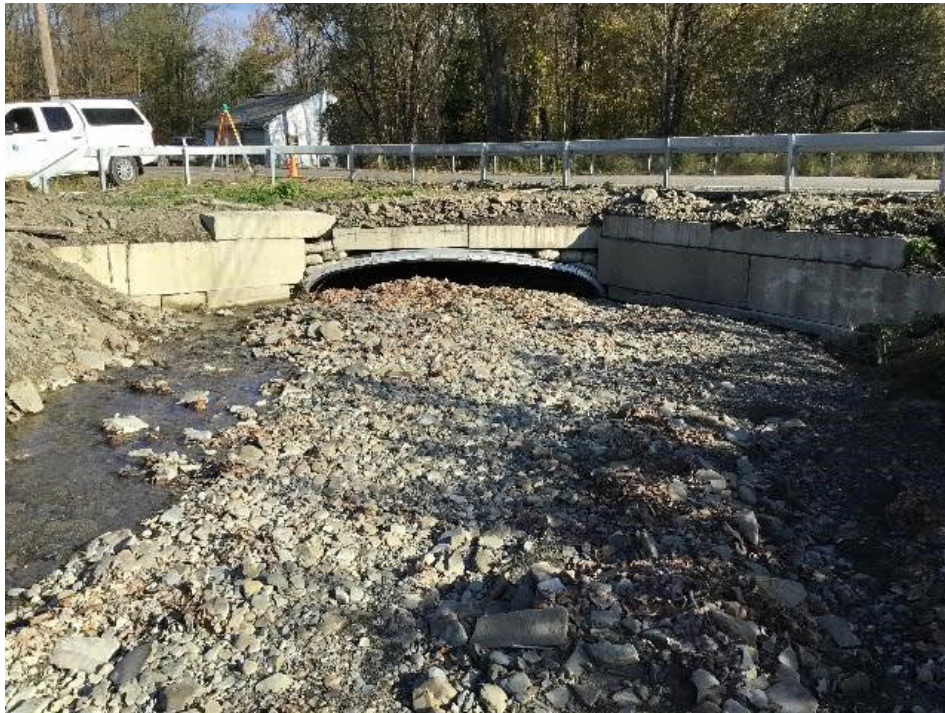
Pennsylvania Avenue over Unnamed Tributary (Card Road Tributary) to Apalachin Creek - structure inlet.  
Note sagging abutment and displaced concrete waste block on left bank.

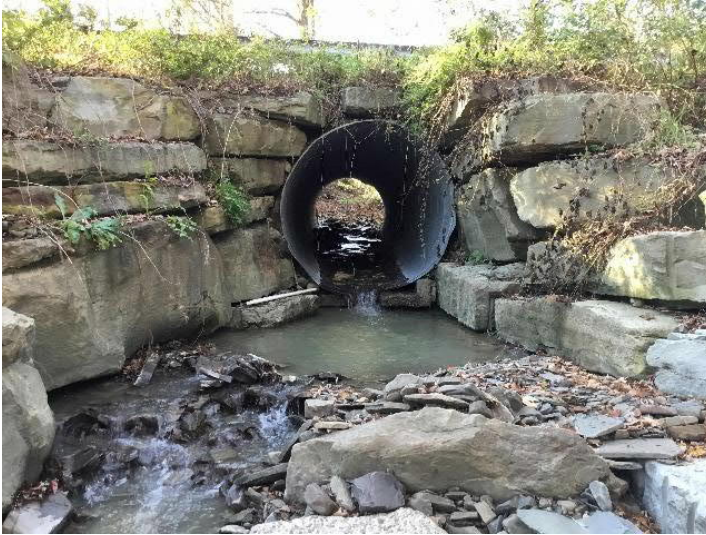
Card Road over Unnamed Tributary (Card Road Tributary) to Apalachin Creek - structure outlet. Note that outlet is perched.

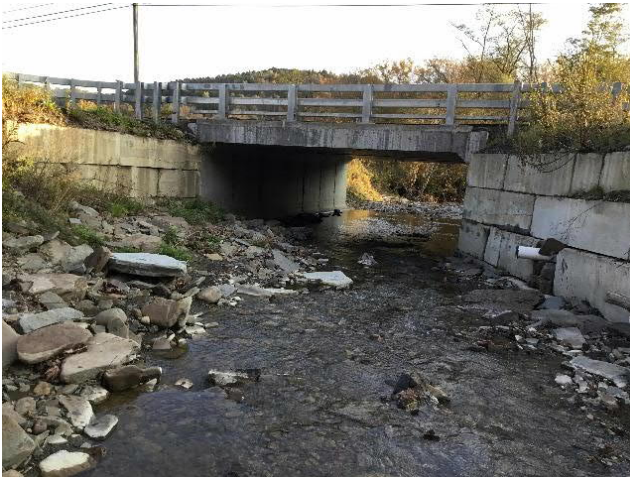
Pennsylvania Avenue over Unnamed Tributary to Apalachin creek – structure inlet. Note the relatively poor condition of the wingwalls and armoring.

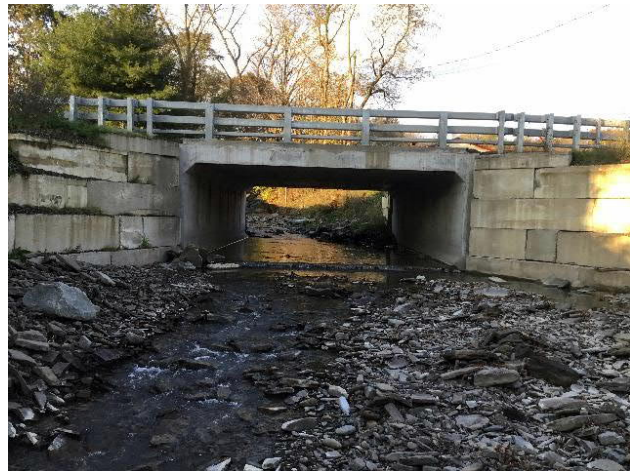
Pennsylvania Avenue over Unnamed Tributary to Apalachin creek – structure outlet. Note the slightly perched invert at the structure outlet.

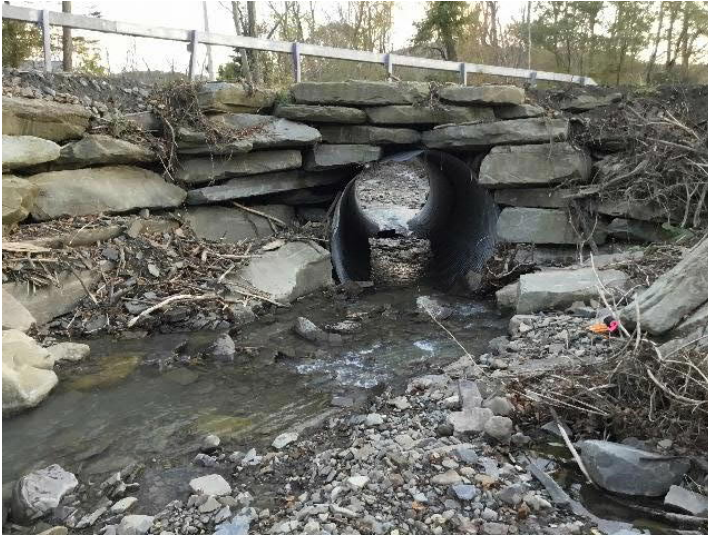
Fox Road over Unnamed Tributary to Apalachin Creek - structure inlet. Note misaligned headwall, constriction in stream, and sharp bend in stream as it approaches the culvert.

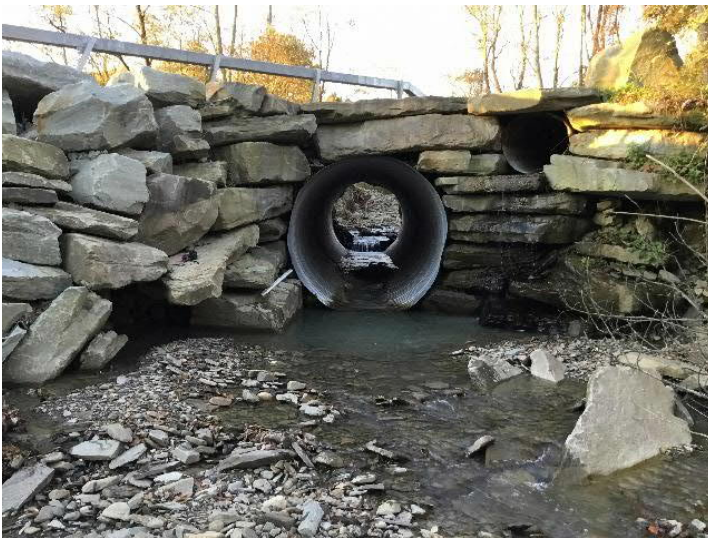
Fox Road over Unnamed Tributary to Apalachin Creek - structure outlet. Note unstable wingwall with large void at base, at left side of photo.
