Wappasening Creek Background Report

Tioga County Soil and Water Conservation District

AUGUST 2019

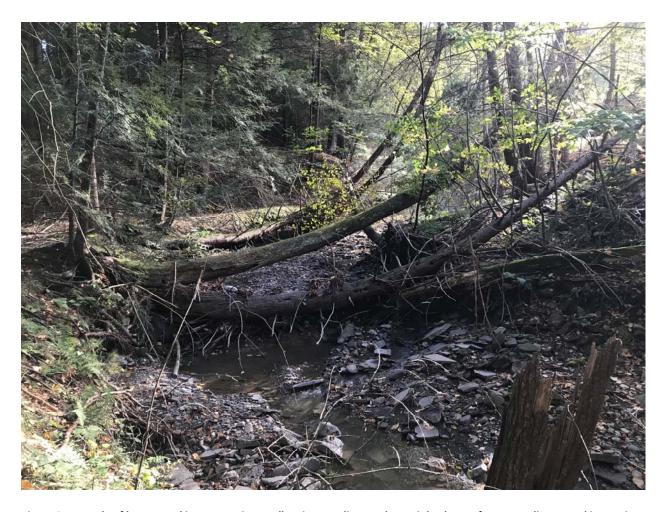
Figure 9. Example of large wood in Upper Briggs Hollow impounding a substantial volume of coarse sediment and improving upstream connectivity between floodwaters and the forest floor. Photo taken October 17, 2018.

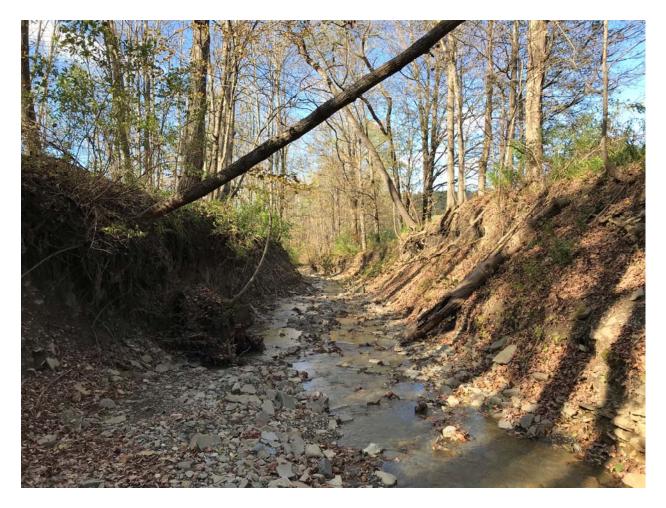
Figure 10. Incised reach of the Briggs Hollow tributary immediately downstream of Briggs Hollow Road. Poorly developed bedforms and freshly eroded banks suggest that the channel bed may be continuing to cut down. Photo taken October 17, 2018.

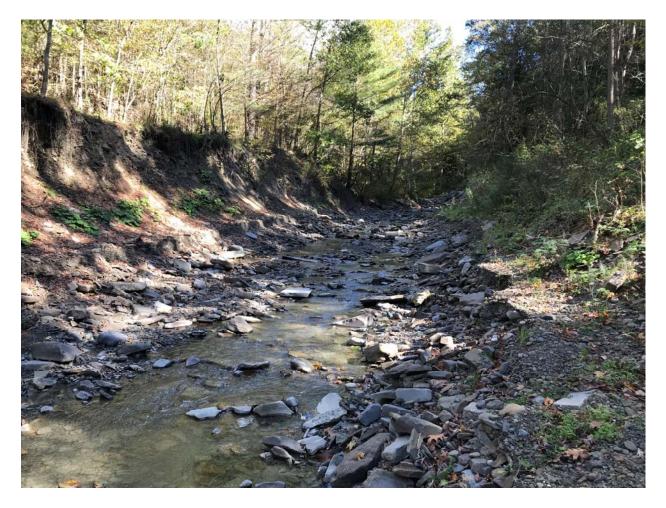
Figure 11. Typical condition of the channel between Briggs Hollow Road and State Line Road. Photo taken October 17, 2018.

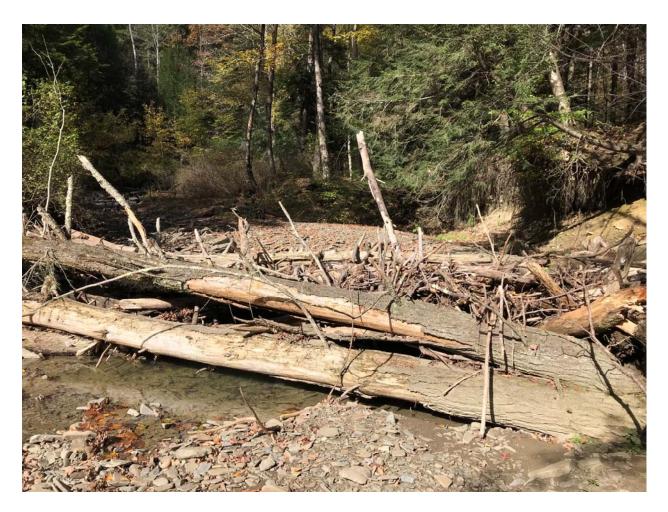
Figure 12. Large woody debris jam in tributary to main Briggs Hollow channel. Photo taken October 17, 2018.

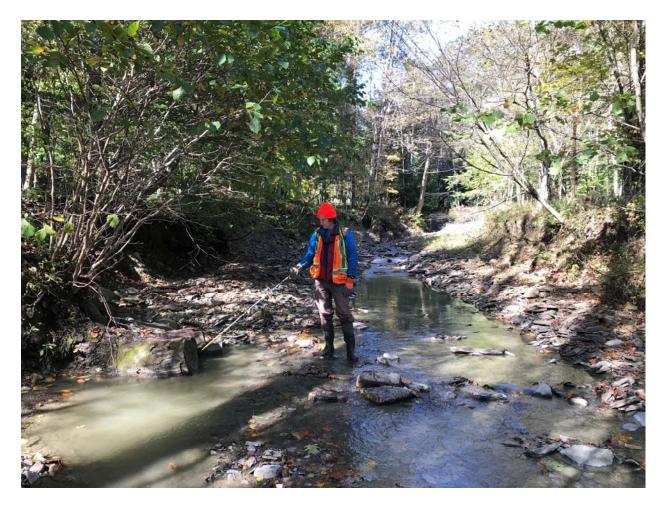
Figure 13. Example of a location where large wood had been removed from the channel. Photo taken October 17, 2018.

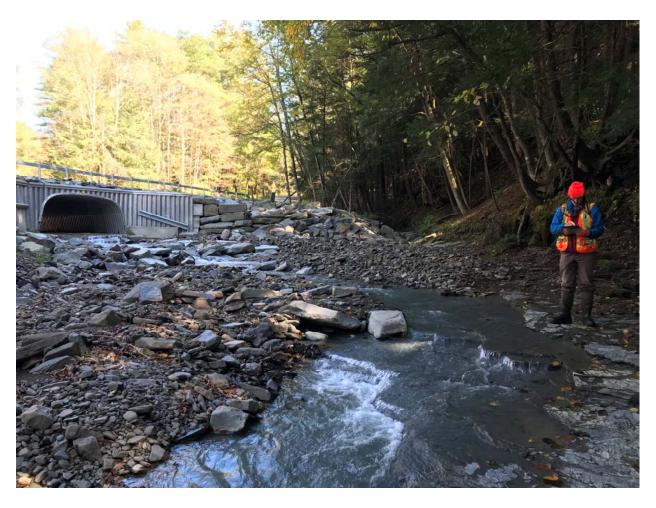
The downstream boundary of the steep, upland channels is approximately defined by the bedrock exposed in the bed downstream of the State Line Road crossings (Figure 14). The State Line Road crossing over the main creek was replaced after debris blockage during the July 2017 flood caused substantial damage (Tetra Tech 2018). Between here and the confluence with Wappasening Creek, the channel diverges from the road and is less incised.

Figure 14. Exposed bedrock in the channel downstream of State Line Road. Photo taken October 17, 2018.

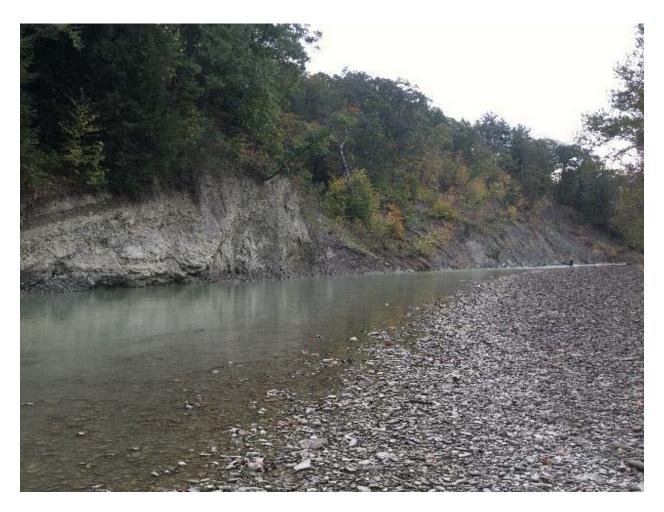
From the state line to the junction with the Susquehanna, Wappasening Creek meanders across the valley floor, generally with a floodplain on either side of the channel. In several locations, however, the channel has migrated to the edge of the valley and is eroding the tall banks forming the valley side (Figure 15).

Figure 15. Eroding outer bank along the edge of the Wappasening Creek valley. Photo taken October 17, 2018.

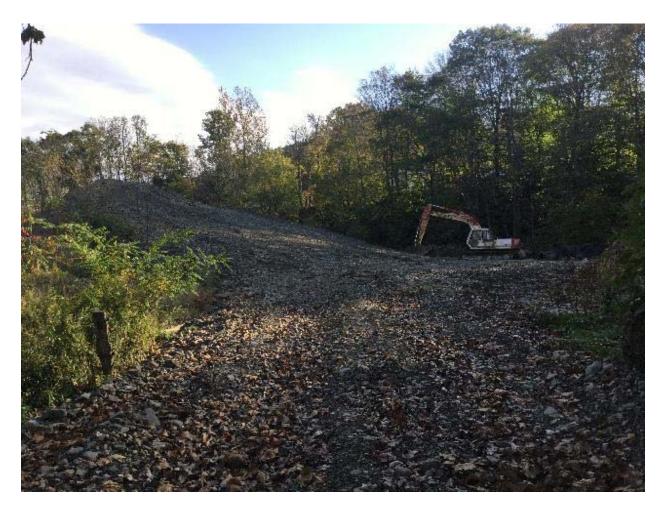
Coarse sediment derived from bank erosion and tributaries is deposited on large, unvegetated bars along Wappasening Creek. Deposition of the abundant load within the channel and on bars forces changes in flow direction and dynamics, resulting in a tendency toward lateral migration, formation of multiple channels, and avulsion. The historic footprint of these dynamic geomorphic processes is what defines the creek's meander belt. The coarse sediment load of Wappasening Creek is eventually deposited within the USACE flood control project at Nichols where it is periodically removed from the channel (Figure 16).

Figure 16. Large pile of material removed from Wappasening Creek near Nichols. Photo taken October 17, 2018.

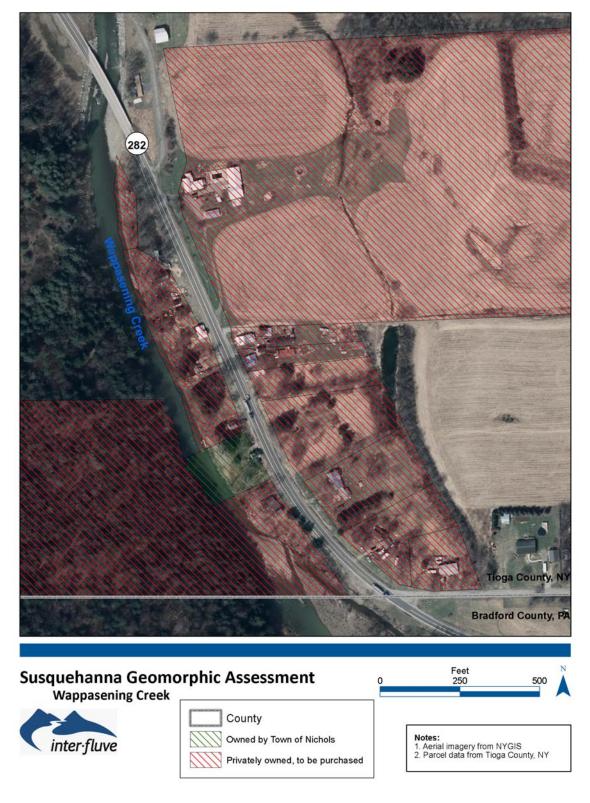
Figure 19. Aerial image of Wappasening Creek at Wa-9400. Hatched parcels not already in Town ownership could be purchased and structures removed to reduce flood risk and allow the river to inundate the area.

Project number	Туре	Description	Photo or image reference
Wa-9400	Riparian Management	From the state line downstream to the NY 282 bridge, Wappasening Creek is constrained to the western edge of the valley. A handful of residences have been built within the 1% annual chance flood event extent, including on a narrow strip of the right bank floodplain between the channel and NY 282. Buy out properties that have not already been purchased as a part of the initiative described in the Hazard Mitigation Plan (Tetra Tech 2018) and remove or relocate the affected structures. Remove rip rap that might currently be protecting homes and allow the creek to evolve naturally to the extent possible given the alignment of NY 282.	Figure 19
Wa-7900	Riparian Management	Landowner mows and farms up to the top of the bank along the right bank. An informal berm constructed of material dredged from the channel has been built at the top of the right bank extending from NY 282 to approximately 400 feet downstream. The berm protects residences and some farm outbuildings from flooding. Remove the berm to allow floodwater to access the right bank floodplain. Buy out property owners and remove affected structures or, where the parcel is large enough, establish conservation easements and relocate affected structures to higher ground. The latter would require an alternative to Old State Road 82 for access. Re-establish forest cover on the right bank floodplain.	Figure 20

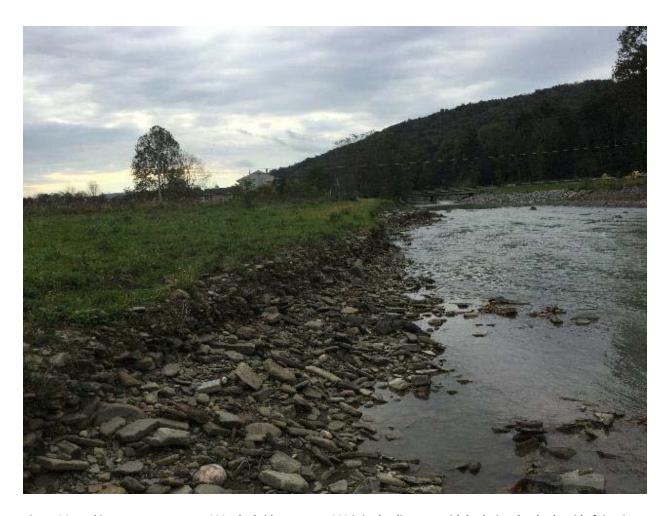
Figure 20. Looking upstream at Wa-7900. The bridge over NY-282 is in the distance, with both river banks devoid of riparian buffer. Photo taken October 17, 2018.

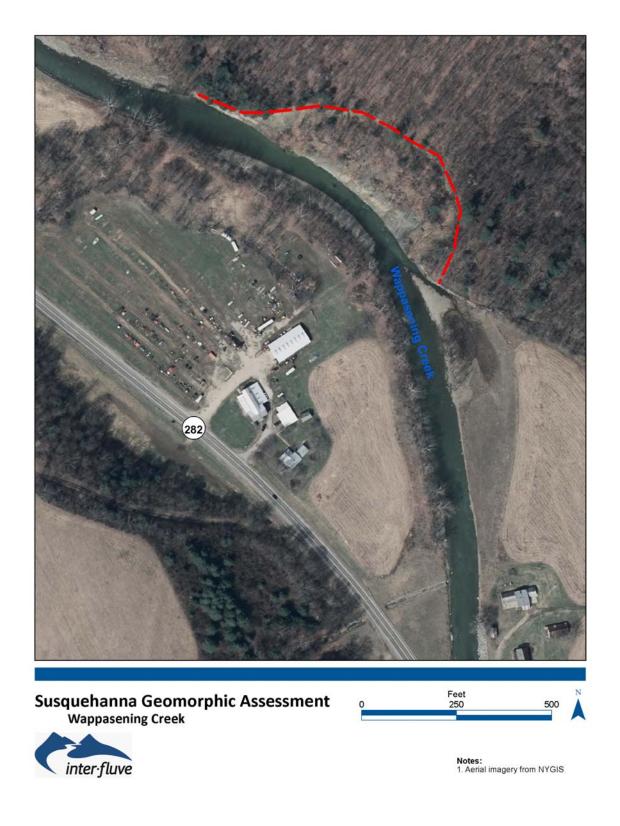
Figure 21. Aerial image from of Wa-7300. A large collection of equipment is visible on the floodplain on river left. The eroding bank is evident on the opposite side of Wappasening Creek. The head scarp of the bank failure is visible and highlighted by the red line.

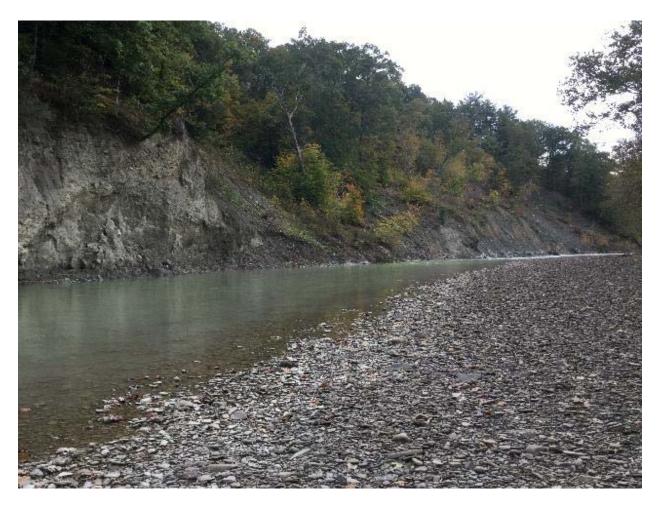
Figure 22. Eroding bank at Wa-7300. The eroding face is large at approximately 40 feet high and 700 feet long. Catastrophic failure of the bank along the scarp visible in Figure 21 could block flow along Wappasening Creek and cause flooding upstream. Photo taken October 17, 2018.

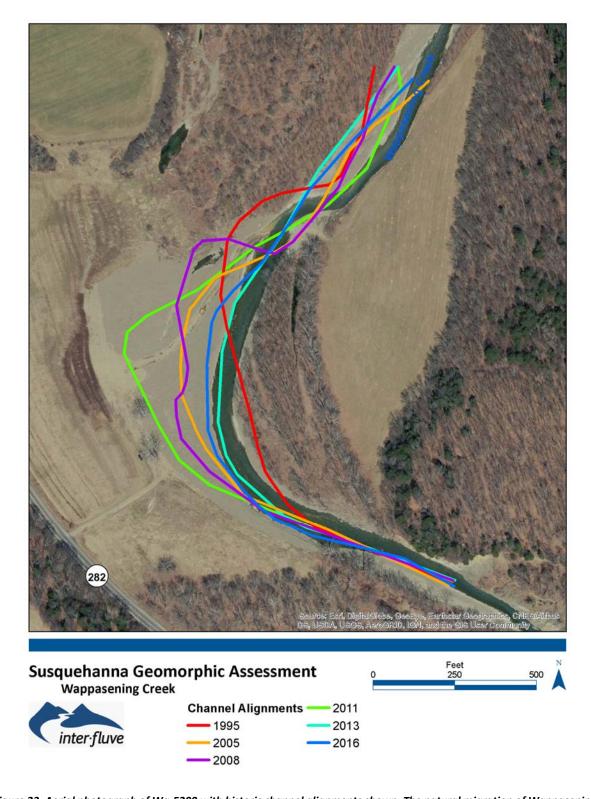
Figure 23. Aerial photograph of Wa-5200 with historic channel alignments shown. The natural migration of Wappasening Creek toward the outside of the bend has been repeatedly counteracted by the landowner and the channel mechanically realigned. Additionally, the right bank of the river downstream of the bend has been stripped of trees and mowed to the edge, which has made the bank susceptible to erosion.

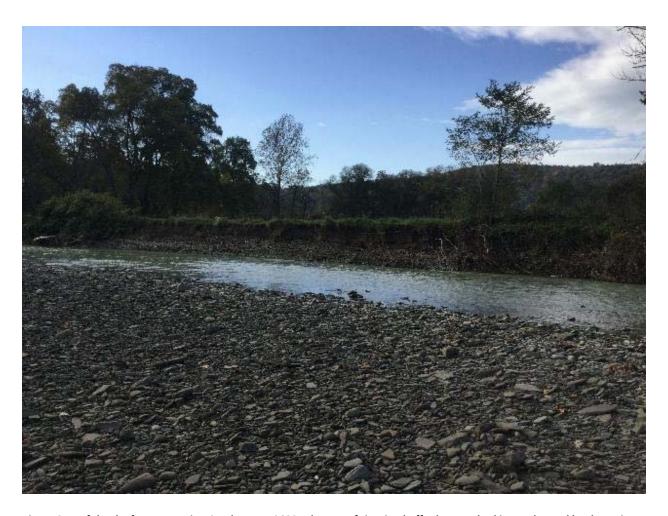
Figure 24. Left bank of Wappasening Creek at Wa-3600. Absence of riparian buffer has resulted in accelerated bank erosion. Photo taken October 17, 2018.

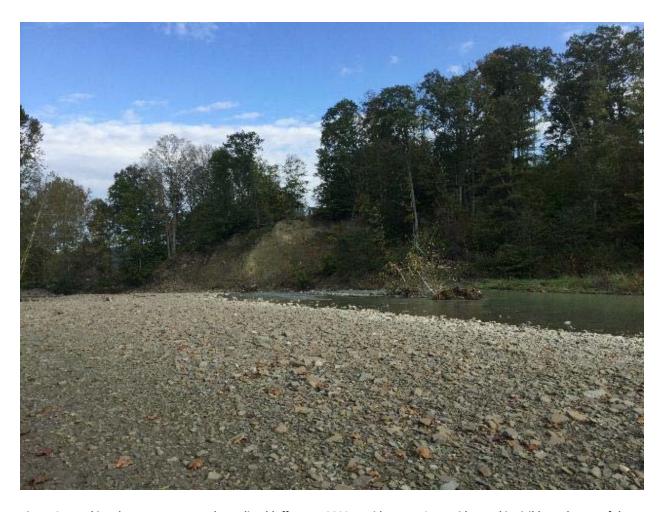
Figure 25. Looking downstream towards eroding bluff at Wa-2800. Residence on Sunnyside Road is visible at the top of the bluff. Photo taken October 17, 2018.

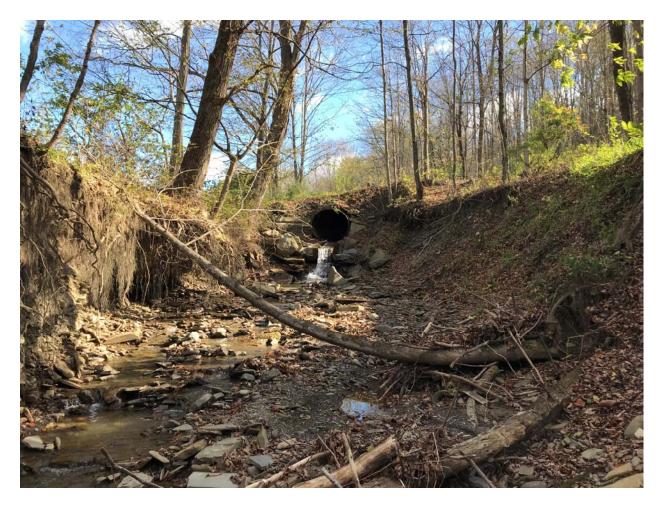
Figure 26. Perched culvert and incised channel at Briggs Hollow Road (WaBH-13900). Photo taken October 17, 2018.

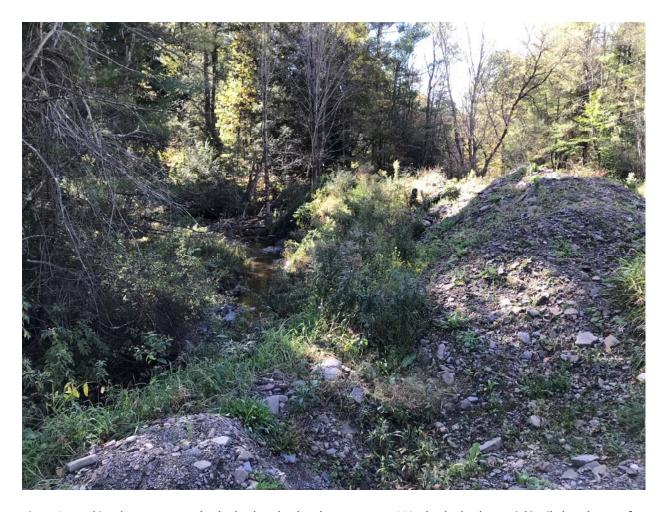
Figure 27. Looking downstream at the dredged wetland outlet at WaBH-11900. The dredged material is piled on the top of the right bank. Photo taken October 17, 2018.

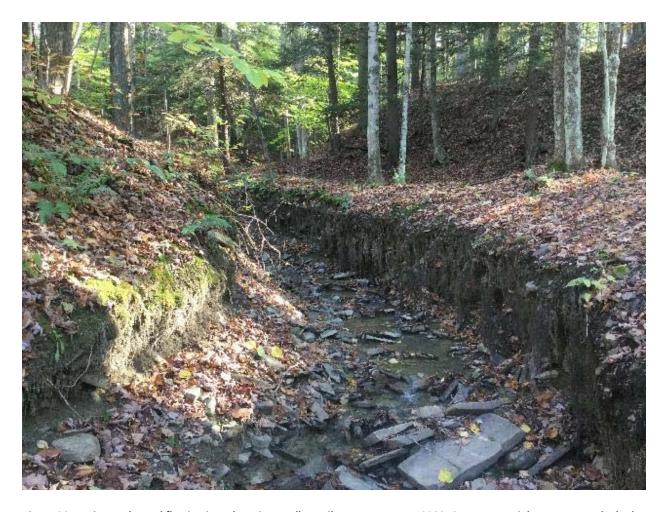
Figure 28. Drainage channel flowing into the Briggs Hollow tributary at WaBH-10300. Coarse material apparent on the bed of the channel is delivered to mainstem during high flows. Photo taken October 17, 2018.

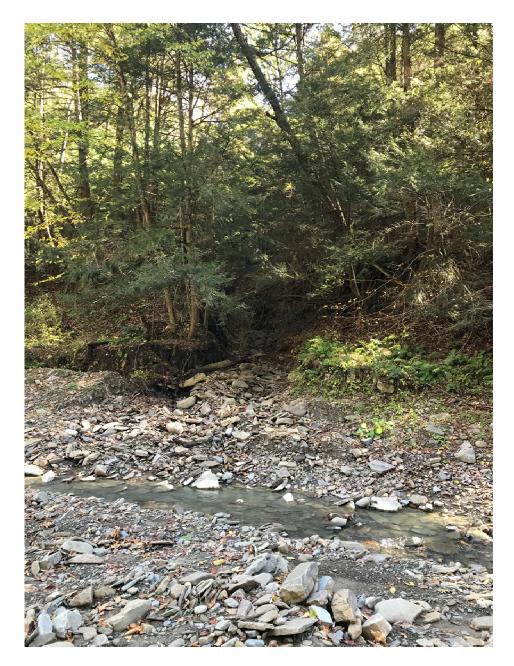
Figure 29. Large deposit of coarse material delivered by an intermittent tributary at WaBH-9100b. Photo taken October 17, 2018.

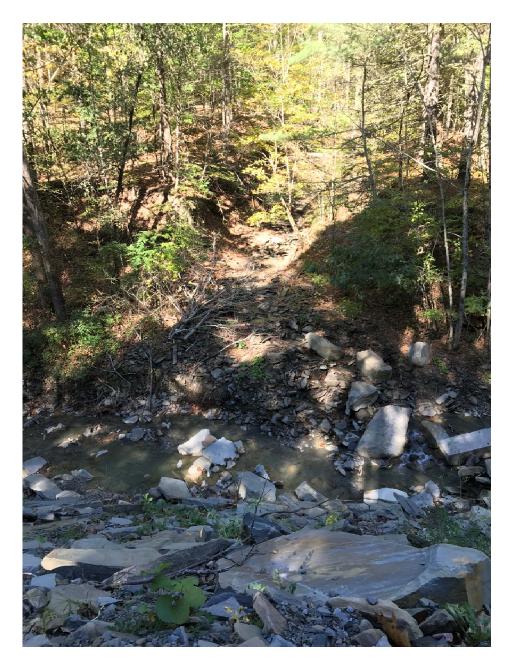
Figure 30. Large deposit of coarse material delivered by an intermittent tributary at WaBH-9100a. Photo taken October 17, 2018.

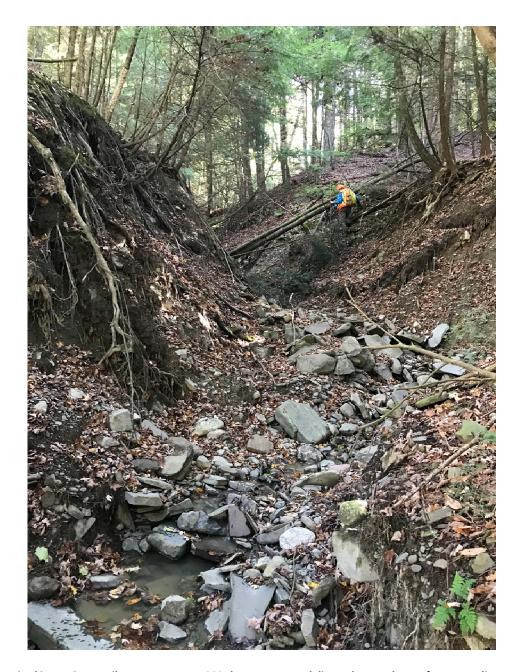
Figure 31. Incised intermittent tributary at WaBH-7300 that appears to deliver a large volume of coarse sediment to the channel. Flow originates in a hilltop field. Photo taken October 17, 2018.

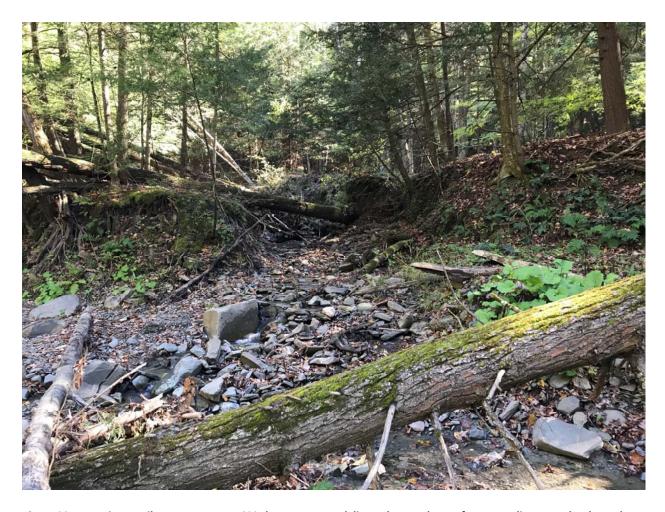
Figure 32. Intermittent tributary at WaBH-5600 that appears to deliver a large volume of coarse sediment to the channel. Flow originates in a hilltop field. Photo taken October 17, 2018.

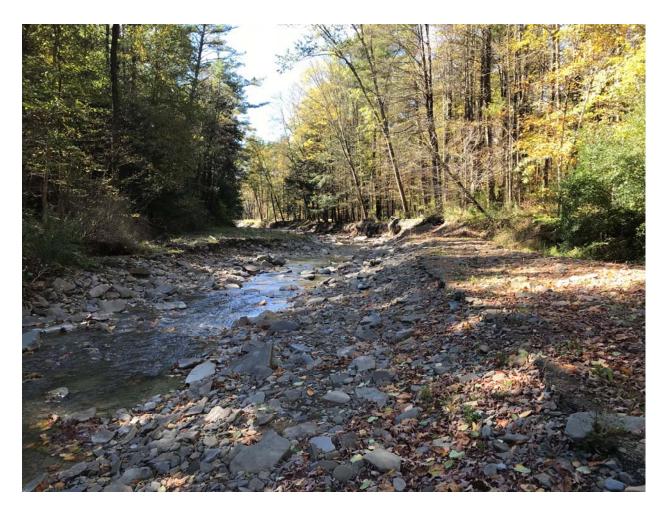
Figure 33. Reach along the mainstem of the Briggs Hollow tributary at WaBH-4800. Photo taken October 17, 2018.

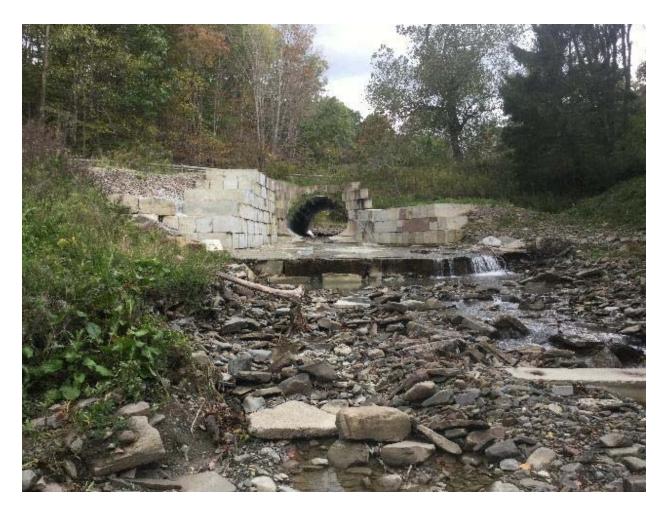
Figure 34. Undersized and perched culvert beneath Lower Briggs Hollow Road. Photo taken October 17, 2018.

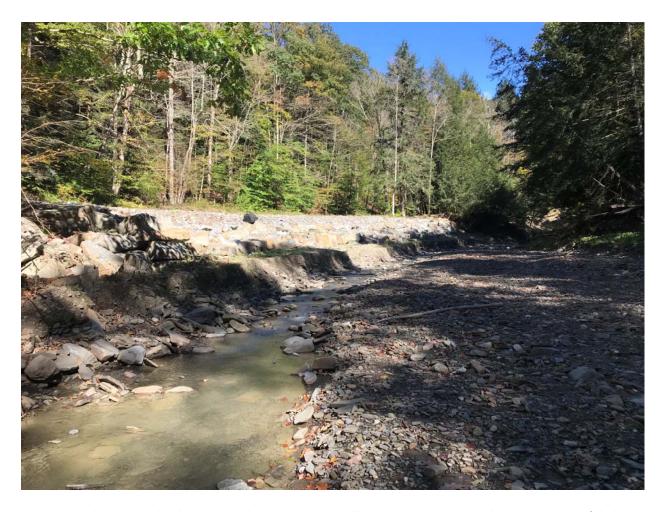
Figure 35. Bank erosion and rock revetment along Lower Briggs Hollow Road. Note television dumped at the top of the bank. Photo taken October 17, 2018.

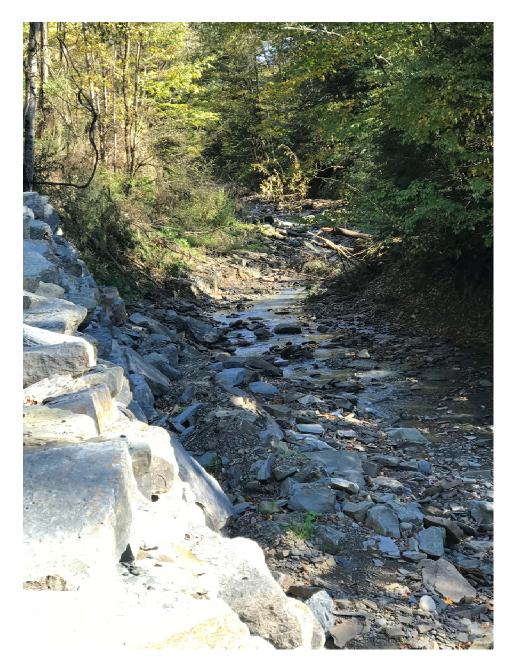
Figure 36. Channel along Lower Briggs Hollow Road showing deep, narrow nature of channel and erosion protection measures along road embankment. Photo taken October 17, 2018.

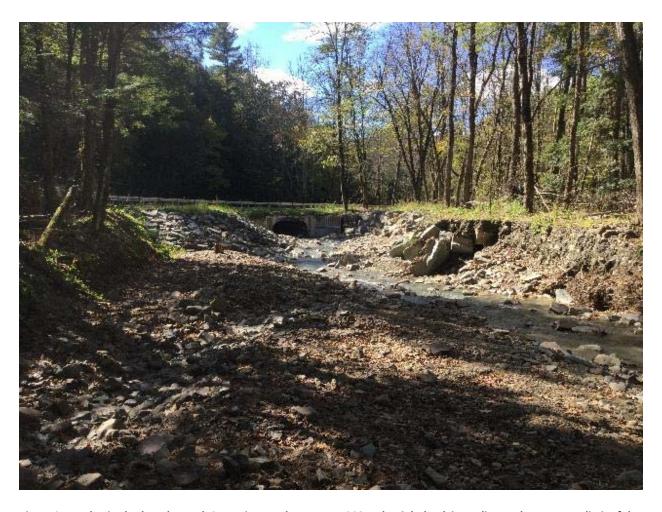
Figure 37. Undersized culvert beneath State Line Road at WaBH-4300a. The right bank is eroding at the upstream limit of the large rock revetment installed as part of the culver replacement. Photo taken October 17, 2018.

WaBH-4300a	Crossing Improvement	The State Line Road culvert washed out in 2017 and was replaced shortly thereafter with a corrugated metal pipe arch culvert similar in size to the one that was washed out. The present culvert appears to be undersized and vulnerable to blockage. Replace the culvert with an appropriately sized open-bottom structure minimize the risk of blockage by woody debris and subsequent failure, and to facilitate aquatic organism passage and improve ecological conditions. Replace the existing rock revetment on the upstream banks with a more ecologically sensitive bioengineered design. See Section 4.1 of Appendix B for more information.	Figure 37
WaBH-3400	Crossing Improvement	The existing State Line Road culvert carrying a tributary to the Briggs Hollow drainage is a corrugated metal pipe arch. The present culvert appears to be undersized and vulnerable to blockage. Replace the culvert with an appropriately sized open-bottom structure to minimize the risk of blockage by woody debris and subsequent failure, and to facilitate aquatic organism passage and improve ecological conditions.	Figure 38

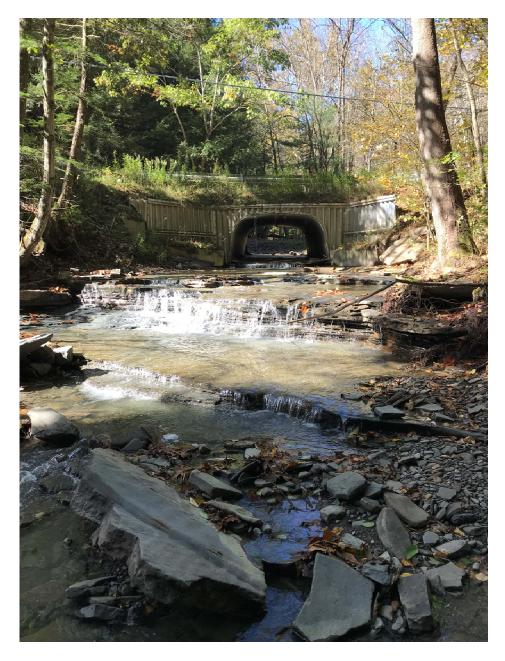
Figure 38. Undersized culvert carrying tributary to the Briggs Hollow drainage beneath State Line Road at WaBH-3400. Photo taken October 17, 2018.

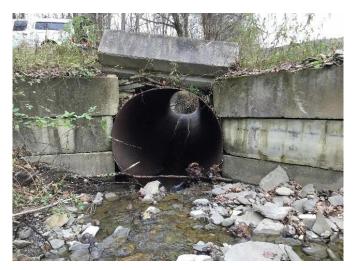
Briggs Hollow Road over Unnamed Tributary at Briggs Hollow - crossing inlet. Note gaps between wingwalls/headwall and pipe that may allow seepage, and misaligned headwall/guardrail block.

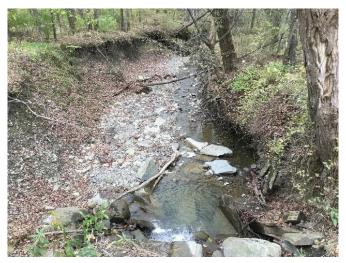
Briggs Hollow Road over Unnamed Tributary at Briggs Hollow – downstream channel. Note incised streambed and overhanging streambanks.

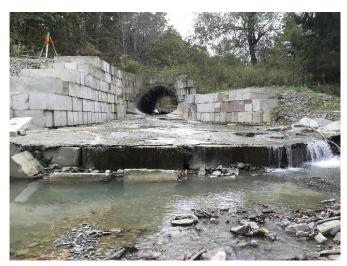
Lower Briggs Hollow Road over Unnamed Tributary at Briggs Hollow - crossing outlet. Note drop at end of apron and scour of apron and streambed below.
