# Apalachin Creek Background Report

Tioga County Soil and Water Conservation District

**DECEMBER 2019**

Inter-Fluve Engineering  
501 Portway Avenue, Suite 101  
Hood River, OR 97031

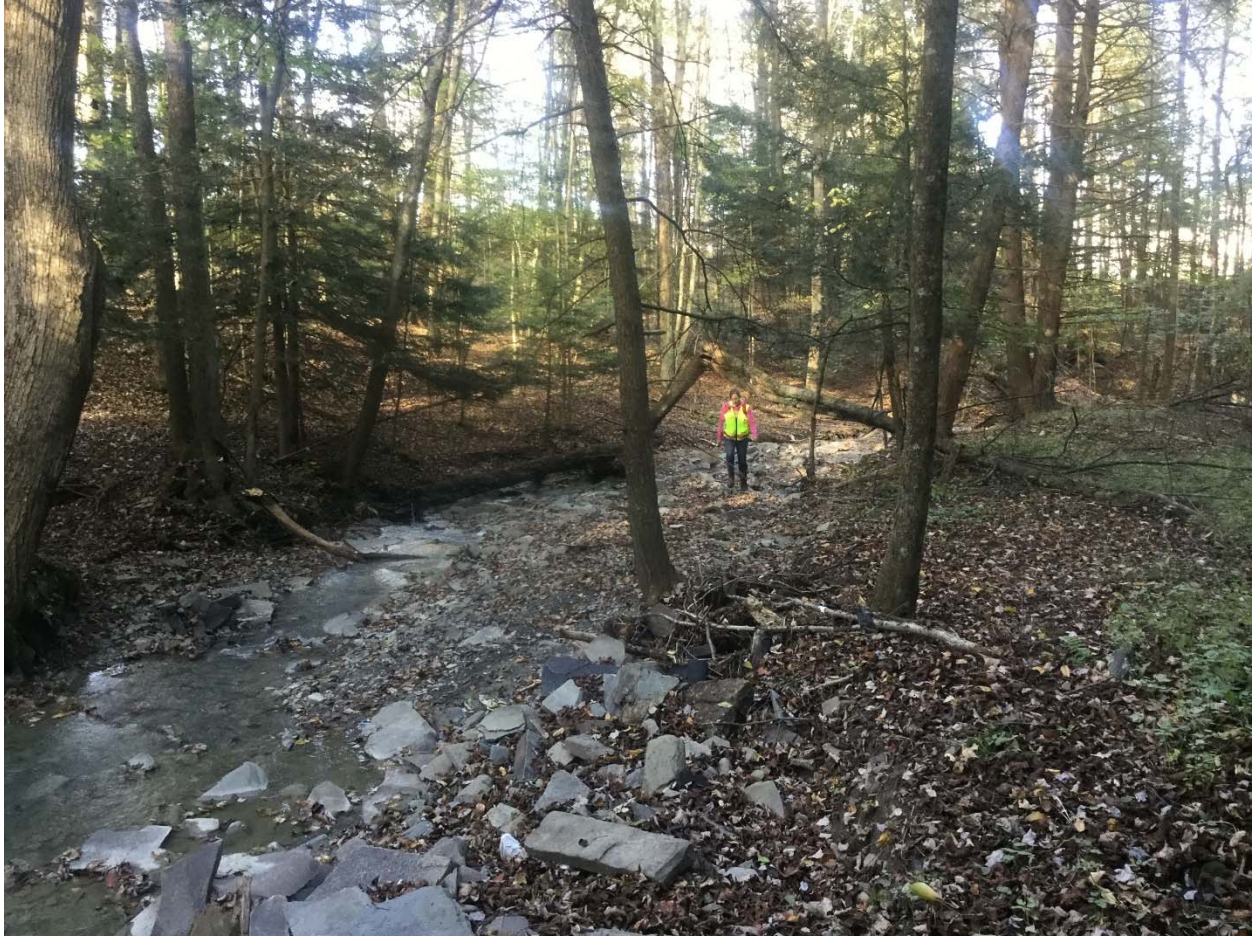
***Figure 13. Example of mid-lower reach of unnamed tributary along Card Road. Photo taken October 19, 2018.***

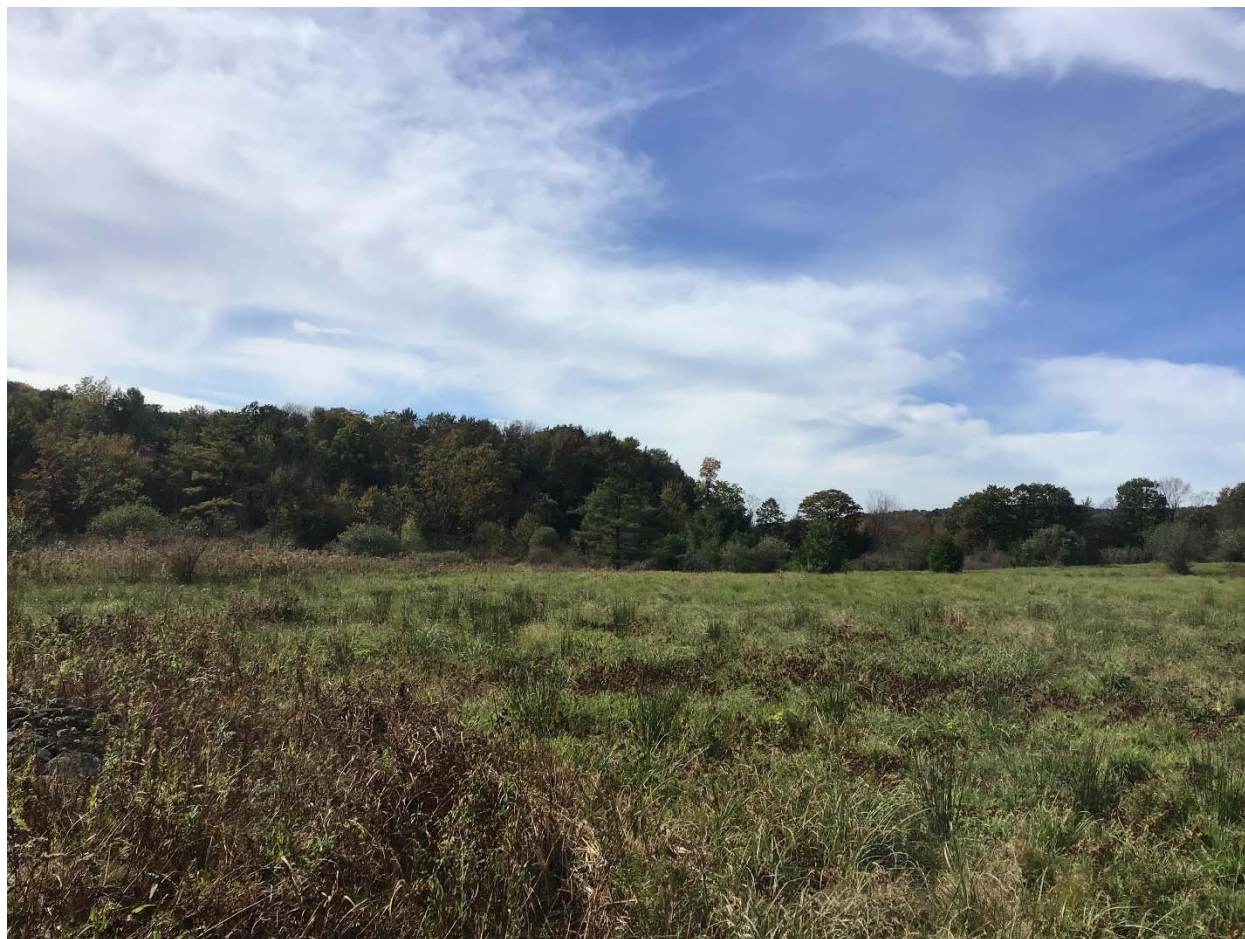
***Figure 15. Wetland at base of mowed hillslope. Creek is near back of photo. Photo taken October 19, 2018.***

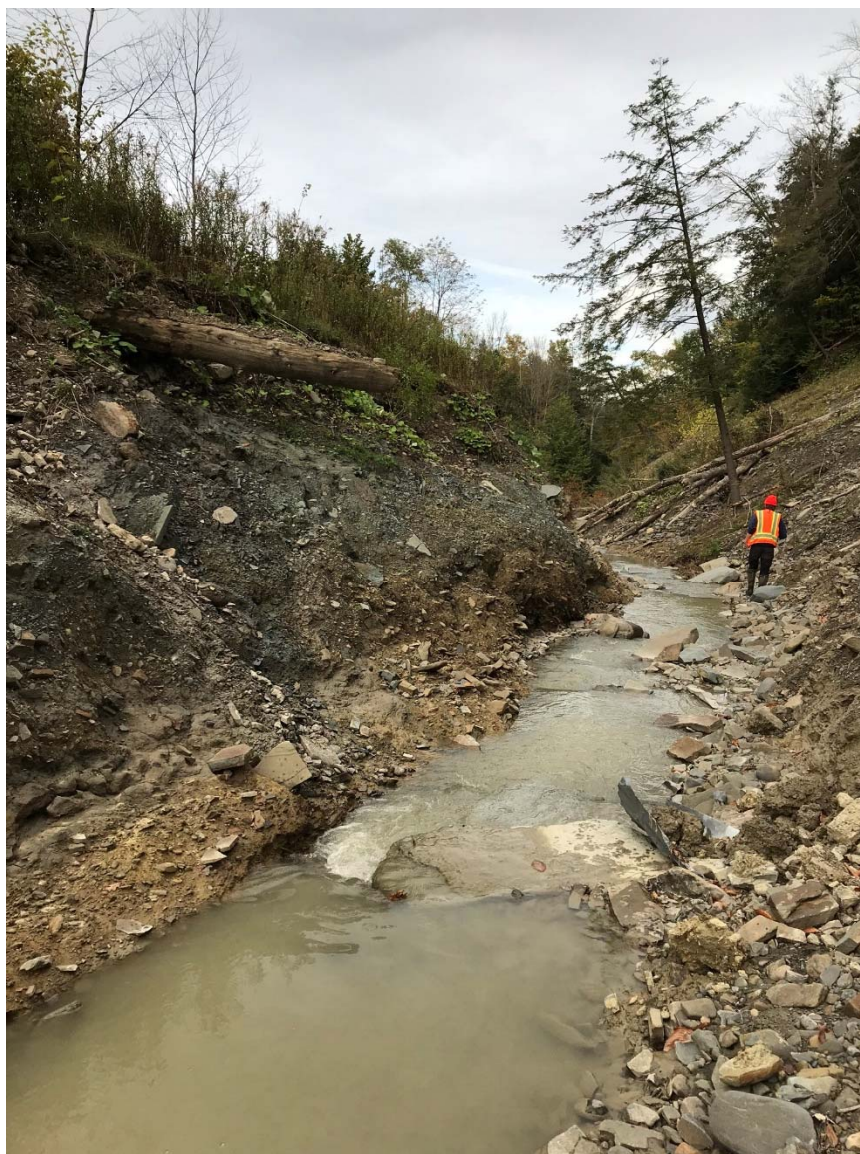
***Figure 18. Incised Long Creek channel. Note large wood preserved in alluvium forming the top of the left bank. Bank material below that is till. Photo taken October 19, 2018.***

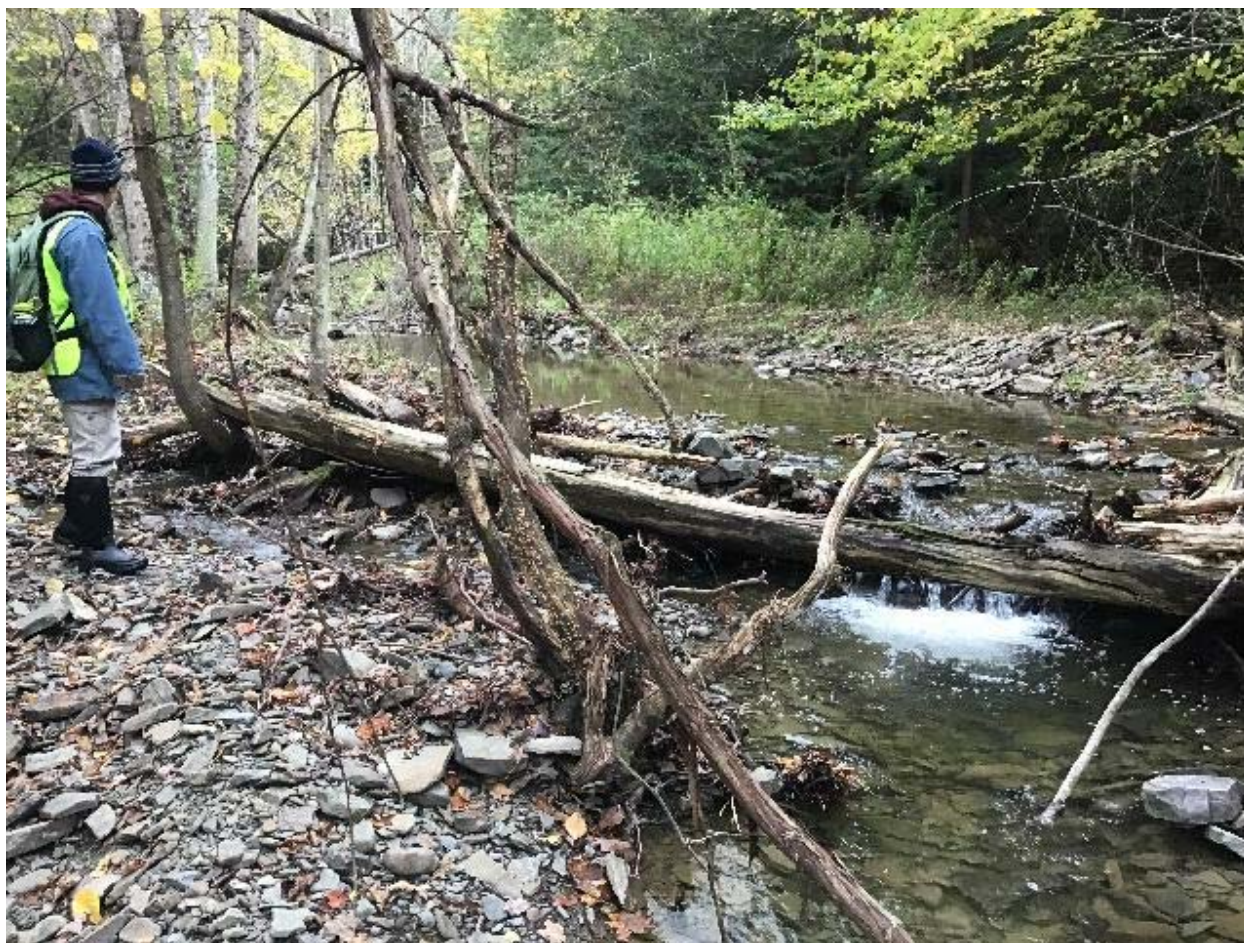
***Figure 22. Example of a small channel-spanning log jam providing grade control and retaining sediment in Deerlick Creek. Photo taken October 18, 2018.***

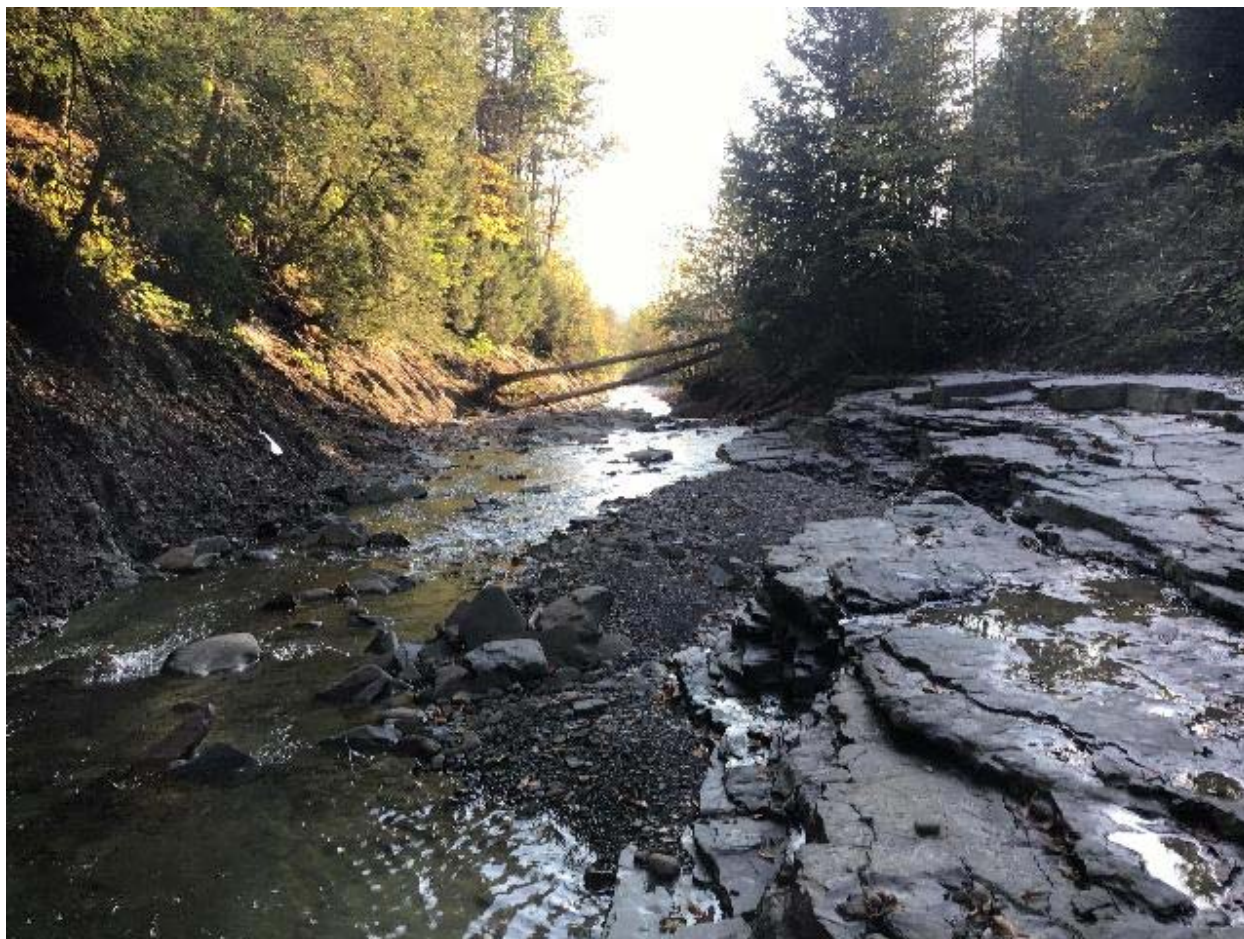
***Figure 23. Bedrock outcrop looking downstream from the downstream boundary of the mid-lower reach of Deerlick Creek. Photo taken October 18, 2018.***

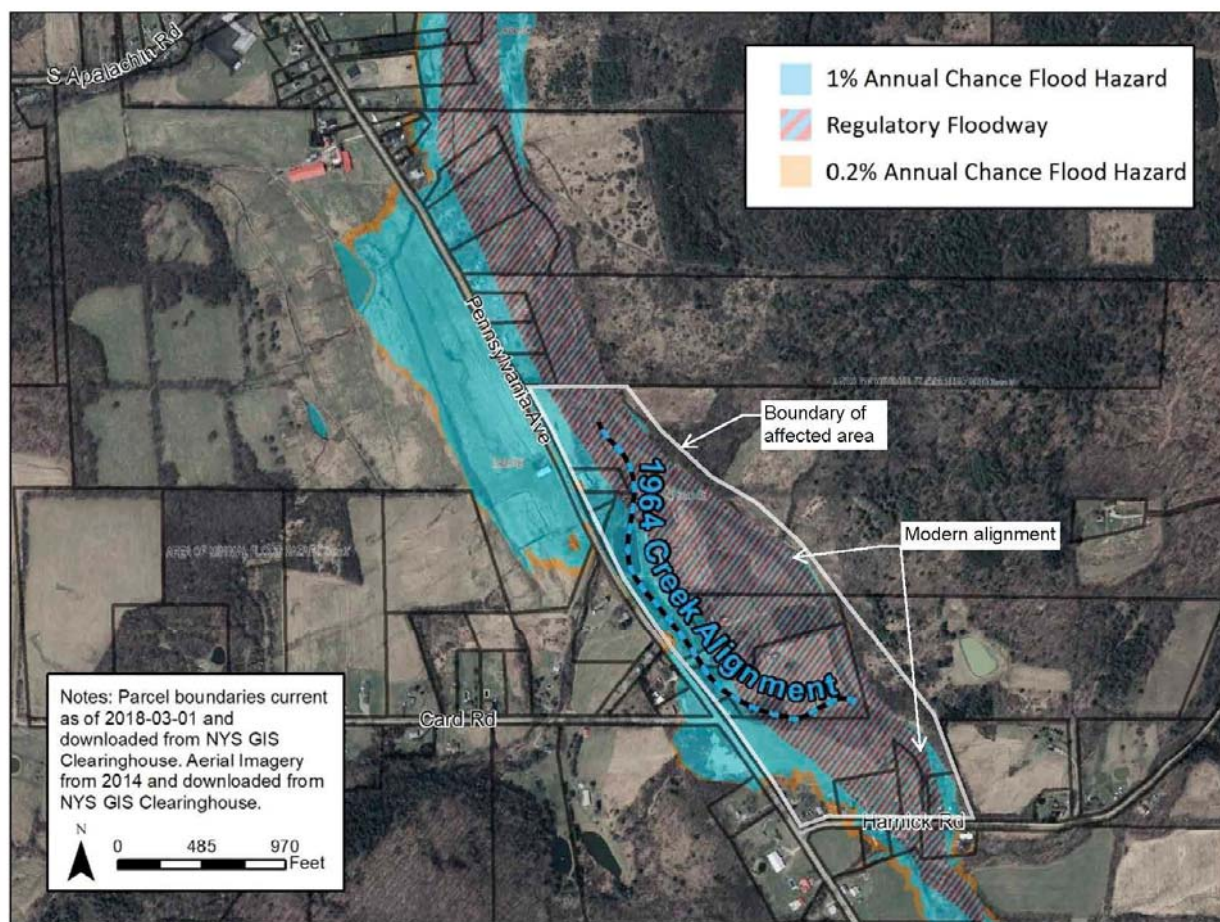
**Figure 27. Aerial photograph showing current (2014) and pre-1960s alignment of Apalachin Creek at Ap-30000. Parcels and portions of parcels proposed for purchase or easement shown outlined in white. Flow is south to north.**

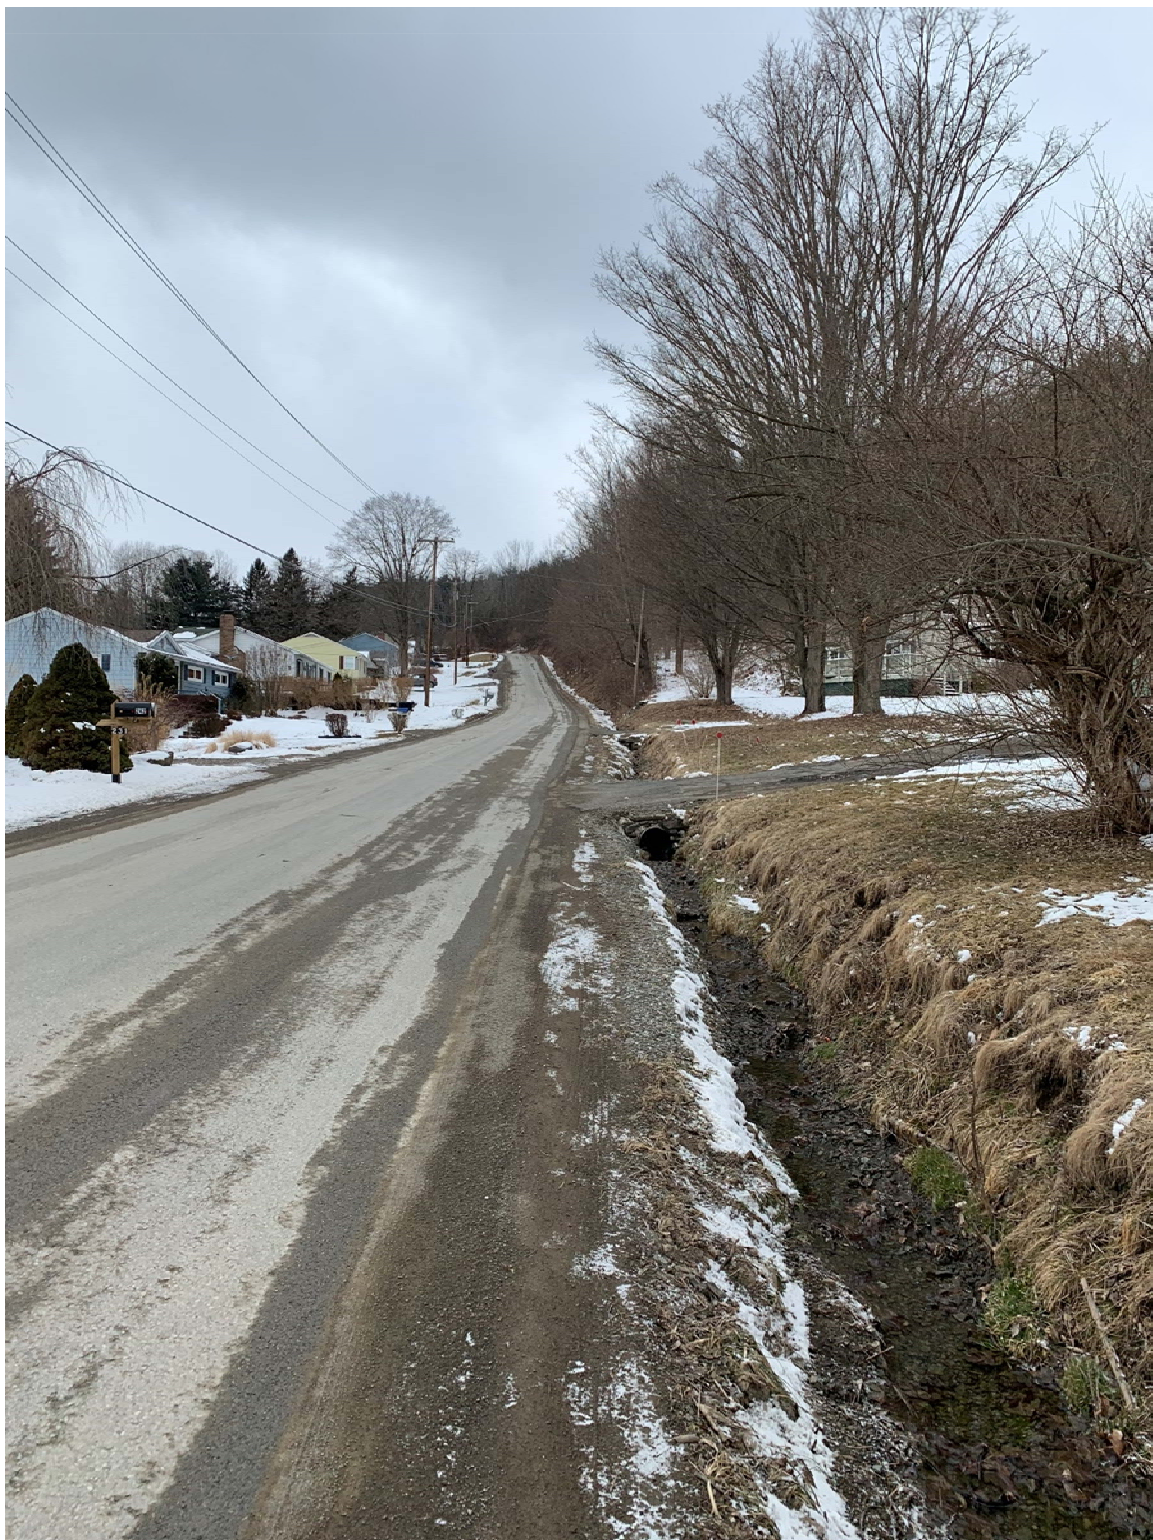
***Figure 33. Looking up slope along Barton Road. Photo taken March 7, 2019.***

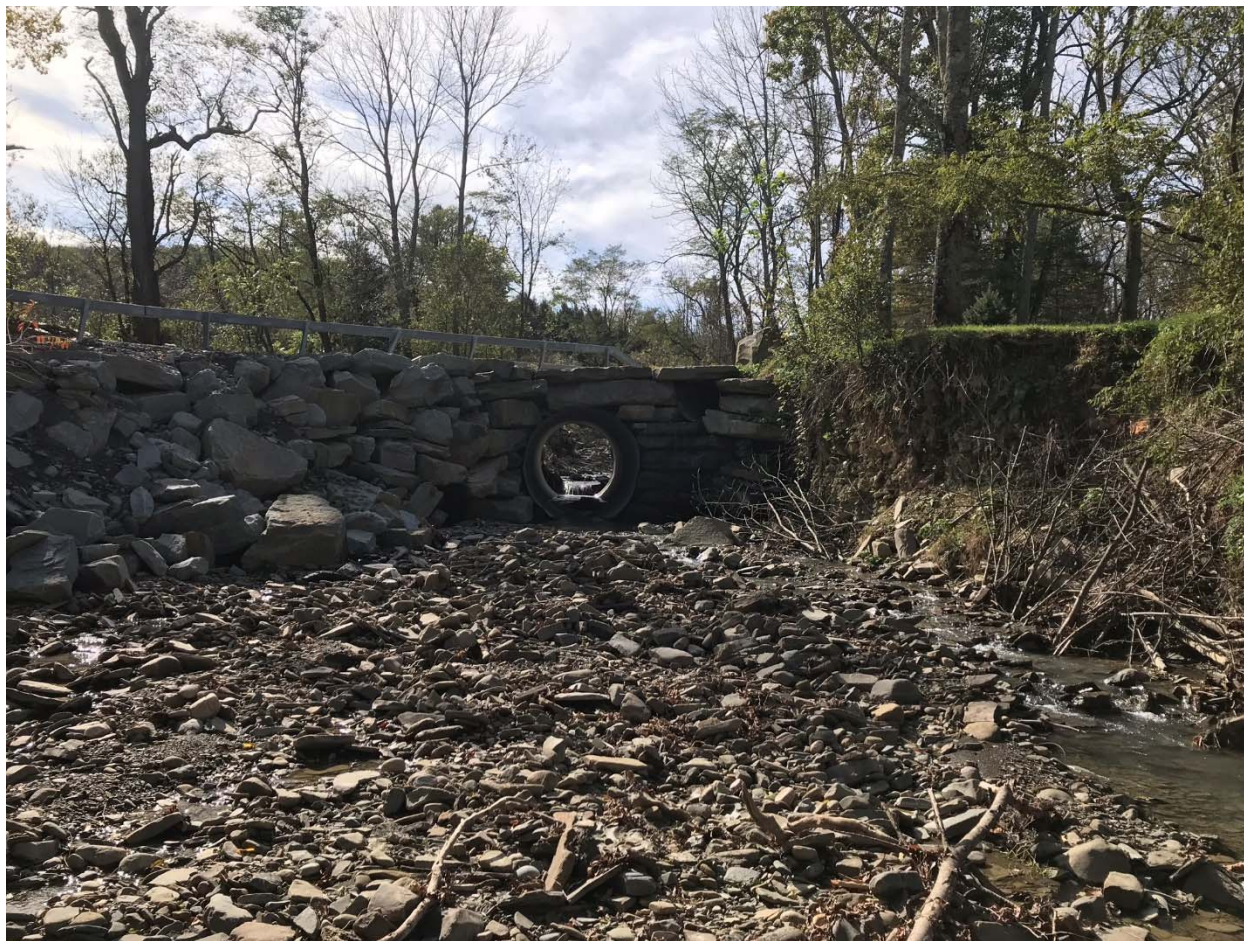
***Figure 36. Downstream headwall at ApFo-1300. Photo taken October 19, 2018.***

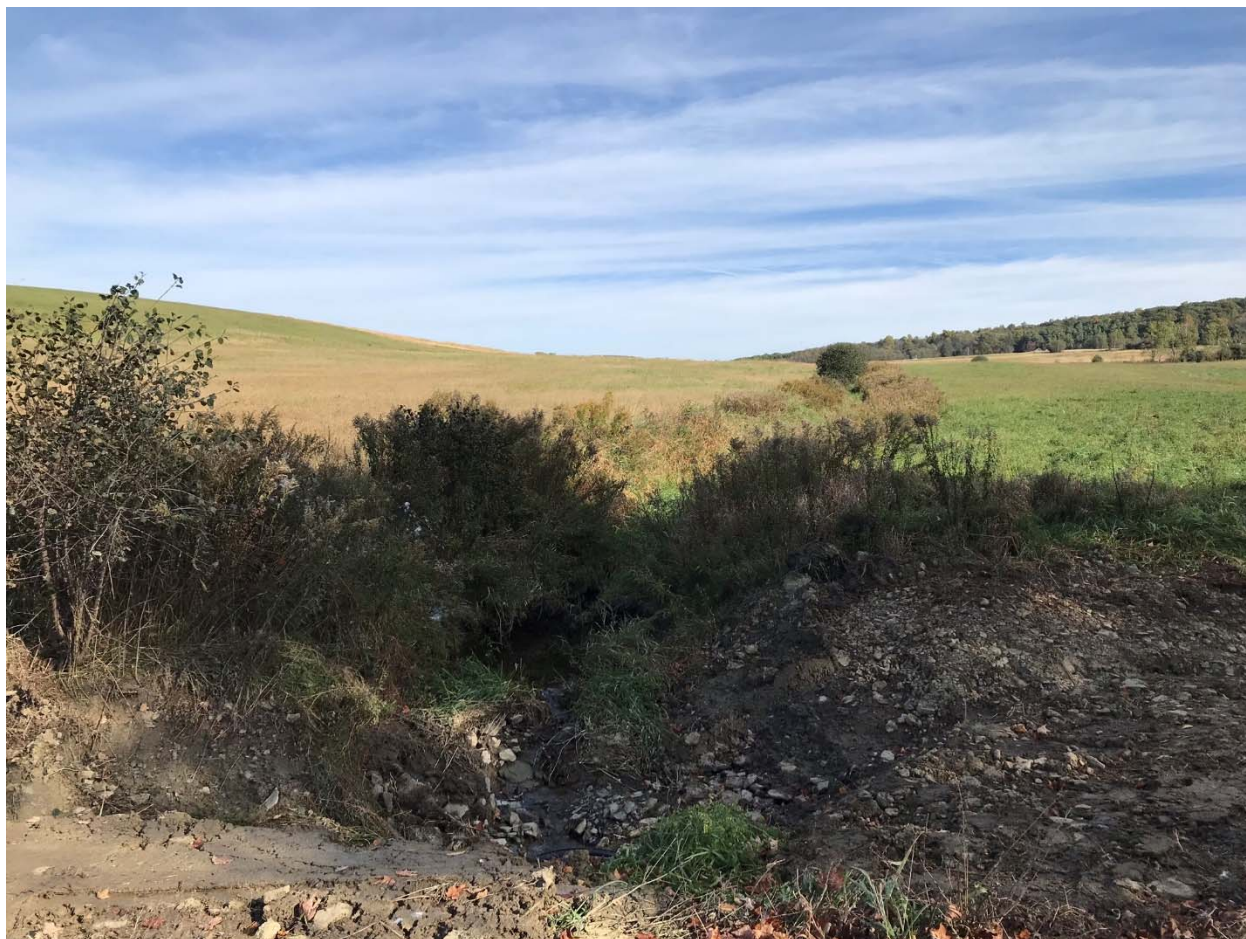
***Figure 39. Headwaters of Harnick Road tributary at ApHa-7600. Photo taken October 19, 2018.***

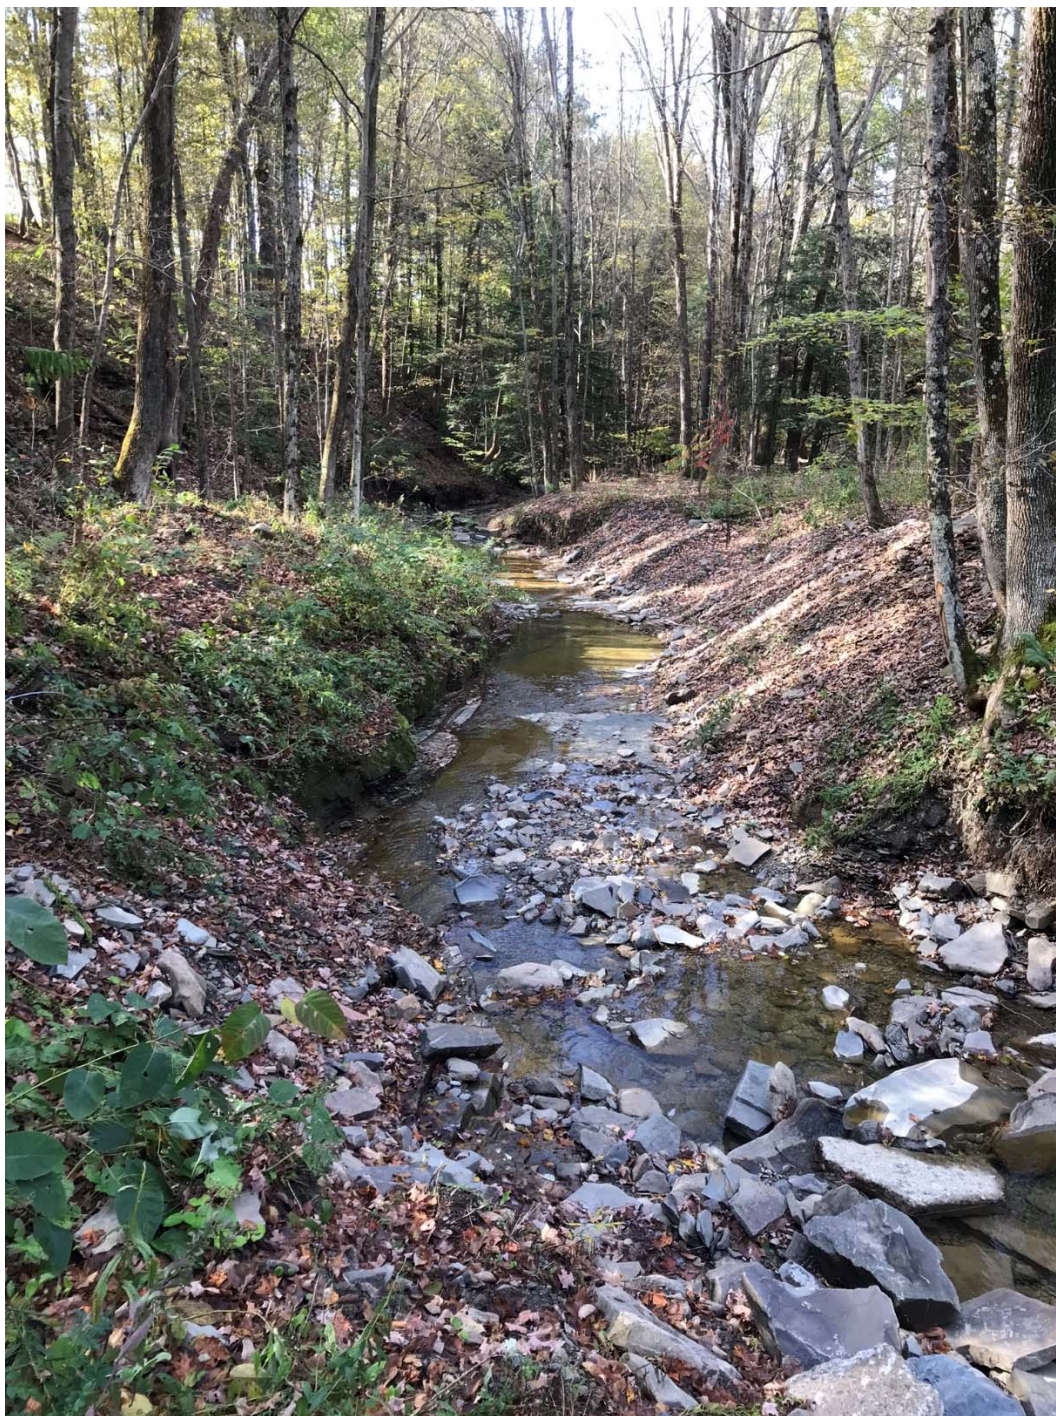
***Figure 41. Looking downstream from crossing at ApHa-5800. Photo taken October 19, 2018.***

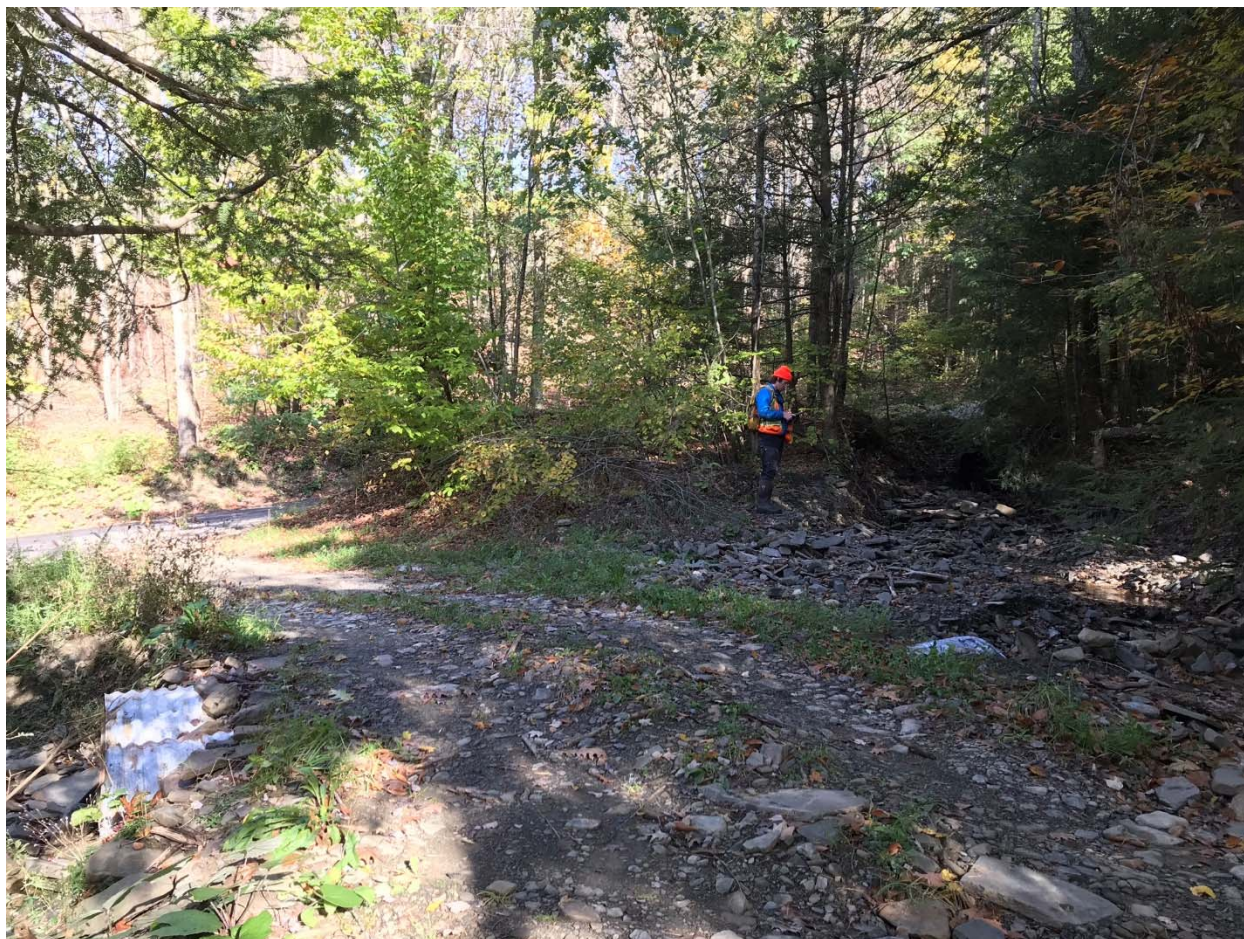
***Figure 43. Private field access off of Harnick Road at ApHa-2400. Photo taken October 19, 2018.***

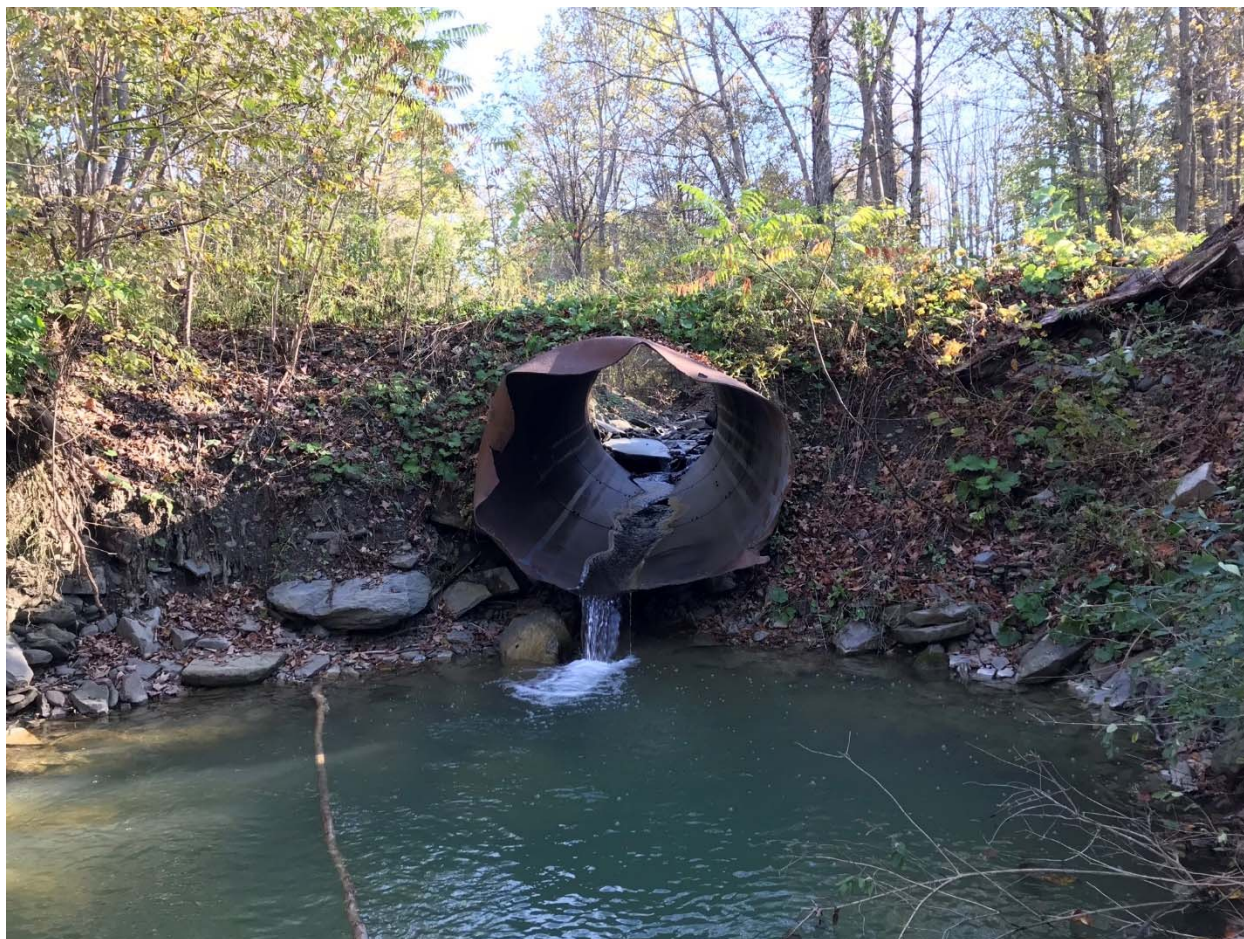
***Figure 44. Private access at ApHa-1100. Photo taken October 19, 2018.***

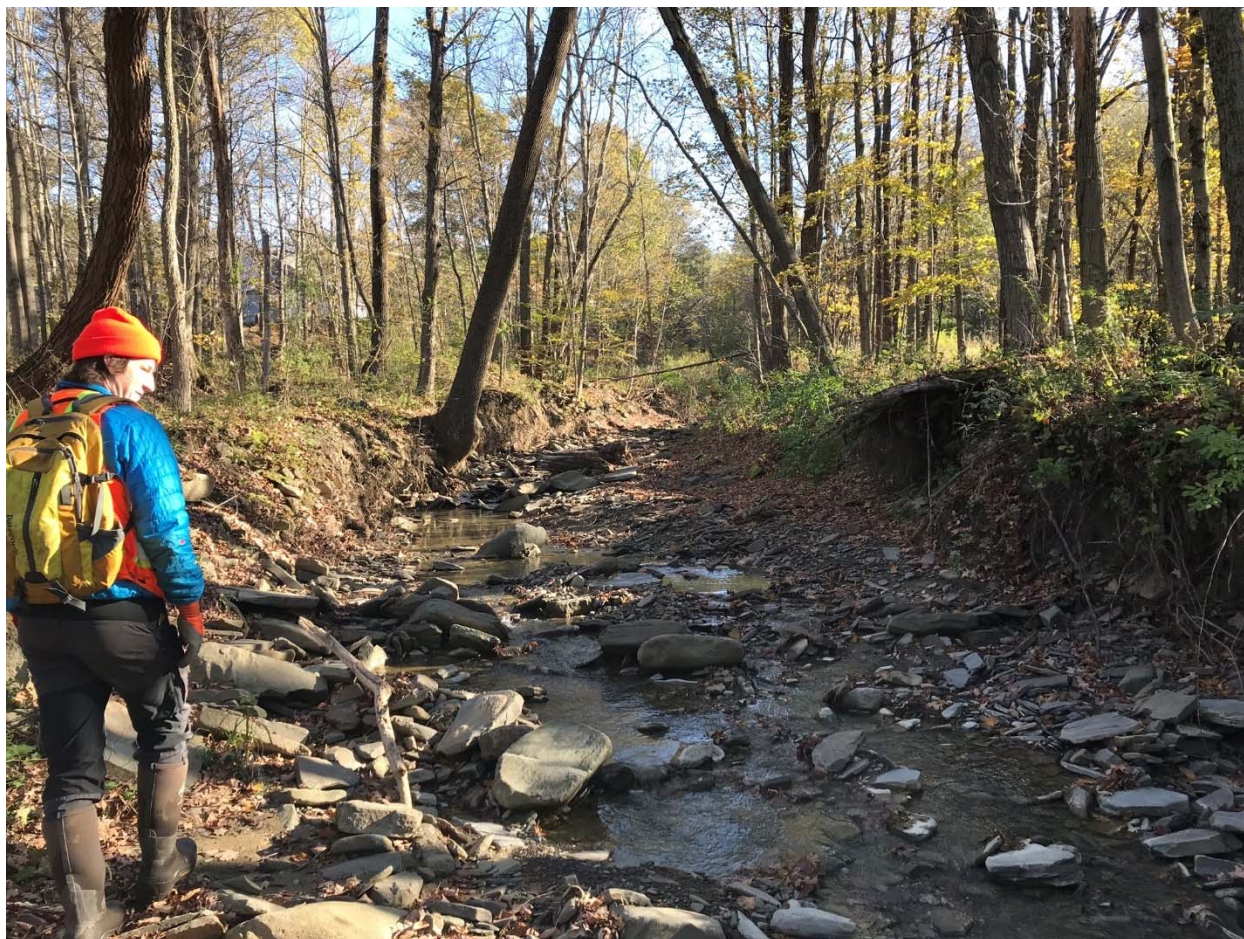
***Figure 45. Looking upstream at ApHa-300. Photo taken October 19, 2018.***

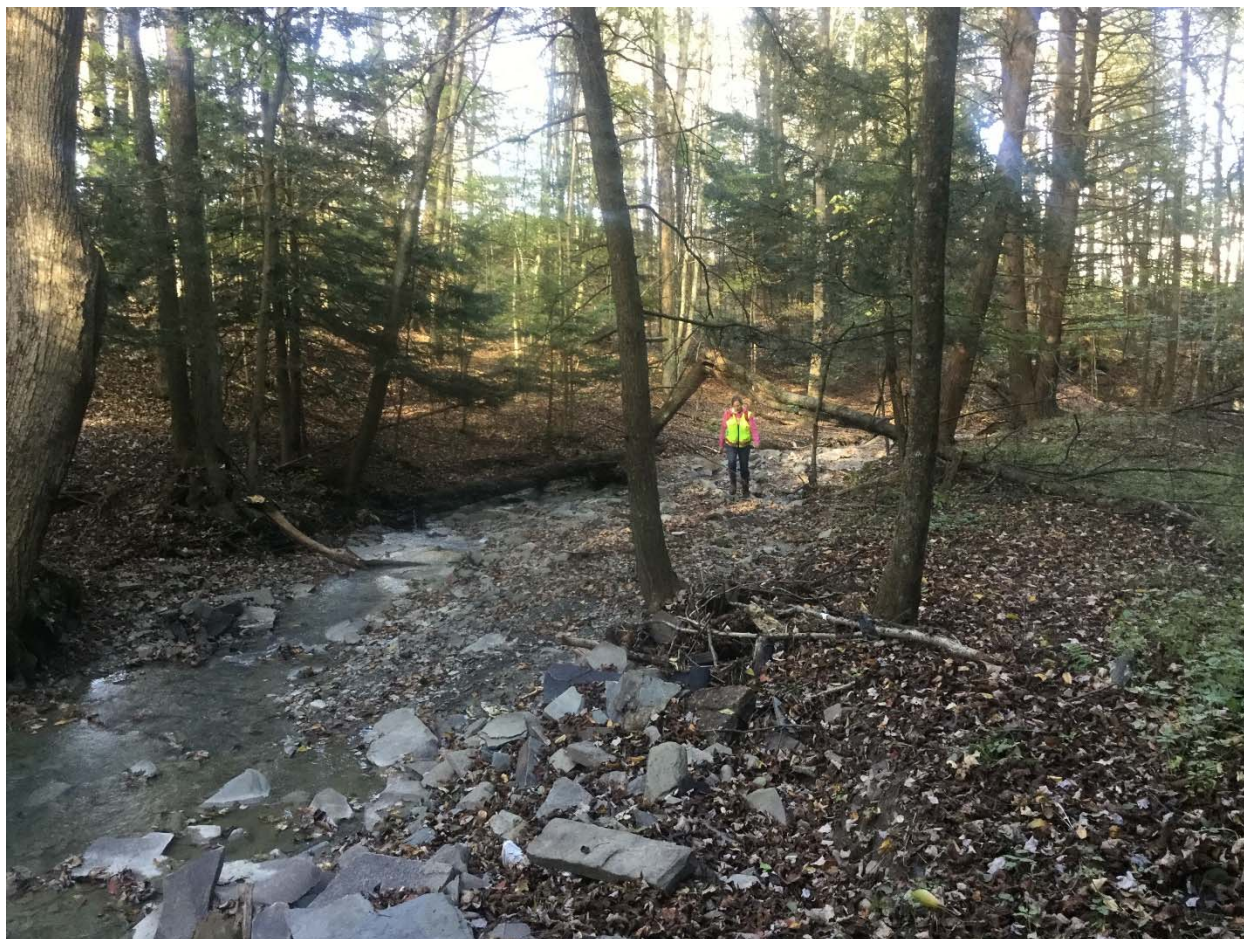
***Figure 48. Low-lying forest floor at ApCa-2800. Photo taken October 19, 2018.***

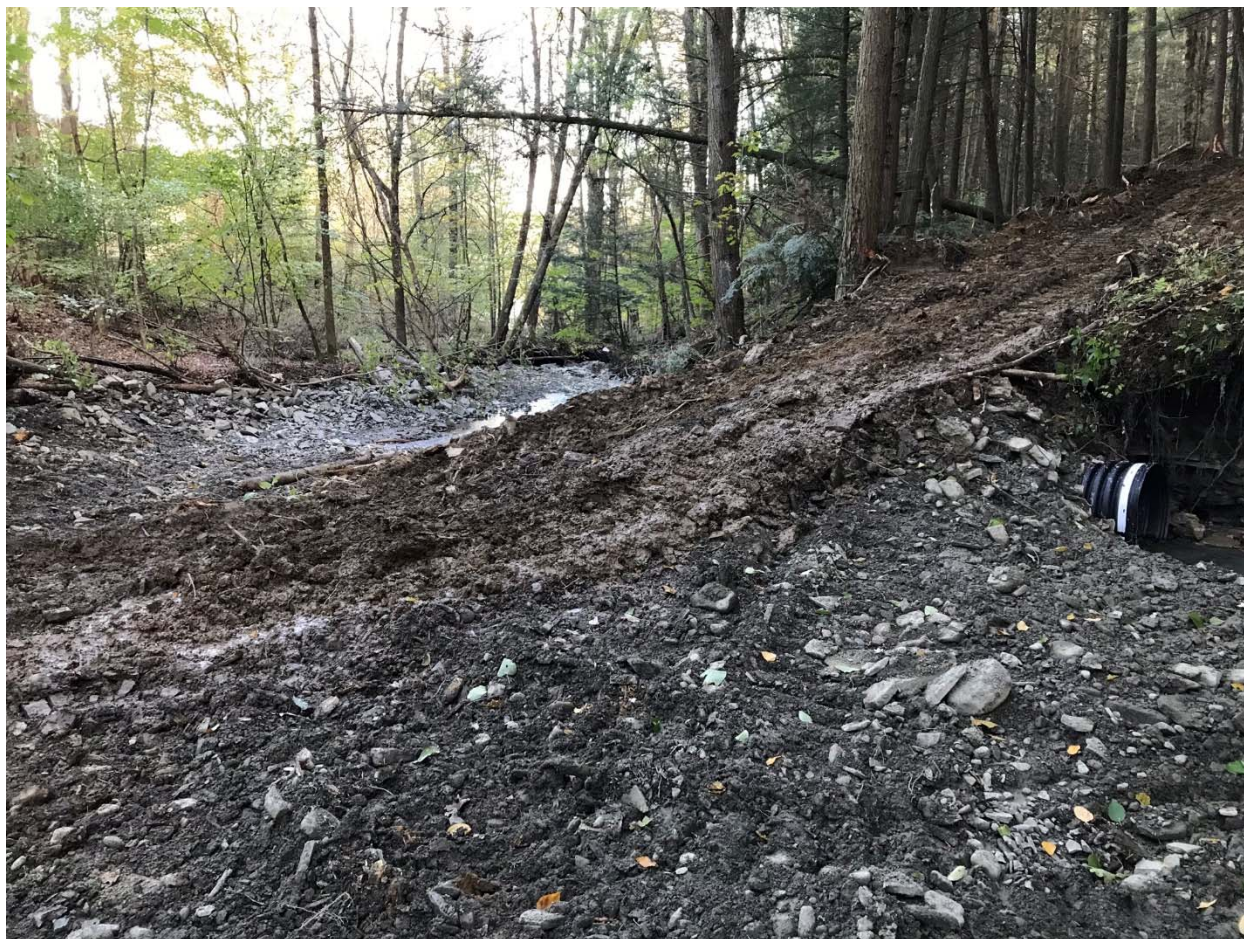
***Figure 49. Looking downstream at temporary crossing and new access constructed up steep right bank at ApCa-2400. Photo taken October 19, 2018.***

- ApCa-3500 and ApCa-2400 – These projects would reduce risk to downstream property and infrastructure and improve water quality;
- ApLo-9800 – This project would eliminate a flood hazard. The current level of funding is likely insufficient to complete construction of a comprehensive restoration project; however, the first steps of draining the pond and designing the project could be completed;

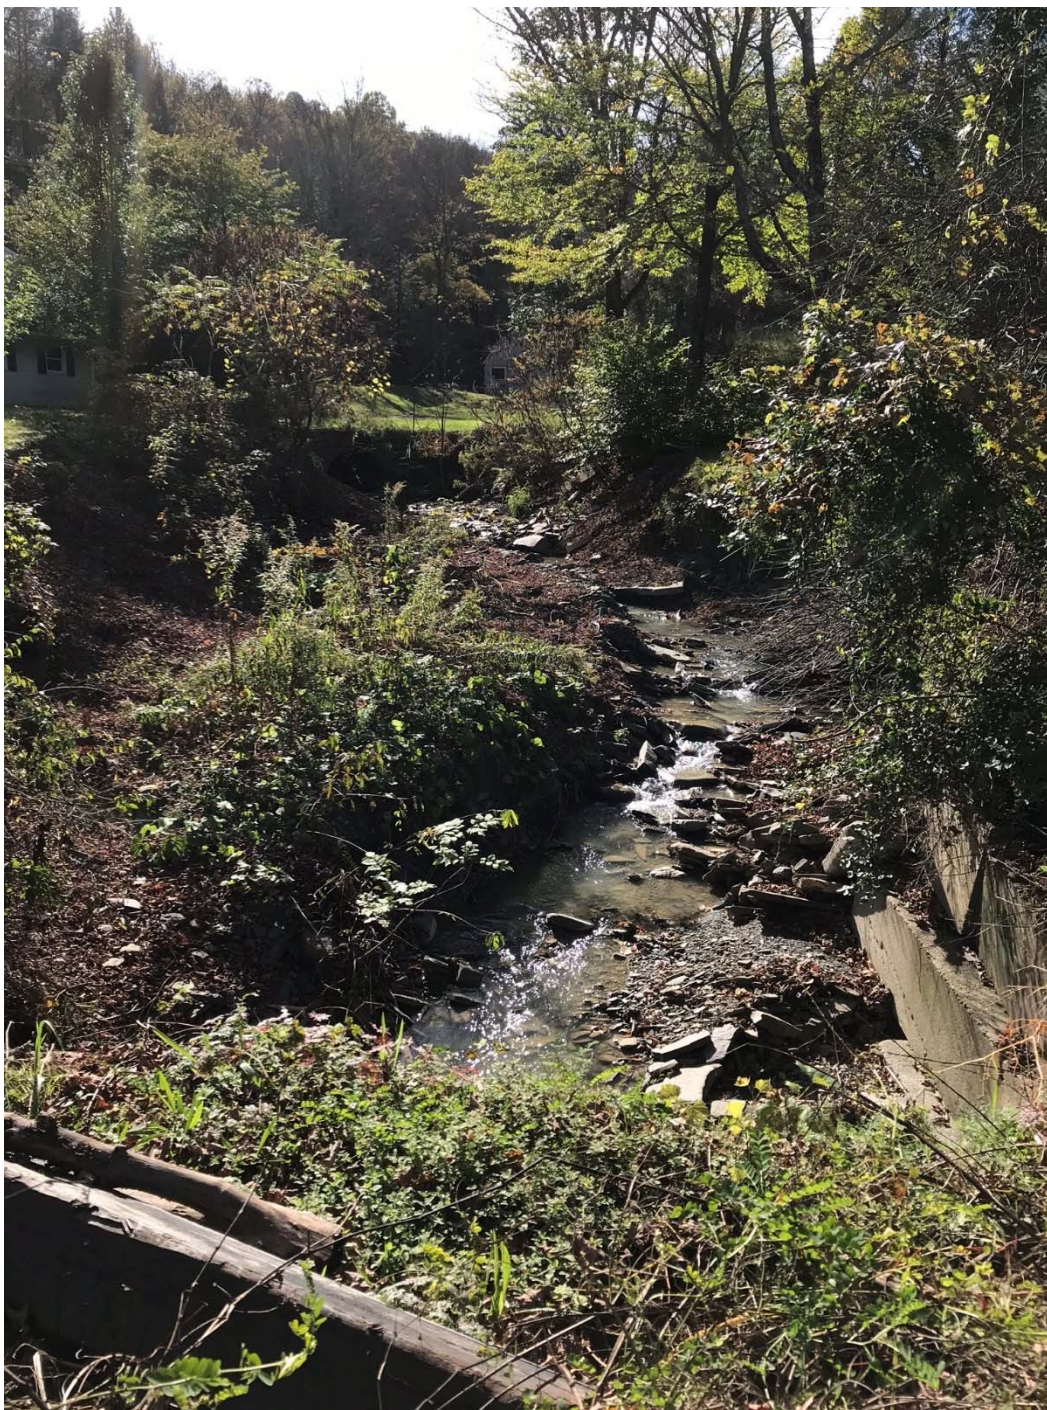
***Figure 50. The channel upstream of the Card Road crossing at ApCa-1400. Photo taken October 19, 2018.***

- One of the other crossing improvements where the current structural condition is critical and replacement would resolve an immediate risk to public safety. Potential projects include ApCa-1400, ApGa-600, and ApLo-3600. These are located in the downstream reaches of tributaries and therefore, the risk of exacerbating downstream flooding is low.

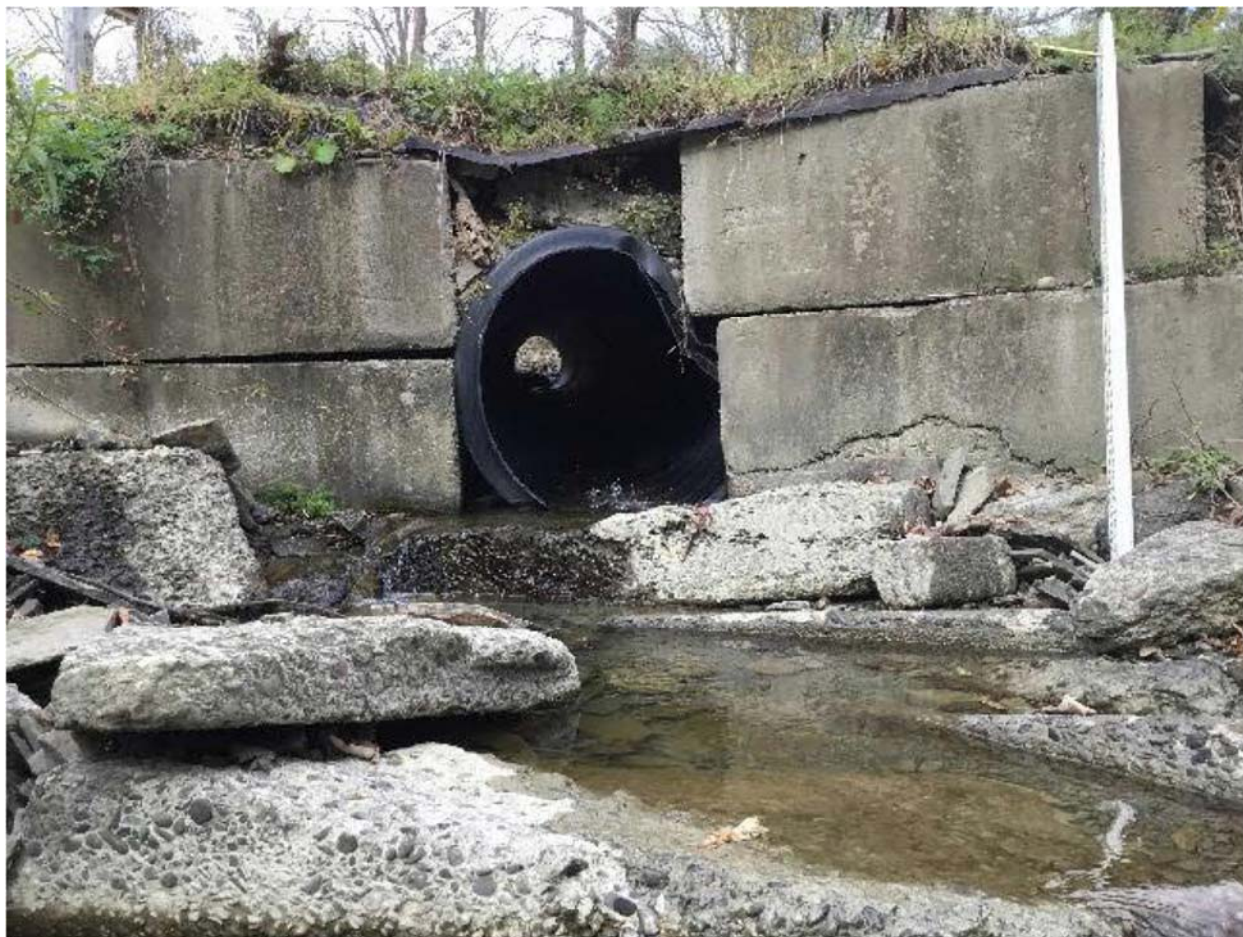
ApLo-12000	Crossing Improvement	The existing Long Creek Road crossing over a tributary to Long Creek appears undersized and is deformed with collapsed and misaligned wingwalls. Soil is eroding from beneath the road. At the time of assessment by Fuss & O'Neill, the road appeared to have been recently overtopped. Replace crossing with an appropriately sized open-bottom structure aligned with stream channel to improve road resilience and road user safety. Refer to Section 4.4 of Appendix B for more information.	Figure 61
ApLo-10800	Upland Land Management	Implement drainage improvements along Long Creek Road to slow runoff and reduce erosion. Repair road ditches and install ditch relief culverts where opportunities exist to divert flow into the forest and thus promote infiltration. Provide adequate erosion control at culvert outlets. Explore opportunities for runoff detention on private land throughout the watershed. Large parcels of agricultural land between Chestnut Hill Road and Long Creek Road appear to be good candidates.	Figure 62

***Figure 61. Outlet of perched and undersized Long Creek Road culvert carrying tributary to Long Creek at ApLo-12000. Photo credit Fuss & O'Neill.***

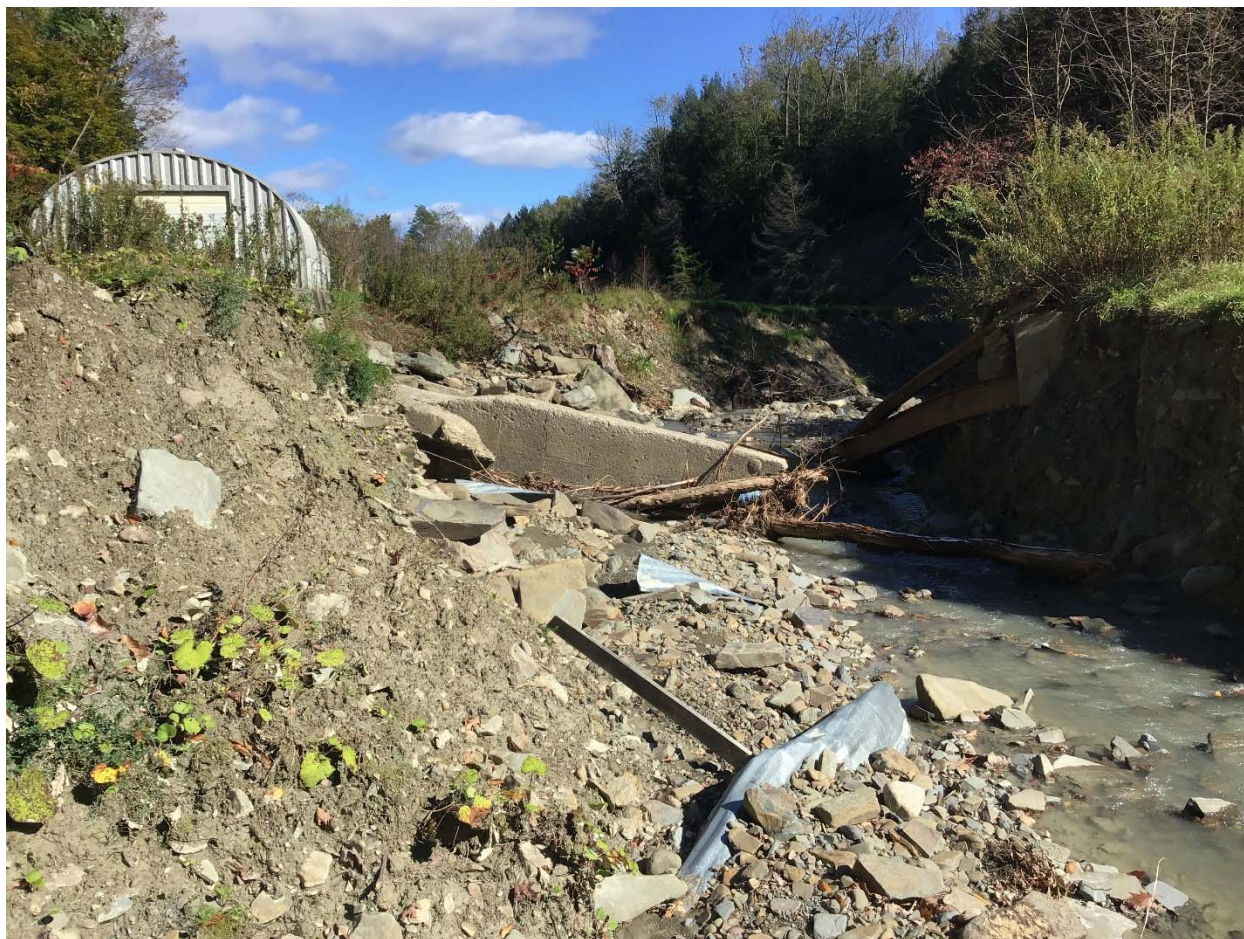
***Figure 65. Collapsed bridge at near upstream end of pond area at ApLo-9800. Photo taken October 19, 2018.***
