# Apalachin Creek Background Report

Tioga County Soil and Water Conservation District

**DECEMBER 2019**

Inter-Fluve Engineering  
501 Portway Avenue, Suite 101  
Hood River, OR 97031

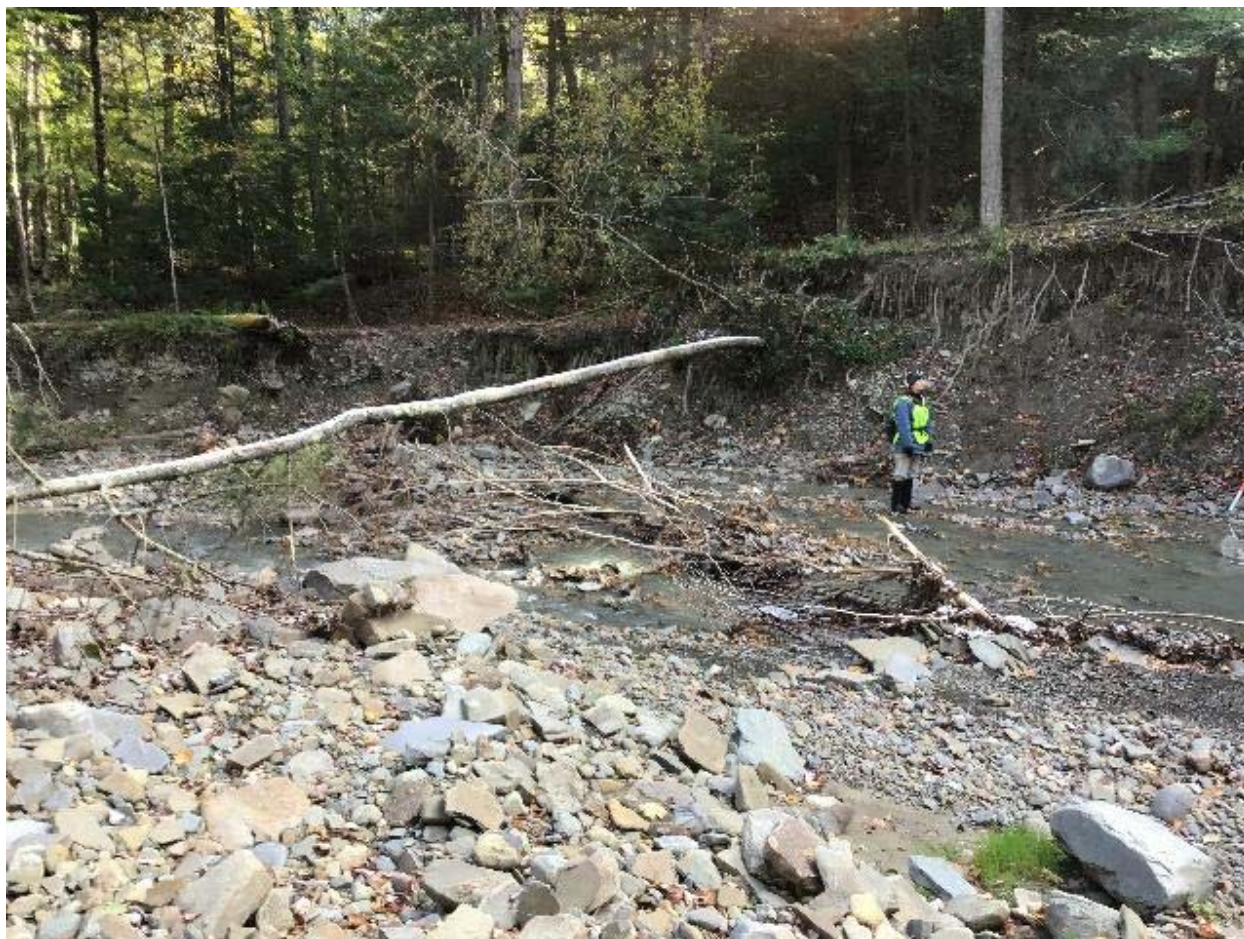
Project number	Type	Description	Photo or Image Reference
ApLo-3800	Bank Stabilization	<p>The 0.5-mile reach upstream of the corrugated metal arch Long Creek Road crossing (see ApLo-3600) marks the transition from the upper and lower portions of the watershed. The valley width increases and the valley and channel slopes decline in this reach, making it an area of coarse sediment and large wood deposition. As a result, the reach is geomorphically dynamic and experiences rapid changes including bank erosion. Rock bank protection was previously installed intermittently along the left bank where bank erosion threatens Long Creek Road or residential properties; however, some of the rock has been displaced or is flanked by upstream or downstream bank erosion. Along river right, the creek is eroding into high, unvegetated banks of till that are contributing to the coarse sediment load. Small, steep drainage channels entering from both banks also contribute sediment. Riparian buffer is absent from most of the left bank and some of the right bank. Stabilize the banks at key locations using engineered large wood and/or rock to reduce sediment input and protect private property and infrastructure, regrade banks to more stable angles, and install native seed and plants to encourage vegetative cover. Install engineered wood and/or rock structures to stabilize the beds of the small drainage channels entering the creek and capture sediment. Establish riparian buffer.</p>	Figure 67, Figure 68

***Figure 67. Eroding bank at ApLo-3800. Photo taken October 18, 2018.***

- ApLo-3800– This project would help protect Long Creek Road and residential properties and would reduce coarse sediment input;
- ApDI-23700 – This project would resolve an immediate risk to infrastructure and public safety. This culvert is located in the upstream reaches of the watershed; the risk of exacerbating sedimentation or flow issues by replacing the culvert is considered low as long as the recommended grade control measures are installed; or

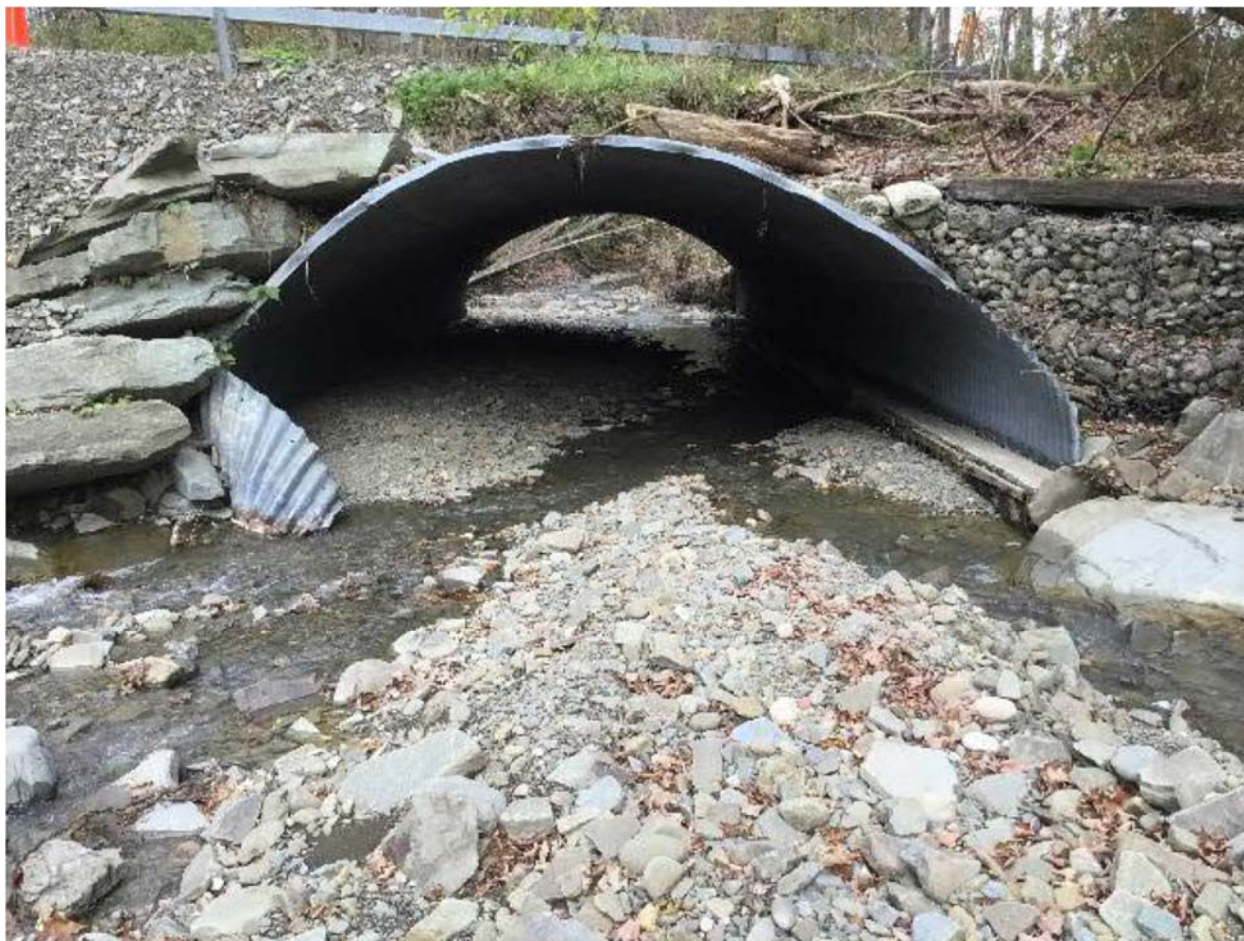
ApLo-3600	Crossing Improvement	<p>The existing Long Creek Road crossing is misaligned and deformed with footings exposed. Erosion of the road embankment is undermining the guard rail and possibly the road and bank erosion is evident upstream and downstream of culvert. Gabions are present on the right bank downstream of the culvert. Replace the culvert with an appropriately sized open-bottom structure correctly aligned with the stream channel. Remove the existing gabions and stabilize both banks over a 150-foot length upstream and downstream of the culvert using engineered large wood and/or rock. Regrade the banks to more stable angles and install native seed and plants. Refer to Section 4.3 of Appendix B for more information.</p>	Figure 69

**Figure 69. Culvert inlet at ApLo-3600. Photo credit Fuss & O'Neill.**

- One of the other crossing improvements where the current structural condition is critical and replacement would resolve an immediate risk to public safety. Potential projects include ApCa-1400, ApGa-600, and ApLo-3600. These are located in the downstream reaches of tributaries and therefore, the risk of exacerbating downstream flooding is low.

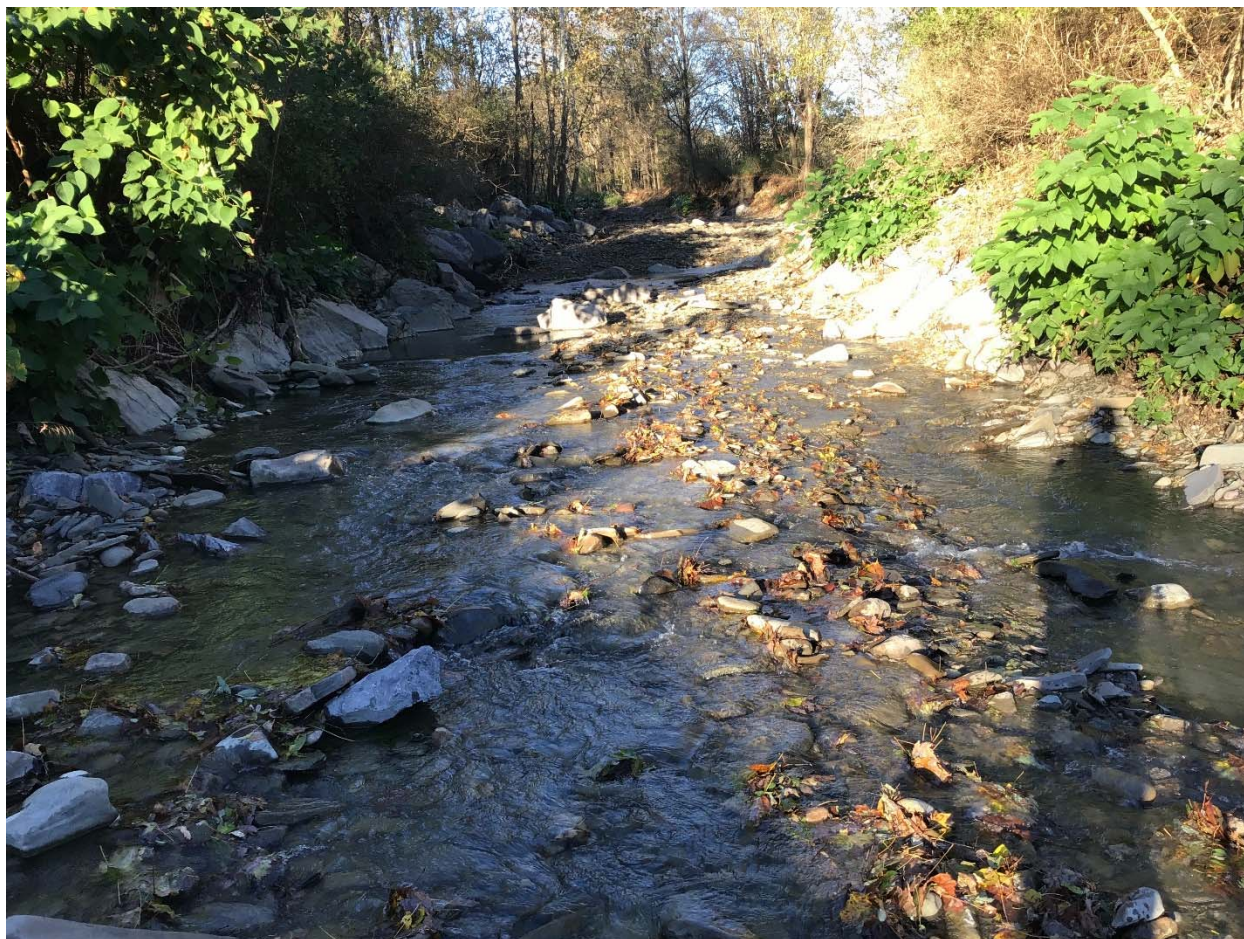
Project number	Type	Description	Photo or Image Reference
ApLo-400	Riparian Management	Long Creek at Pennsylvania Avenue is within a natural zone of deposition near the confluence with Apalachin Creek. Although outside the 1% annual chance flood extent of Apalachin Creek, the bridge at Pennsylvania Avenue sustained damage in 2011 and was replaced. The reach upstream of Pennsylvania Avenue has been straightened and dredged, and the channel bed is currently approximately 5 feet below the floodplain. Restore the riparian zone by removing existing bank protection measures and improving riparian cover on the banks by treating invasives and installing native seed and plants. The length of treatment would be approximately 500 feet. Establish dredging thresholds and limits (horizontal as well as vertical) to reduce the frequency and volume of local dredging operations, avoid over dredging, and avoid initiating headcuts that exacerbate the problem. Remove berms that have been constructed from dredged material. Refer to Section 4.2 of Appendix B for more information on the Pennsylvania crossing over Long Creek.	Figure 70, Figure 71

***Figure 71. Long Creek channel at ApLo-400. Channel has been straightened and dredged, minimizing potential access to former floodplain. Note rock bank protection and the presence of the invasive Japanese knotweed on the banks. Photo taken October 18, 2018.***

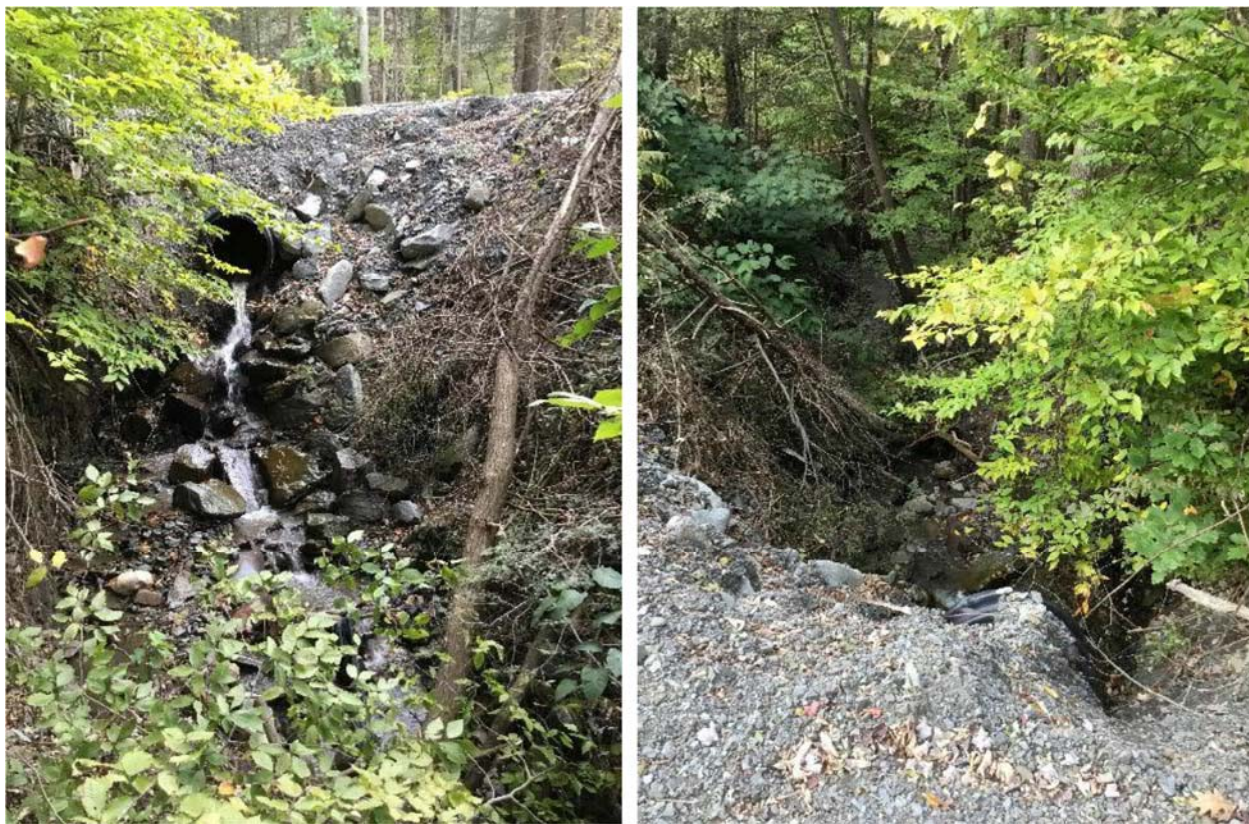
ApDI-23700	Crossing Improvement	The existing Chestnut Ridge Road culvert appears to be undersized and is in poor condition with road material eroding over the banks at the upstream and downstream openings. There is a substantial grade change across the culvert, and the downstream end is perched. Replace the culvert with an appropriately sized embedded structure aligned with the stream channel and install guardrails to reduce risk of flood damage, reduce the risk of blockage, and improve road user safety. Install a series of engineered large wood and/or rock structures in the downstream ravine to establish grade control, slow flows, and trap coarse sediment. Refer to Section 4.5 of Appendix B for more information.	Figure 72
ApDI-21100	Crossing Improvement	Twin HDPE pipes carry Deerlick Creek past a natural gas pipeline crossing. The culverts appear undersized, the inlets were clogged with debris on the day of the field assessment, and the outlets are perched. The level of the pipeline crossing in relation to the culvert is unknown and requires further investigation. Coordinate with the gas company to replace the culverts with an appropriately sized structure to improve resilience of the pipeline crossing and provide aquatic organism passage.	Figure 73

***Figure 72. Chestnut Ridge Road crossing at ApDI-23700. Left image shows perched outlet. Right image is looking downstream along Deerlick Creek. Photo credit Fuss & O'Neill.***

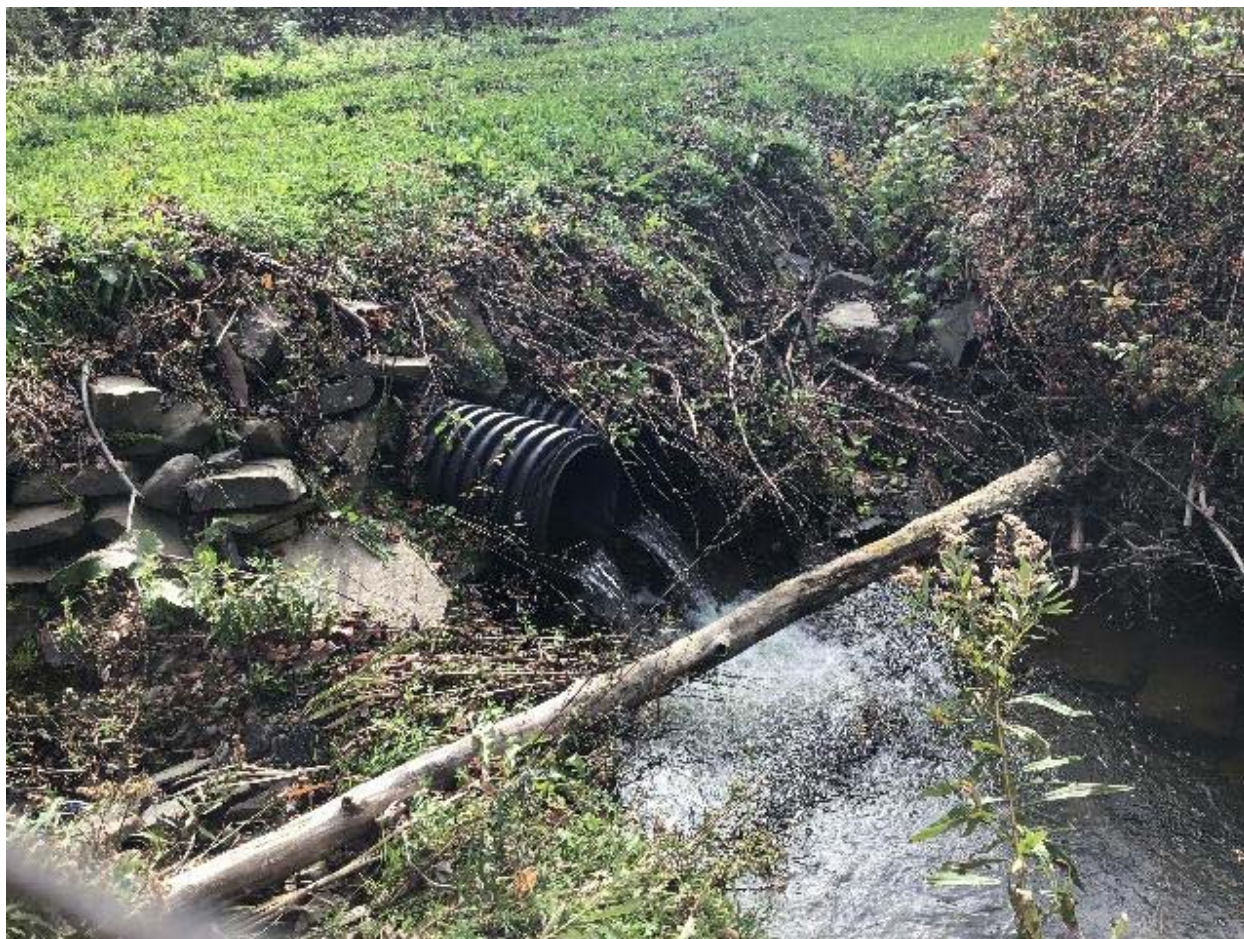
***Figure 73. Twin undersized and perched culverts at ApDI-21100. Photo taken October 18, 2018.***

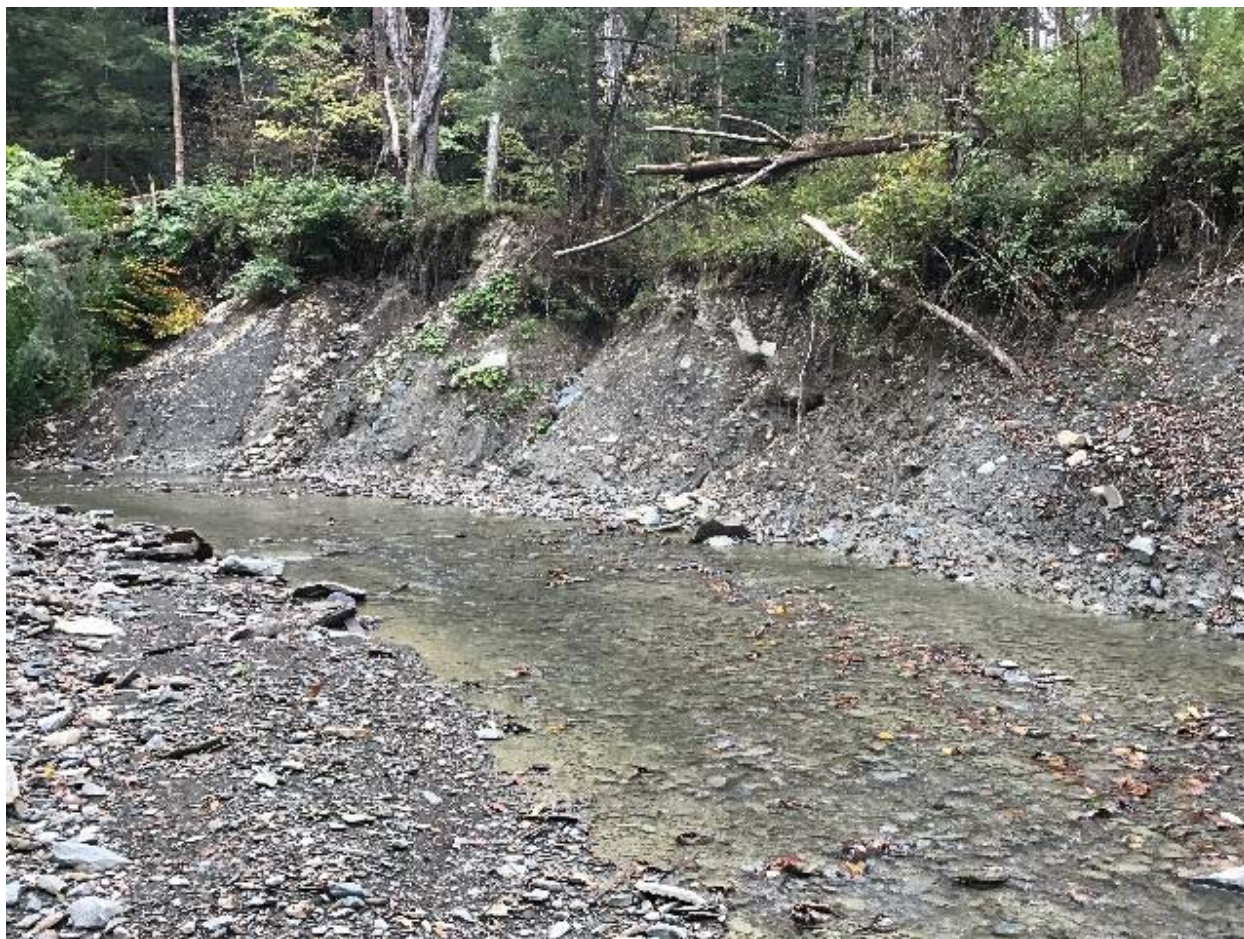
ApDI-9000	Grade Control	The bed level along an approximately 1,000-foot reach currently sits 10 to 15 feet below the top of the bank. Bank failure has contributed some large wood to the channel, but natural jam structures that could help trap sediment and slow erosion are generally absent. Install a series of engineered large wood and/or rock structures to establish grade control, slow flows, and trap coarse sediment.	Figure 74

***Figure 74. Eroding bank at ApDI-9000. Photo taken October 18, 2018.***

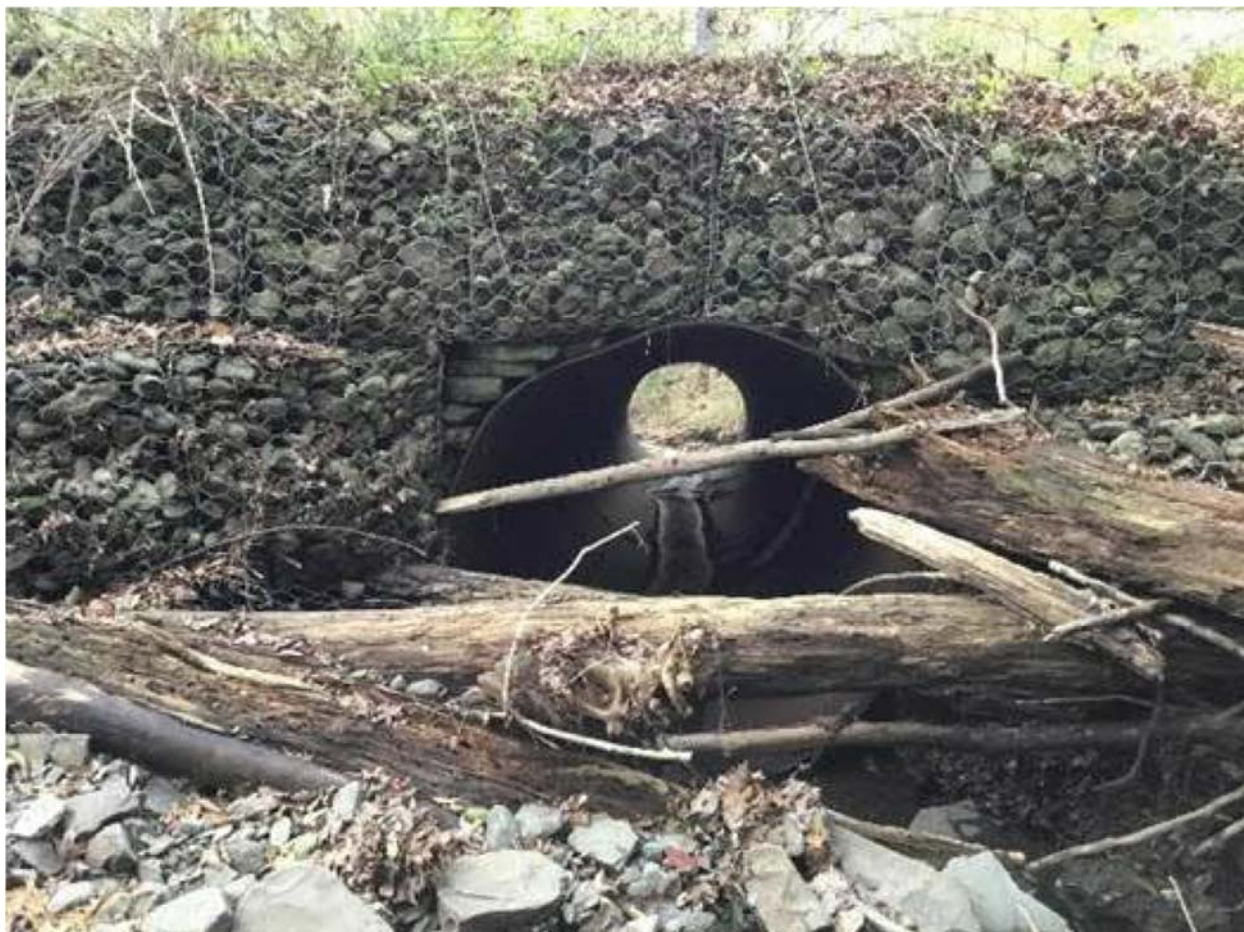
Project number	Type	Description	Photo or Image Reference
ApDI-8900	Crossing Improvement	The culvert under Beach Road carrying a small tributary to Deerlick Creek appears to be undersized. The upstream gabion headwall is deformed and collapsing, and upstream and downstream banks are eroding and overhanging. The inlet is partially blocked by debris, and a substantial volume of coarse sediment is deposited in the channel upstream. The downstream outlet is perched by approximately 5 feet above the streambed which is scoured down to bedrock. Replace the culvert with an appropriately sized open-bottom structure to reduce the risk of flood damage, reduce the risk of blockage, and improve road user safety. Remove the gabions and stabilize the banks over approximately 100 feet upstream and downstream using engineered large wood and/or rock and riparian plantings. Install a series of engineered large wood and/or rock structures to establish grade control in the downstream channel. Refer to Section 4.1 of Appendix B for more information.	Figure 75

***Figure 75. Undersized and blocked Beach Road tributary culvert inlet at ApDI-8900. Photo taken October 18, 2018.***

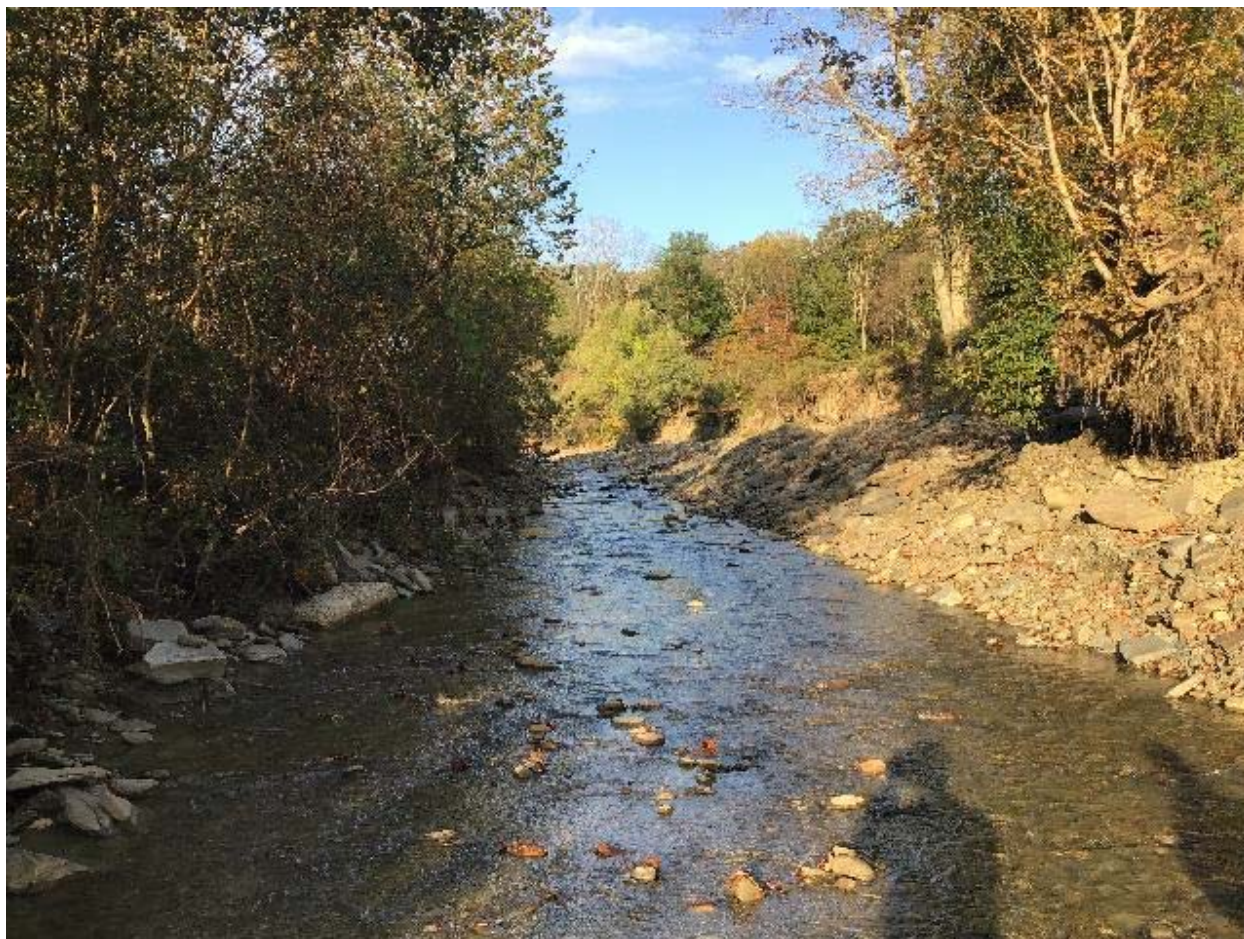
***Figure 76. Deerlick Creek at ApDI-1500. Channel has been straightened and dredged, minimizing potential access to former floodplain. Photo taken October 18, 2018.***

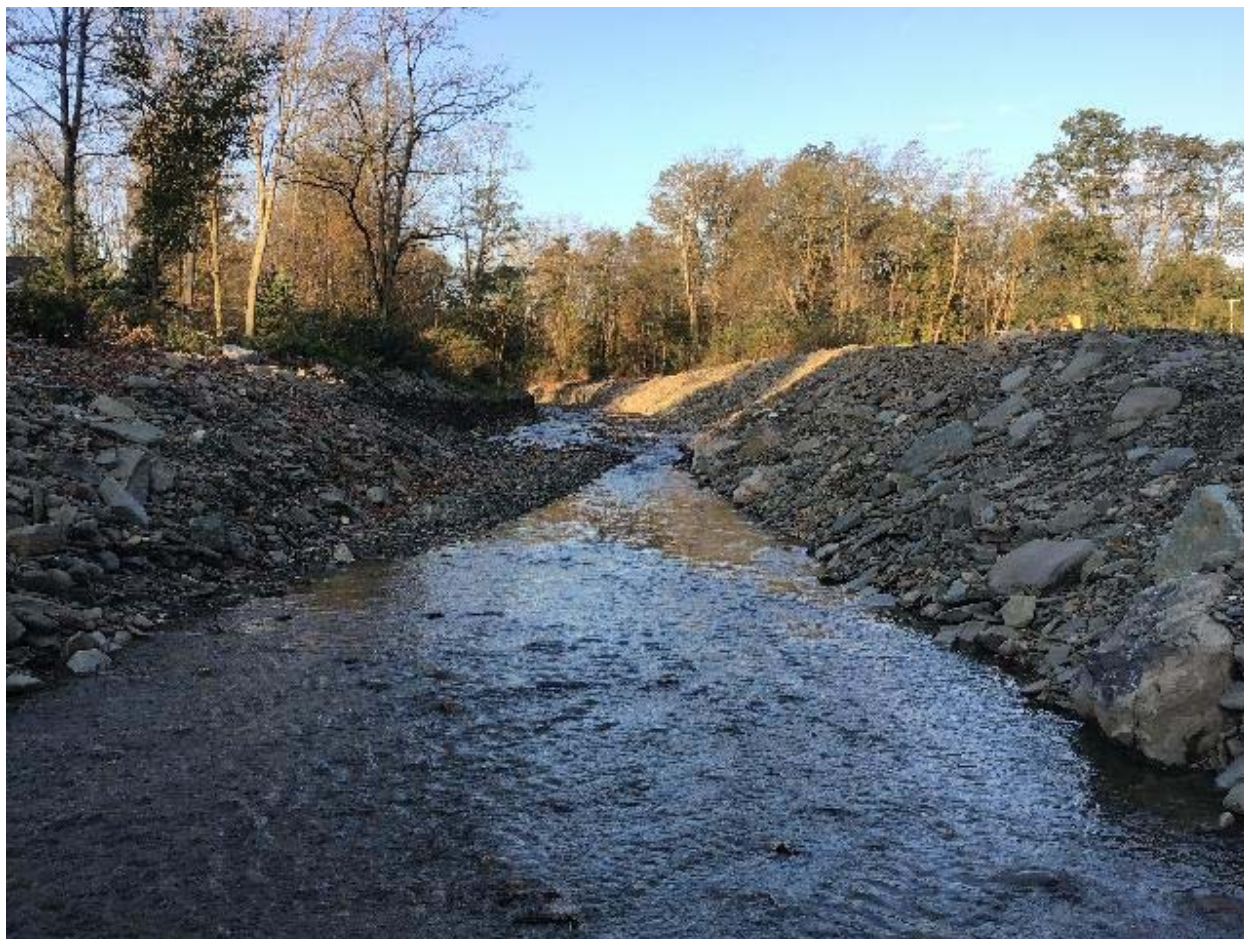
ApDI-1500	Floodplain Reconnection	The channel bed over an approximately 1,500-foot reach is 5 to 10 feet below the surrounding floodplain. Riparian buffer is absent, and the channel appeared to have been recently dredged at the time of the survey and material piled up at the tops of the banks to form berms. A private field crossing to access the right bank floodplain is present. Purchase the portion of the parcel that includes the right bank or establish a conservation easement, and remove the private crossing and small outbuildings on the right bank. Install a series of engineered large wood and/or structures to improve channel connection to the floodplain and trap coarse sediment. Remove berms, revegetate the banks, and establish riparian buffers.	Figure 76
ApDI-500	Structure Removal	The channel upstream and downstream of Pennsylvania Avenue has been straightened and dredged with dredged material piled up along the tops of the banks to form berms. The Faith Christian Fellowship Church at the corner of Pennsylvania Avenue and Beach Road has sustained repeated flood damage in recent decades. Buy out or raise the church and buy out the property on the right bank to give the stream space and opportunity to migrate laterally, access overbank areas, and deposit and process sediment. Remove the berms and affected structures that are not being raised, and improve riparian cover on the banks by installing native seed and plants. Install bank erosion countermeasures immediately upstream of the Pennsylvania Avenue bridge to manage the return of flood flows into the channel. At the Pennsylvania Avenue crossing itself, establish dredging thresholds and limits (horizontal as well as vertical) to reduce the frequency and volume of local dredging operations, avoid over dredging, and avoid initiating headcuts that exacerbate the sedimentation problem.	Figure 77

***Figure 77. Deerlick Creek at ApDI-500. Channel has been straightened and dredged, minimizing potential access to former floodplain. Photo taken October 18, 2018.***

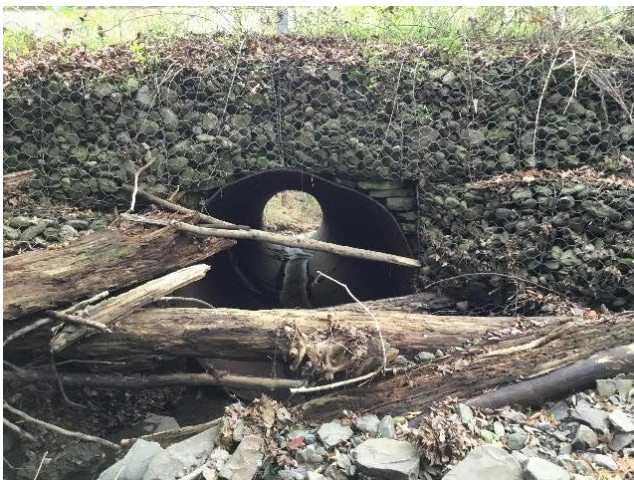
- The structure inlet is partially blocked by debris. Gabions at the inlet are collapsing and the structure is deformed at the inlet.
- The structure, as designed, has sufficient hydraulic capacity to convey the 100-year peak flow, although the flow capacity is reduced by the debris blockage at the inlet. The structure width is significantly smaller than bankfull width, which constricts streamflow.
- The structure outlet is perched approximately 4.6 feet above the downstream streambed.
- The streambanks upstream and downstream of the structure are eroded and overhanging.
- The streambed downstream of the structure has been scoured to bedrock, while a substantial amount of sediment has been deposited upstream of the culvert.

Beach Road over Unnamed Tributary to Deerlick Creek - structure inlet. Note debris blocking inlet. Gabions behind debris near culvert base are partially or fully collapsed.

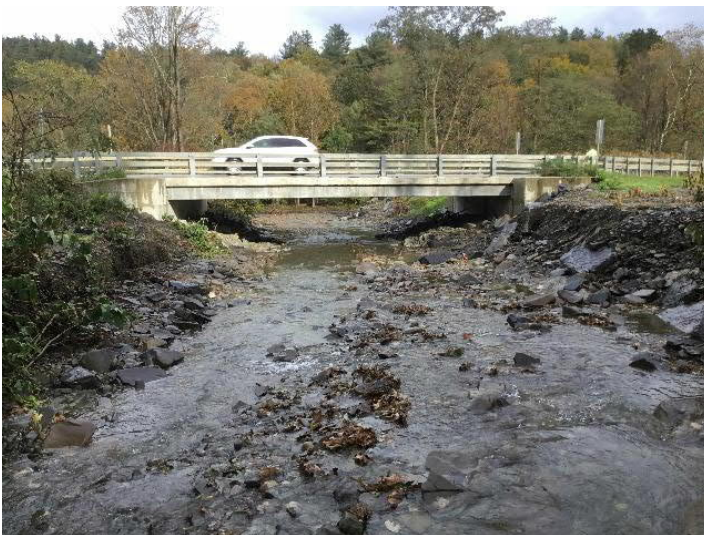
- The streambanks on the upstream side of the crossing and the armoring below the structure are severely eroded.
- The structure has sufficient hydraulic capacity to convey the 100-year peak flow.

Pennsylvania Avenue over Long Creek - structure inlet. Note the bank erosion on the upstream side of the crossing and scour of the embankment at the crossing structure.

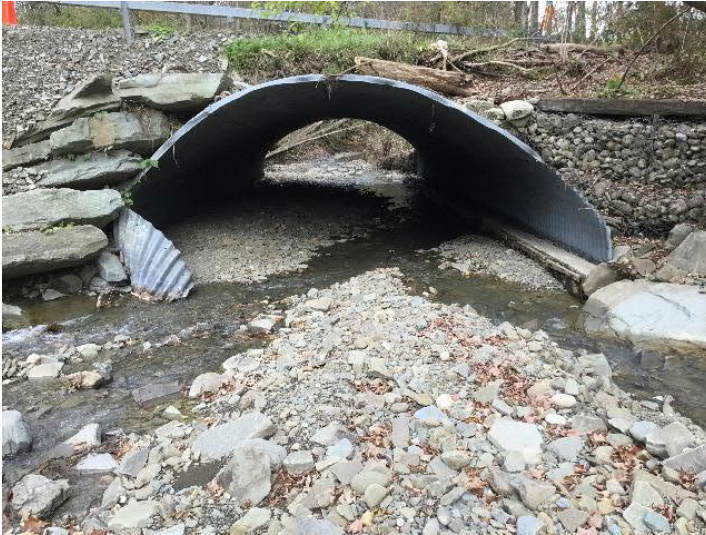
- The structure has sufficient hydraulic capacity to convey the 100-year peak flow, although this capacity has likely been reduced due to sediment deposits at the inlet and within the structure. The crossing also constricts streamflow since the structure is significantly narrower than bankfull width.
- Erosion of material from the road embankment threatens the integrity of the guardrail and possibly the road.
- The structure is deformed and undermined, and footings are exposed.
- At the outlet, gabions are used to armor the downstream right bank for over 150 feet. The other streambanks both upstream and downstream of the structure are severely eroded.
- Sediment deposits are located in the channel and in the structure.

Long Creek Road over Long Creek (downstream of Section 4.4 crossing) - structure inlet. Note different wingwall materials on either side of outlet; exposed footings; and deformation of structure.

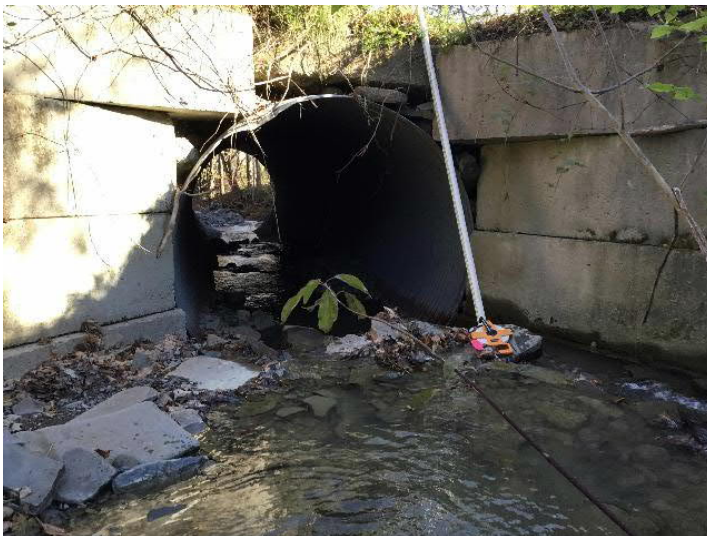
- The structure is capable of passing the 100-year peak flow, but constricts streamflow given its narrow width relative to bankfull flow.
- The structure's upstream and downstream headwalls are misaligned.
- The streambanks upstream and downstream of the structure are eroded and overhanging.

Card Road over Unnamed Tributary (Card Road Tributary) to Apalachin Creek - structure inlet. Note misaligned headwall, constriction in stream, and sharp bend in stream as it approaches the culvert.
