Wappasening Creek Background Report

Tioga County Soil and Water Conservation District

AUGUST 2019

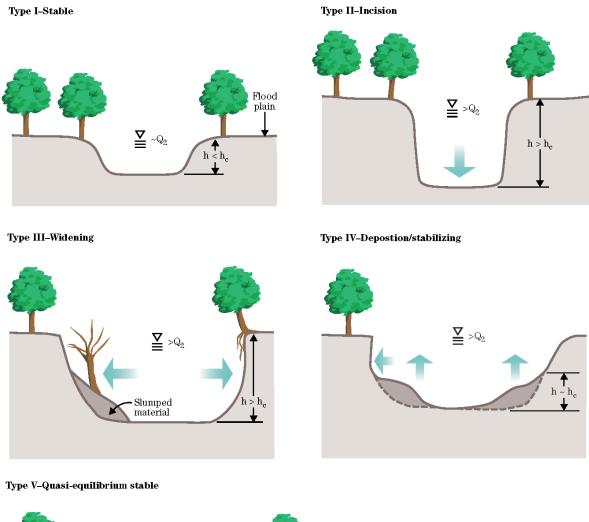
Figure 17. Conceptual model of incision channel evolution by Schumm et al. (1984). Reprinted from USDA NRCS (2008).

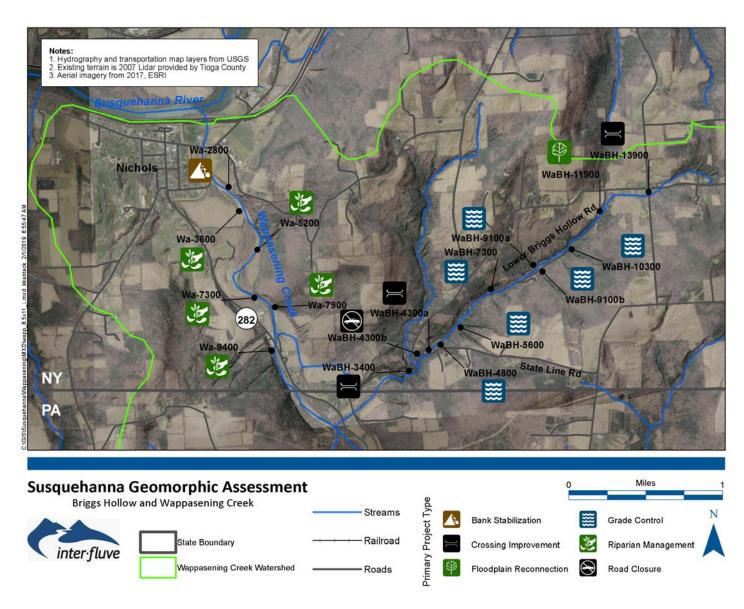
Figure 18. Map of site-specific potential flood mitigation and resilience construction projects. Refer to Table 3 for descriptions.

A map of site-specific construction projects is provided in Figure 18. At each site, a project number has been assigned based on the distance of the site from the mouth of the stream (e.g., WaBH-3400 is located 3,400 feet upstream of the Briggs Hollow tributary confluence with Wappasening Creek). For each project that involves treatment over an extended length of the channel, the project number and and location marker is set at the downstream limit of treatment; the corresponding project description in Table 3 provides the distance that the treatment extends upstream of that point.
